SYNERGISM IN CONDITIONS EVALUATION TECHNOLOGIES: THE EXAMPLE OF THE SAN JUAN FORTIFICATION WALLS

J. FEINBERG¹, D. WOODHAM² & C. CITTO²

The original construction of the San Juan fortification walls in Puerto Rico dates from the mid-16th century. The fortifications were constructed with the single purpose of defending the City of San Juan and its harbour from attack, principally by sea. Over a four-century period of construction and reconstruction, the fortification walls evolved from one construction typology into at least ten identifiable types. The walls investigated in this study are 750 m long and 15 m high, and include two bastions and the San Juan Gate. The challenging task of evaluating such complex structures required the synergism between historic research and modern diagnostic techniques to develop a deep understanding of the history, materials and structural behaviour of the fortification walls. In addition to historic research, 21st-century technologies selected to evaluate the walls included laser scans, digital photo-documentation, wall coring, remote visual inspection of the core interior, microwave radar scans, thermography, characterization of stone and mortar typ

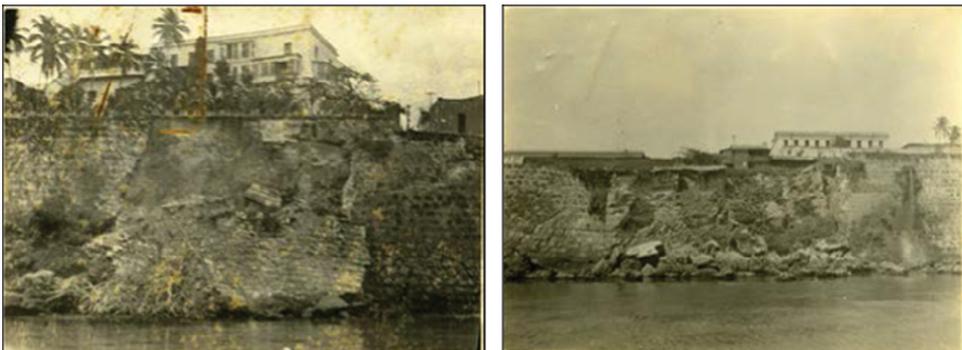
Figure 3: Historic photos documenting past collapses of wall sections of Casa Blanca Scarp circa 1922, at left, and of El Polvorín Scarp circa 1922, at right.

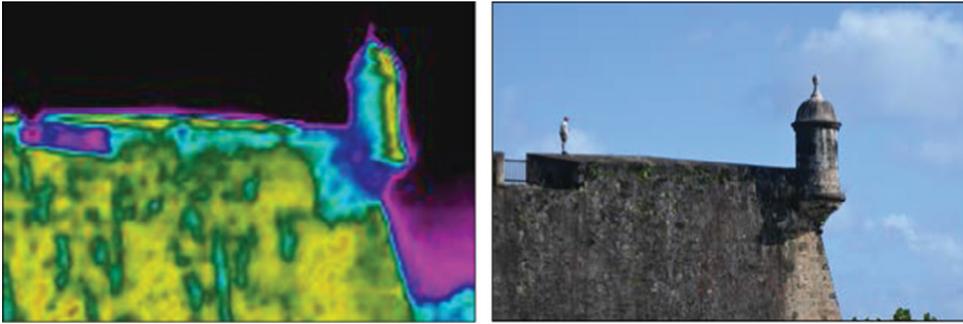
Figure 5: Thermal (left) image and visible light (right) of Santa Elena Bastion. The blue-green areas in the thermal image show areas with dampness in the masonry.

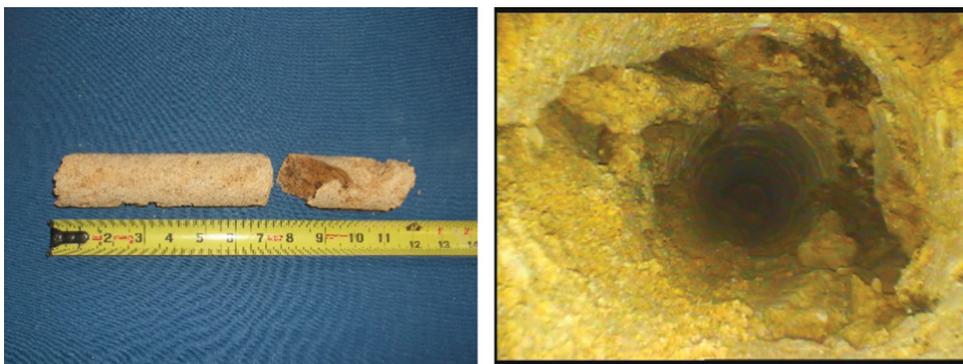
borescope with colour video recording, clearly indicating the subsurface conditions including the significant lack of mortar and prevalence of voids (Fig. 6).

Figure 6: Comparison between a segment of wall section retrieved by deep coring at a depth of 0.55–0.85 m (left) and a videoscopic image of the interior of the core hole (right).

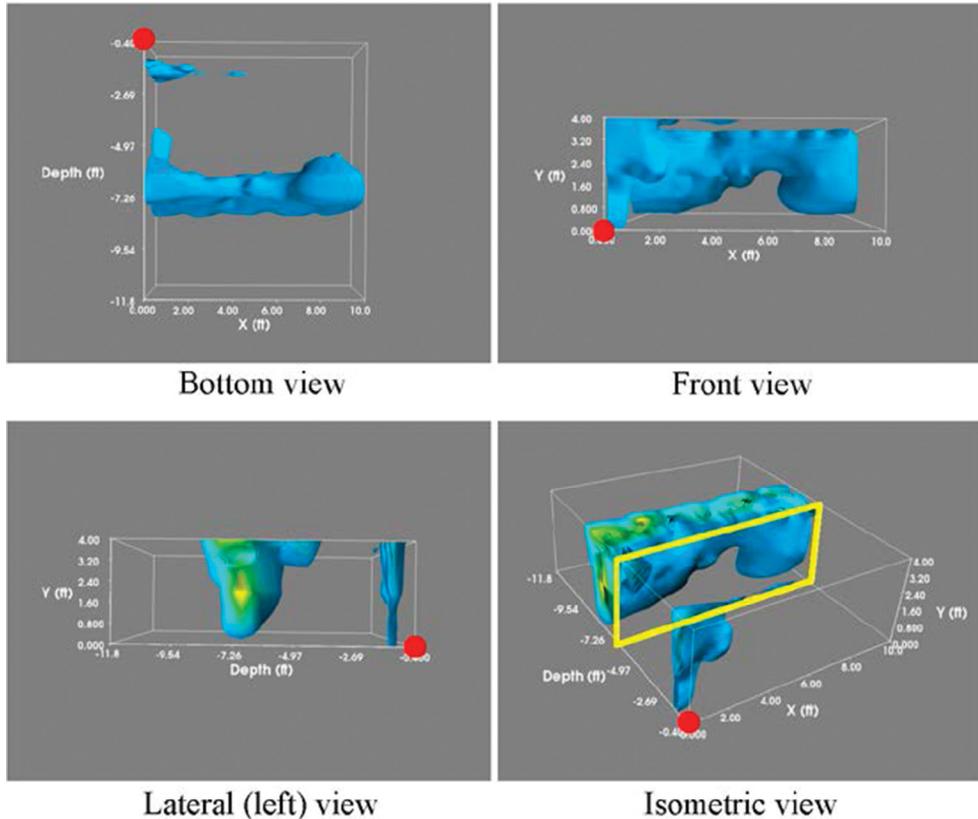
Figure 7: Three-dimensional rendering images based on GPR data showing the most likely extent and distribution of internal voids. Estimated wall thickness at this location is 2.0 m (6.5 ft). Large voids at the back of the wall, extending to the soil, are visible. Yellow frame in image at lower right indicates approximate location of the back of the wall.
