ISLAMIC HERITAGE ARCHITECTURE ANALYSIS AND RESTORATION OF RAS CHERRATINE IN FEZ, MOROCCO

K. EL HARROUNI¹ & A. EL HAMMOUMI²

3.2 Visual inspection: Main damage and problems requiring intervention

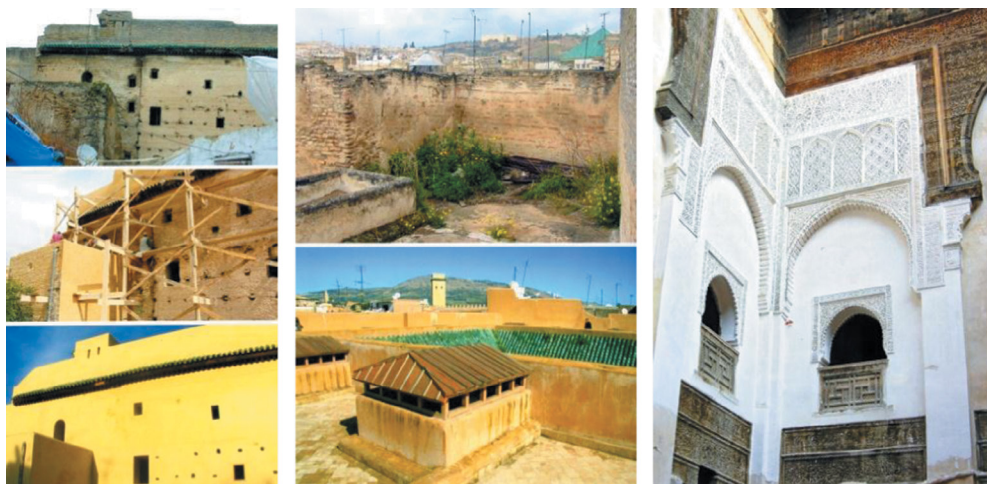
Figure 1: Treatment of the exterior façade, the terrace and the courtyard interior façade (Groupe Al Omrane [1]).

During the period 2006–2008, the Ras Cherratine Madrasa was restored by the Al Omrane Group, a national company under the Ministry of Housing and Urbanism, responsible for the implementation of state policy in social housing and town planning sectors. The project led by the Al Omrane Group was the subject of extensive consultations with representatives of the Ministry of Culture, Ministry of Endowments and Islamic Affairs, Ministry of Tourism, local authorities and other administrative services including the Agency for the Dedensification and Rehabilitation of Fez Madina (ADER), the Urban Agency and Safeguard of Fez. The intervention programme consisted of restoring the entire Madrasa in accordance with the universal principles of historic building restoration and conservation. The restoration programme was concerned with vertical and horizontal structures, architectural elements and decorations, use of the same original materials including fired clay bricks, earth, lime mortar, wood, plaster, zellij, etc, and the same traditional construction techniques (Fig. 1).

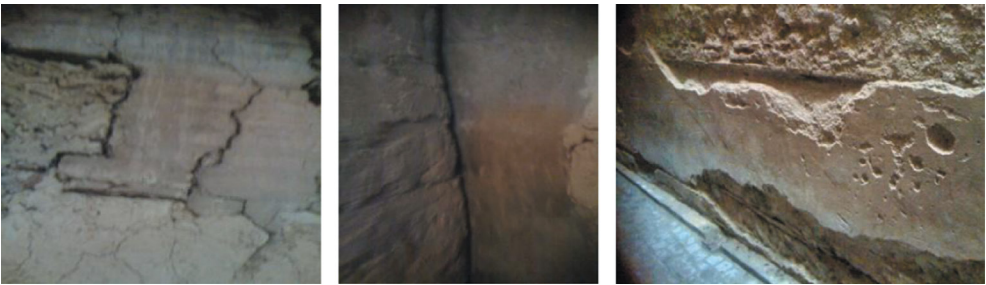
- Cracks: There are very large cracks in the walls around the dome and there is a problem of separation of joints. A visible deterioration can also be seen on the exterior walls, outside the Madrasa; these walls are reinforced with horizontal wooden planks (Fig. 2).

Figure 2: Cracking in walls.

1. Existing cracks in walls should be repaired by means of deep injection or grouting, with possible local reconstruction of the masonry or local substitution of deteriorated fired clay bricks. This action is oriented to ascertain some level of energy dissipation to the building during the occurrence of an earthquake. This energy dissipation would be provided by the generating new cracks in places with limited structural compromise.
2. Most of the deteriorations such as loss of mortar visible in the exterior walls, outside the Madrasa, do not allow a repair based on grout or injection. They can be repaired by means of grout and lime mortar. Walls should also be reinforced with horizontal wooden planks.

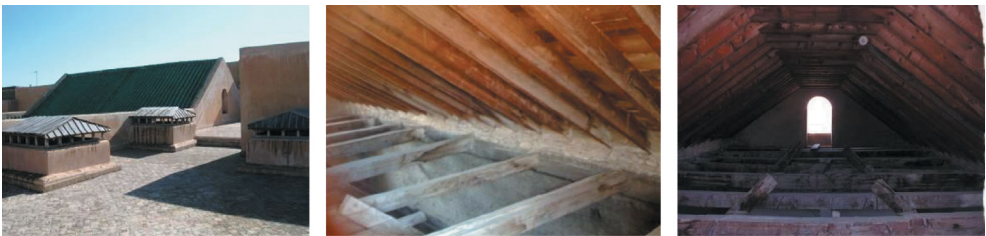
- Deformation: The wooden roof above the dome is supported on a reinforced concrete chaining laid on poorly executed concrete columns, dating from 1965. The wooden structure shows a perceptible deformed condition (Fig. 3).

Figure 3: Wooden roof structure.

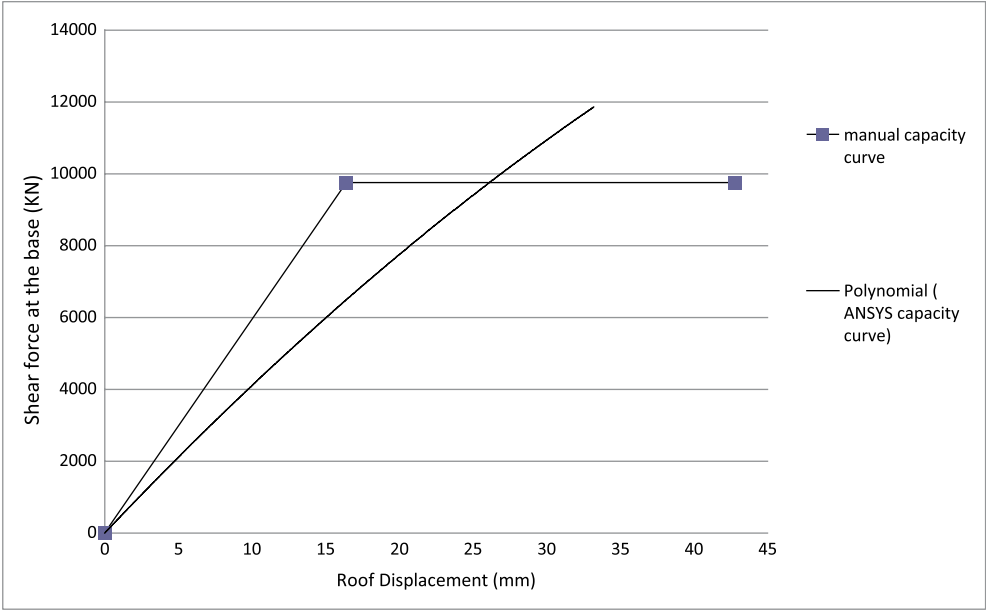
The performance point reflects the allowed maximum displacement of the structure; it represents the point for which the structure and the ground vibrate at the same frequency. For both directions, the real displacements of the Madrasa as a result of an earthquake of 10% g are under the point of performance that defines the limit state of deformation of the structure. The risk of minor to moderate damage is identical in both directions. However, the probability of severe damage or destruction is much higher in the x -direction compared with the y -direction.

Figure 6: Capacity curves along x-direction.

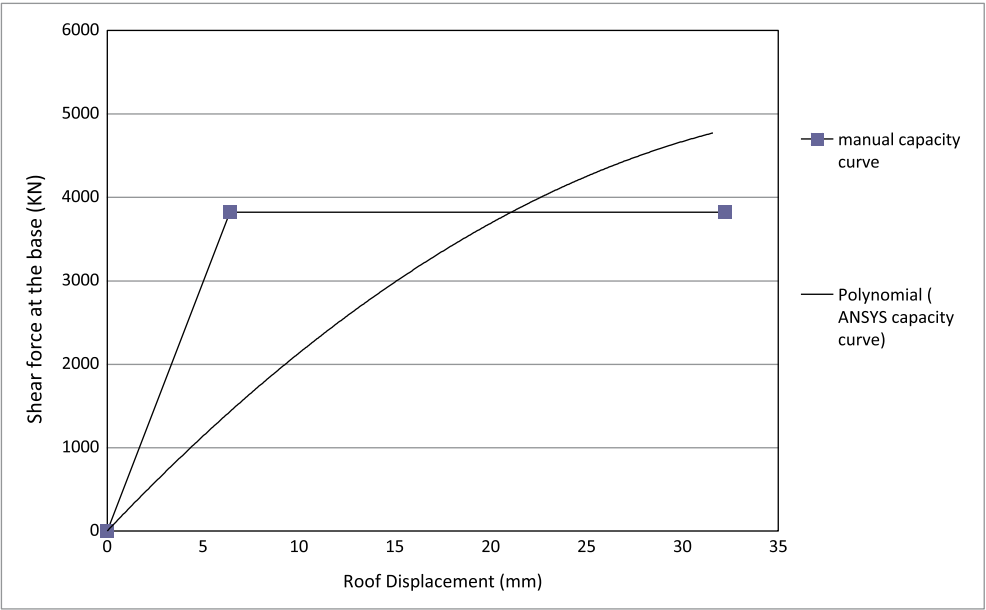
Figure 7: Capacity curves along y-direction.
