## NON-DESTRUCTIVE EVALUATION OF A DIESTE'S HISTORICAL REINFORCED BRICK MASONRY CHURCH

Instituto de Estructuras y Transporte, Universidad de la República, Uruguay

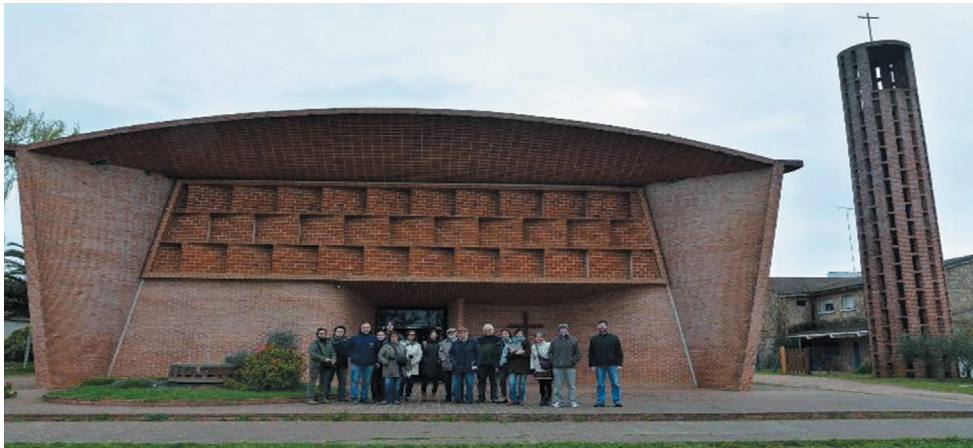
Overall, as Figure 4 in part shows, Dieste's church is in very good condition. Only particular moderate pathologies were identified at specific locations; these are explained as follows.

Figure 4: Picture of front *façade* of Church of Christ the Worker.

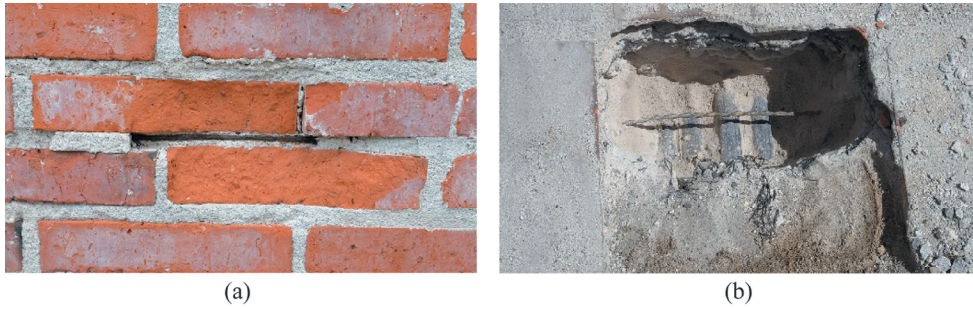
Several signs of corrosion with exposed rebar and mortar detachment were observed throughout the building, at the interior and exterior of the church and, particularly, at the baptistery and bell tower. In the case of the church building, these corresponded to secondary horizontal reinforcement along the walls, as Figure 5a shows. Signs of corrosion were also observed at the ceiling, mainly in the valleys. The destructive inspections in the roof exposed the principal steel tie rods in perfect condition without signs of corrosion, as Figure 5b shows. Signs of severe corrosion, with mortar and brick detachment, and mortar patching, indicating previous repairing efforts, were observed in the baptistery's ceiling.

Figure 5: (a) Corrosion with exposed rebar and mortar detachment in the church building and (b) actual state of tie rods in the roof's valleys.

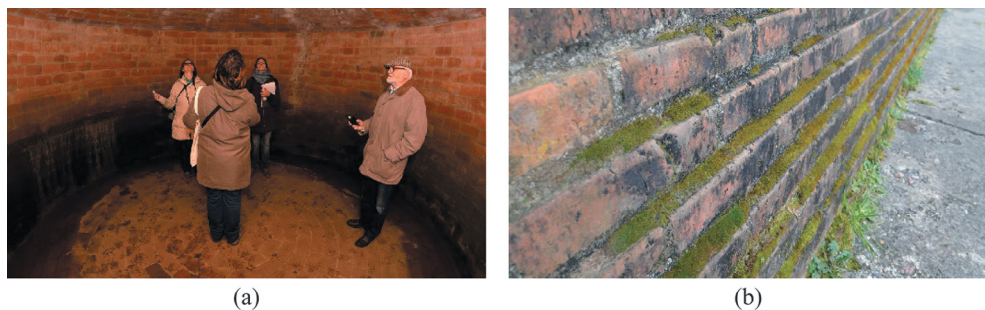
The walls and ceiling of the baptistery had presence of moisture. As Figure 6a shows, ponding had occurred at some parts of the baptistery's floor. In other parts of the structure, particularly the valleys of the church's roof, presence of moisture was also visually detected, although to a lesser extent than in the baptistery. Finally, partial degradation of mortars was detected in several zones, especially in those exposed to rain. Figure 6b shows the biological colonization and deterioration of mortars by phototropic organisms.

Figure 6: (a) Ponding at some parts of the baptistery's floor and (b) biological colonization and deterioration of mortars by phototropic organisms.

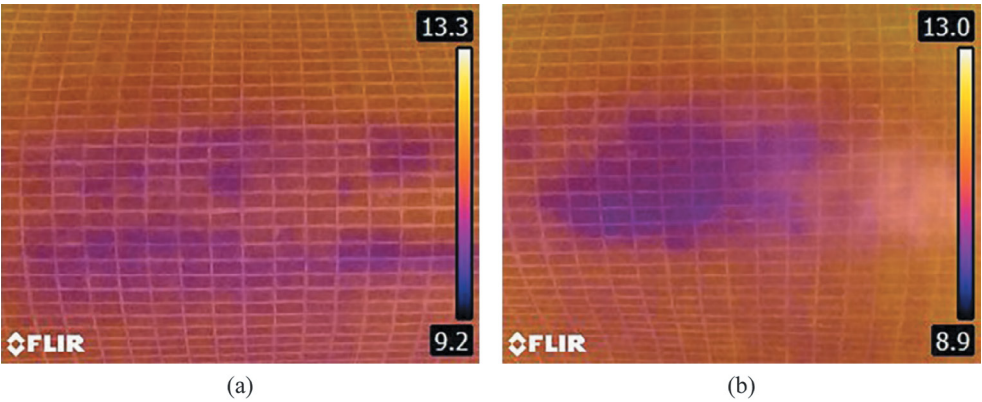
With respect to the passive approach, a general inspection was performed looking for differences in temperature patterns. The colder areas were further investigated and compared with other parts of the structure. On the one hand, as Figure 7 shows, general presence of moisture was primarily detected in the valleys of the church's ceiling; this was confirmed later in a closer inspection. General presence of moisture was also detected in the baptistery, particularly close to the foundation of the retaining walls. These two results match with those obtained from the visual inspection. The presence of moisture in the exterior walls of the

Figure 7: Presence of moisture in the valleys of the church's ceiling.

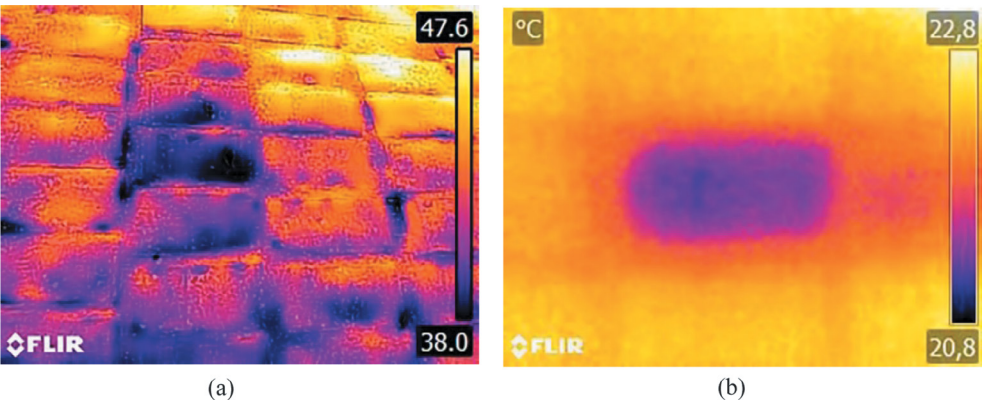
church could not be assessed because, given that these walls are curved, there were zones with different exposition to rain and wind. On the other hand, some symptoms of damage were detected in the church's ceiling; e.g. figure 8a shows some loose ceramic tiles.

Active infrared thermography was carried out on the roof and on the internal surface of the church's walls. This approach was not able to show any new results different from those obtained with the passive approach. Regarding the second location, this technique was used to look for the extension of the damage in the church's walls. With this procedure it was possible to determine the extension of the damaged zone, as Figure 8b shows.

Figure 8: Symptoms of damage in the ceiling and walls of Dieste's church. Thermal images showing (a) an area with some loose ceramic tiles and (b) a loose ceramic brick after two hours of exposure to two halogen lamps.

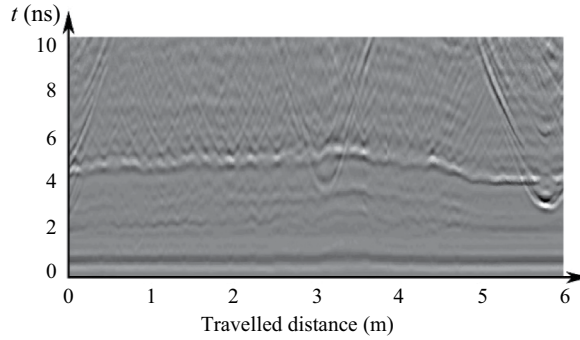
Figure 9: Horizontal GPR profile of a part of church's curved walls.

Figure 9 shows a horizontal GPR profile of the part of Dieste's church curved walls. It can be seen that, in the scanned zone, the EM pulse arrival time changes while the travelled distance varies. More precisely, the arrival time is greater in the centre of the profile – where the inclined geometry of the walls and the edge beam do not provide rain protection to the walls – than in the beginning and end of it – where the walls are indeed protected to rain. Given that these measurements were taken one day after a heavy rain event, it is reasonable to think that differences in arrival times are due to variations in moisture content.

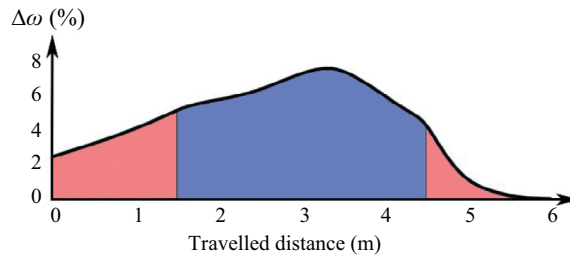
This relationship was applied to quantify the variation of moisture content along the church's walls. Figure 10 presents  $\Delta\omega$  as a function of the travelled distance for the GPR profile shown in Figure 9. In Figure 10, the blue zone corresponds to a ridge while the red

Figure 10: Variation of moisture content ( $\Delta t$ ) as a function of the travelled distance.

one corresponds to two consecutive half-valleys. The average difference in moisture content between the valleys and ridges of the walls was approximately equal to 4%.

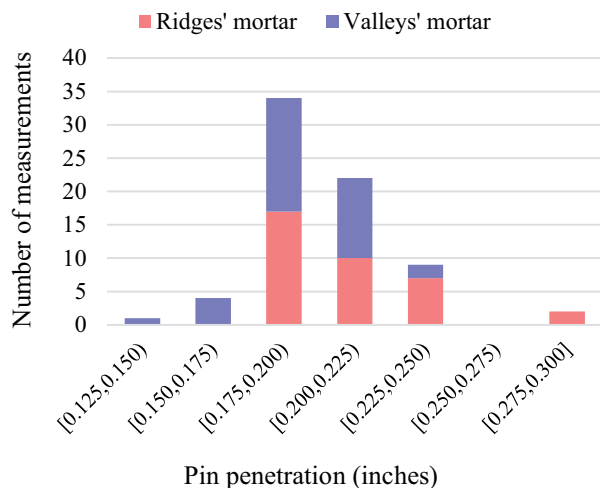
Figure 11: Penetration resistance results on the mortar of church's exterior walls.

This NDE technique was applied on both the bricks and mortars of different parts of the structure. Figure 11 presents the results on the mortar of church's exterior walls. In this case, Windsor pin was used in three inspection points per valley and three inspection points per ridge, giving a total of 36 points per *façade* – west and east.

Figure 11 shows that the ridges' mortar tended to yield higher penetration results – values towards the right in Figure 11 – valleys' mortar. A more detailed analysis indicates that the average pin penetration on ridges' mortar is 0.208 inches while on valleys' mortar is 0.194 inches. A two-sample *t*-test assuming equal variances reveals that the *t*-value is equal to 2.42, which implies that the means of the two groups can be assumed as statistically independent from each other [25]. In addition to the comparative analysis, the penetration resistance values represent a good way of estimating of the mortar compressive strength, since these two quantities are inversely correlated between them [20, 21]. This data will improve the developing of a numerical model of the structure, which will be performed by another subgroup of the project working group.
