THE DIALOGUE BETWEEN ANCIENT AND MODERN MATERIALS IN THE RESTORATION OF A COLLAPSED ANCIENT CHAPEL

ANTONIO GALIANO-GARRIGÓS¹, VÍCTOR ECHARRI-IRIBARREN¹, ANGEL-BENIGNO GONZÁLEZ-AVILÉS¹ & MARÍA DOLORES ANDÚJAR-MONTOYA²

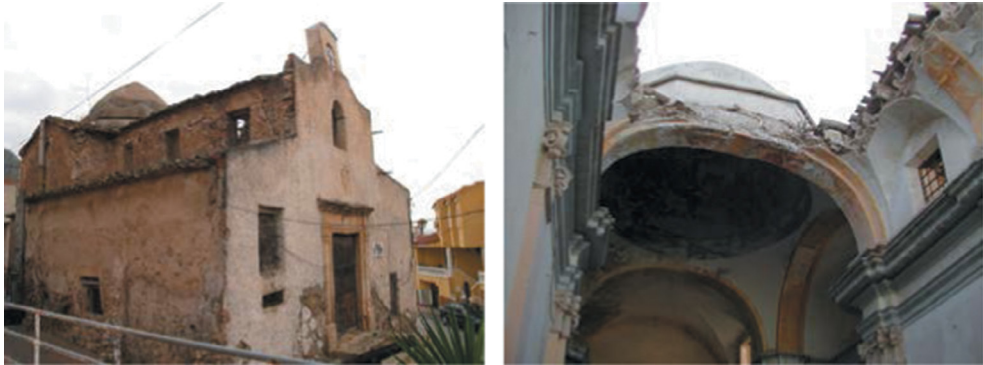
The lack of maintenance made the chapel collapse in part at the end of the 1990s (Fig. 1). The City Council of Orihuela acquired the building in 2007 and planned to recover it as a

Figure 1: Condition of the chapel in 2009.

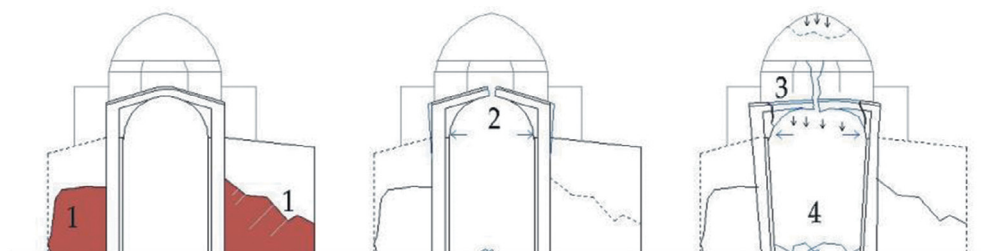
At the time of intervention, the Chapel of the Holy Sepulchre was under structural failure and a total collapse process (Fig. 2). Although some repairs were carried out in previous years, they were unfortunately carried out and, in some cases, worsened the damage.

The roofs, structural elements and adjoining buildings were in a state of deterioration and ruin. The deterioration of the adjoining buildings, which for decades had contributed to the stability of the structure, generated significant deformations of the main vault and the dome. This caused movements, opened cracks in key parts of the arches and made them lose stability

Figure 2: Collapsing process cross section. 1. Adjoining buildings collapse. 2. Load-bearing walls movement. 3. Damage at toral arches. 4. Vaults collapse.

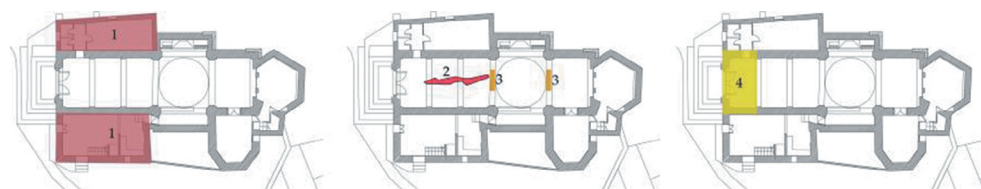
Figure 3: Collapsing process floor plan. 1. Adjoining buildings ruin. 2. Vaults collapse. 3. Damages at toral arches. 4. Choir room collapse.

(Fig. 3). These damages occurred in the main axe of the nave, from the main entrance to the dome, just in the area adjoining the buildings [6].

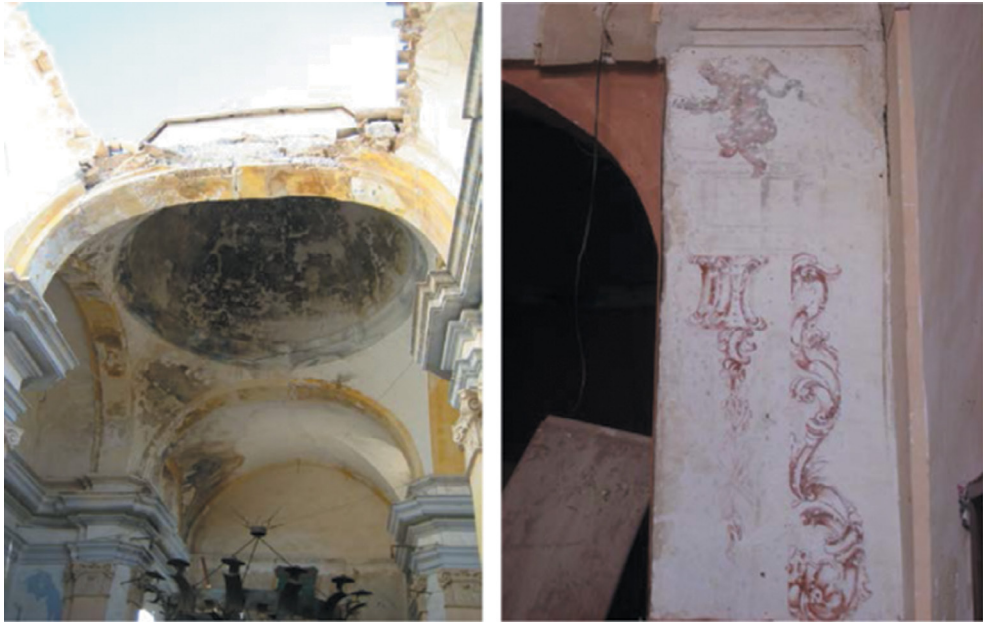
The lack of maintenance of the roofs adversely affected the permeability of the building. The water infiltration caused materials to become damp and increase in weight. Because of the initial deformation, the damages in the adjoining buildings, and the additional excess weight, the load-bearing walls continued to move, the cracks in the arches widened and the vault started to collapse. The collapse of the chapel started with the section of the vault closer to the dome and finished at the section closer to the main entrance that, dragging the choir room down with it, fell down just before the restoration started. The dome, however, remained standing, but in a very dangerous state, as two of the four supporting arches were out of use and the dome was resting over the other two only (Fig. 4).

Figure 4: Detail of the dome, the supporting arches and frescoes.

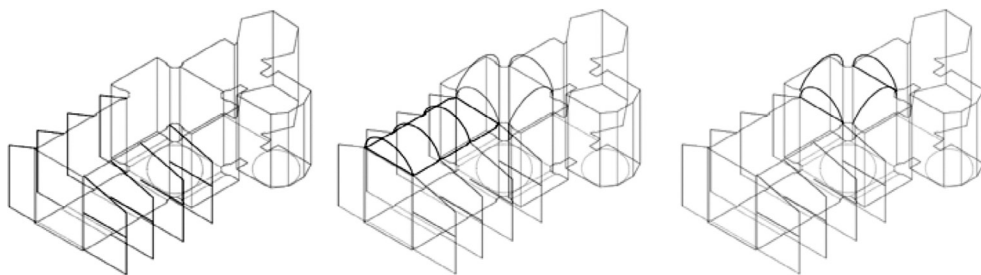
Figure 5: Reconstruction layout of the chapel structure.

Once this part of the building was secured, the reconstruction of both adjoining houses carried out with a concrete structure started. The design of the structural system meant placing vertical reinforcements along the existing load-bearing walls acting as buttresses for protection against horizontal thrusts and to limit the current bowing movement (Fig. 5). The line of pillars along the walls was doubled with another one in the façade and was connected by beams dimensioned to absorb loads due to horizontal thrusts.

Topping the line of pillars along the walls, a flat beam was designed with the purpose of receiving the new vaults. Load-bearing walls were so bowed, over 0.70 m in verticality, that it was not possible to use them as a structure anymore and they could not support the new vaults. The designed structural system used the above-mentioned flat beam for supporting the new vaults and transmitting loads to the new adjoining structures.

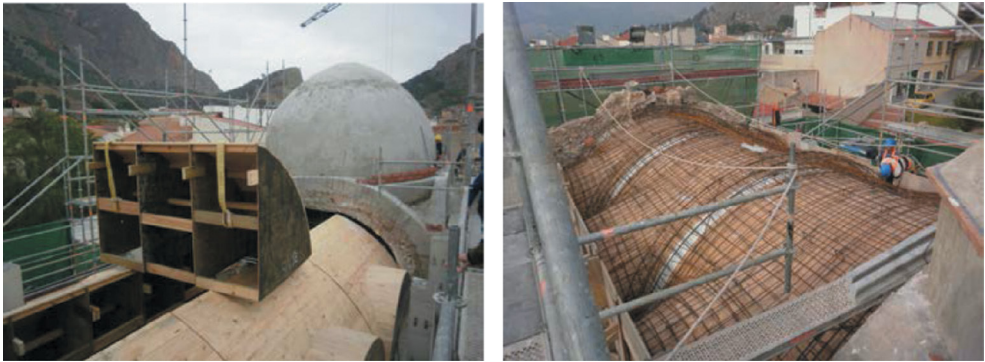
Figure 6: Wooden form-works and new vault reinforcement.

The shape of the vaults was obtained through wooden form-works that were copied from the original still-standing vault bays (Fig. 6). The concrete was not covered, and its grey colour was left as the final coating so that it could be identified as a reconstructed element.

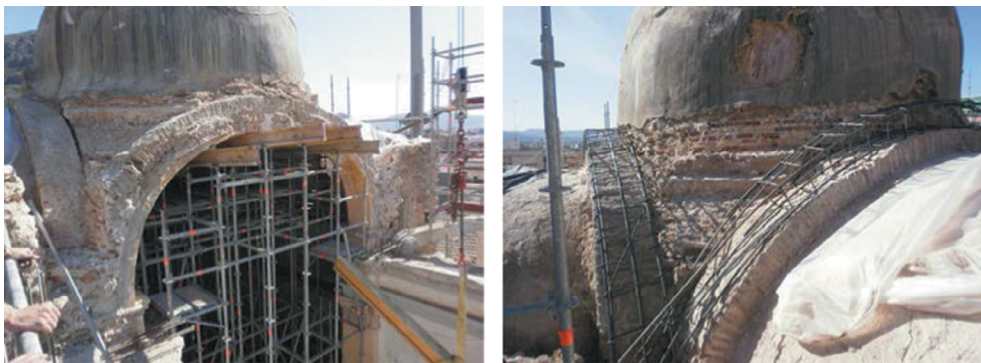
Figure 7: Reinforcement of the arches supporting the transept dome.

Reinforcement was achieved by complementary solutions to the existing constructive elements by banding the dome, reinforcing the supporting arches with concrete beams and installing four steel stays at the bottom of the two supporting arches parallel to the nave [8].

Once the supporting structure of the dome was reinforced, materials damaged during a previous repair of the dome were removed and a restoration through replacement of part of the webbed part, using hollow ceramic bricks, was carried out (Fig. 7). A final reinforcement, mortar with a light iron net, was needed for supporting the cover and helped the construction of an eight-sided fluted dome, covered with Arabic roof tiles.

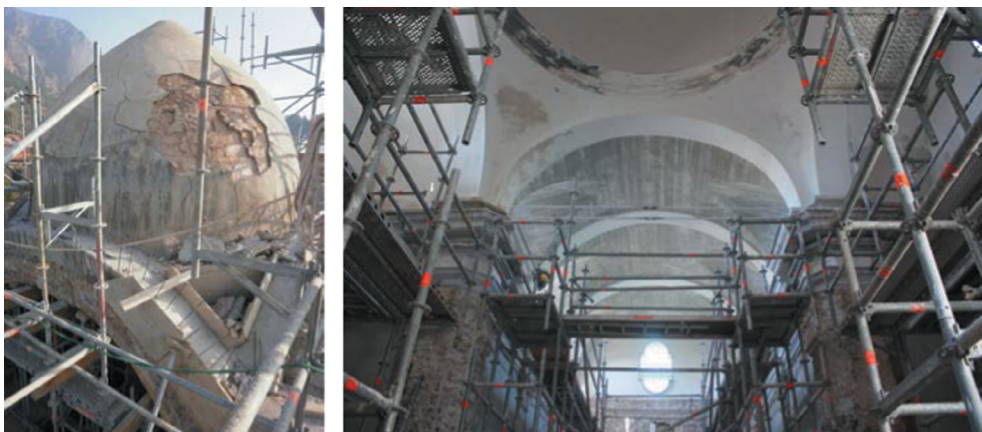
Figure 8: Restoration of the transept dome and interior walls.

The lack of maintenance affected the interiors from two sides: water coming from the roof and humidity growing from the bottom of the walls. Both lesions damaged the interior coatings, especially made from cal-gypsum mortars. Also, the various paintings over the walls suffered deeply with the presence of water. Reparation of the wall surfaces was carried out by eliminating particularly damaged areas and rendering a breathable mortar, which permits the rising damp to evaporate (Fig. 8). The same material was extended in the external walls. No paint was placed over the mortars and the material colour was left as final coating.

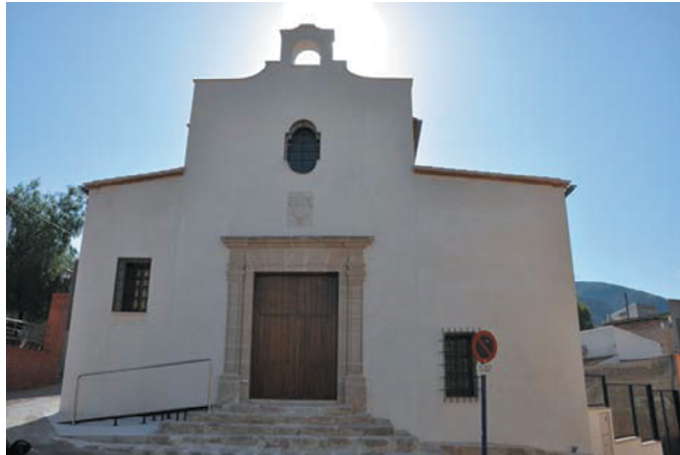
Figure 9: Main façade after restoration.

The restoration of the chapel showed visitors a dialogue between two intervention techniques, one inclusive and another one that contrasts, showing which parts of the chapel were reconstructed (Fig. 9).

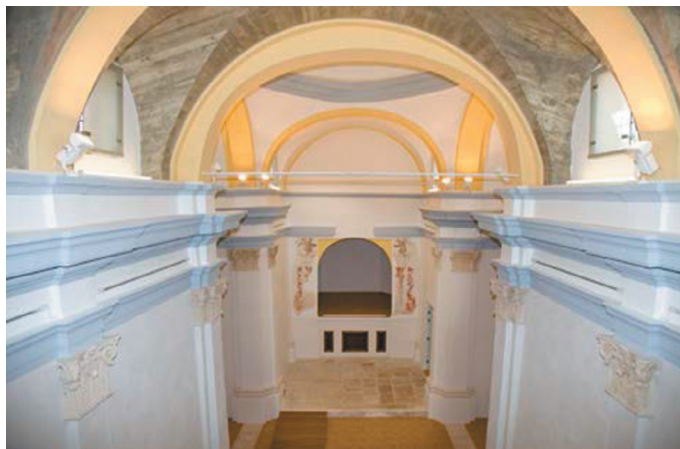
Figure 10: View of the main altar from the choir.

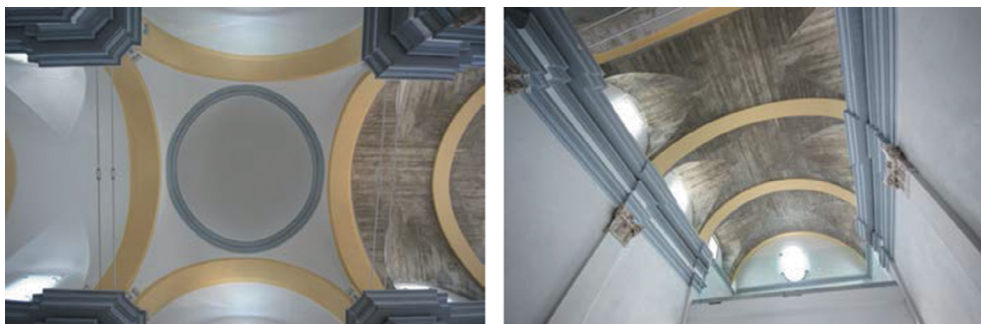
Figure 11: View of the dome and of the reconstructed vault.
