Remediation and development of a former rubber products manufacturing facility in Colorado, USA

J. V. Accashian¹, R. L. Olsen¹ & D. C. Mosteller²

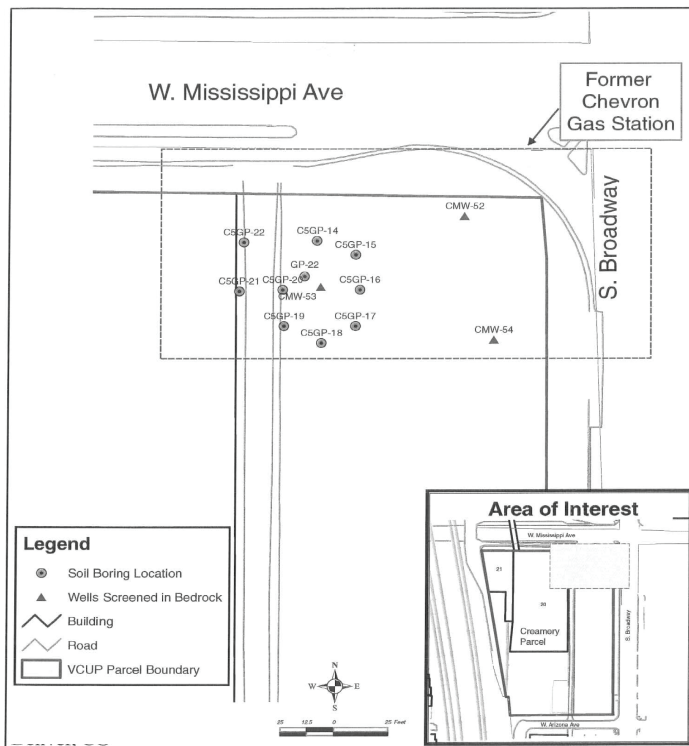
Figure 3: Former Chevron gas station.

Groundwater associated with the former Chevron gas station portion of the project parcel is affected primarily with low concentrations of 1,1-dichloroethene (1,1-DCE) from an unknown source. 1,1-DCE is the only contaminant in this area that exceeds CDPHE cleanup goals and standards.

Depth to groundwater is approximately 20 ft. bgs in the area of the former Chevron station. Based on groundwater data, groundwater flow direction is generally to north/northeast in the former Chevron gas station area. Alluvium consisting of silts and clays overlying sand and gravelly sand is present to approximately 18 ft. in the area of the former Chevron station.

The only contaminant of concern detected in groundwater at the former Chevron gas station was 1,1-DCE. Extensive investigation on the site was unable to definitively locate the source of the 1,1-DCE contamination. Three separate investigations (i.e., resistivity survey, soil gas survey, and hydraulic connectivity testing) were performed in an effort to identify a source of 1,1-DCE contamination on the site. The resistivity survey concluded that (1) no subsurface tanks, sump structures, or other likely source features were evident; and (2) further subsurface investigations were not warranted. The soil gas survey indicated that 1,1-DCE was detected in only one soil-gas sample at the method detection limit ($10 \mu\text{g}/\text{m}^3$), suggesting that a source of 1,1-DCE is not located on the site. The soil-gas survey indicated the presence of only very low levels of other VOCs, which also suggests that a source of other VOCs in this area is not likely. The hydraulic connectivity test indicated a connection between the contaminant-bearing zones in the area north and the former Chevron gas station area. Furthermore, the highest concentrations of 1,1-DCE were located north of the area and no evidence of a source of 1,1-DCE existed on the site. The source of 1,1-DCE was probably associated with the northern property. The groundwater samples collected in February 2006 indicated that only one of the four monitoring wells sampled in this area had concentrations of 1,1-DCE above the cleanup goals and standards. Because of the low concentrations, 2,412 gallons of NaMnO₄ were injected in four monitoring wells. The concentrations of NaMnO₄ ranged from 3 percent to 10 percent.

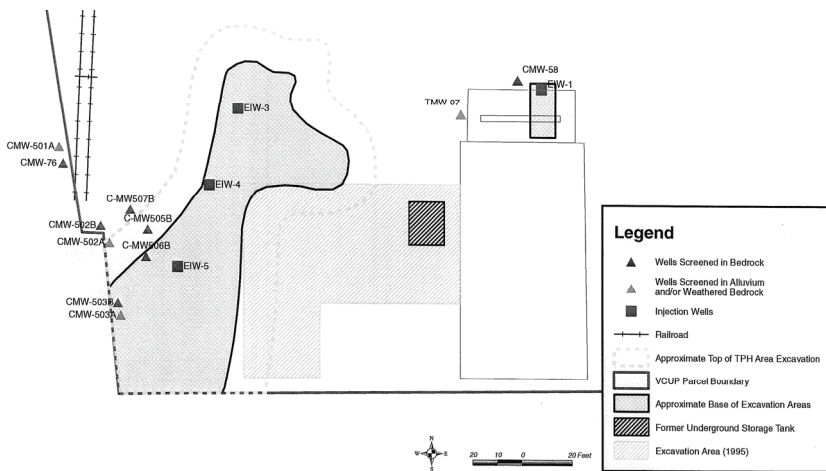
Figure 4: TPH-impacted excavation area and injection/monitoring wells.

TPH-containing soil associated with the former diesel UST at Unit 22 was excavated in March 2005. Excavation was completed vertically along West Arizona Avenue to the south of the site, and for approximately 40 ft. along the western side of the site. Vertical excavation was facilitated by shoring to protect an active water main and other major utilities located in West Arizona Avenue. The other areas on the northwest, north, and east sides of the site were excavated with a 1.5:1 side slope. Figure 4 shows the approximate extent of the excavation in the TPH-containing area.

The excavator removed material 1 to 2 ft. into the weathered bedrock interface or until refusal was reached throughout the base of the TPH-containing area. The maximum depth of excavation was approximately 18 ft. Consistent with the estimate of total in-place volume of clean soil to be excavated, approximately 7,000 cubic yards of soil were excavated from the TPH and former sump areas. These soils were screened for potential contamination, placed

The infiltration gallery in the TPH-containing area, which consisted of three separate celled units, was constructed after excavation. Wells EIW-3, EIW-4, and EIW-5 were installed, with EIW-3 being the northernmost and EIW-5 being the southernmost well, as presented in Figure 4. Steps in constructing the infiltration gallery include the following:
