## A study on debris flow disasters along Japanese railways and its critical rainfalls

S. Watanabe<sup>1</sup>, T. Sugiyama<sup>1</sup>, O. Nunokawa<sup>1</sup>, T. Fujii<sup>1</sup>, K. Okada<sup>2</sup>  
& H. Mitsunaka<sup>3</sup>

<sup>1</sup>*Railway Technical Research Institute, Tokyo, Japan*

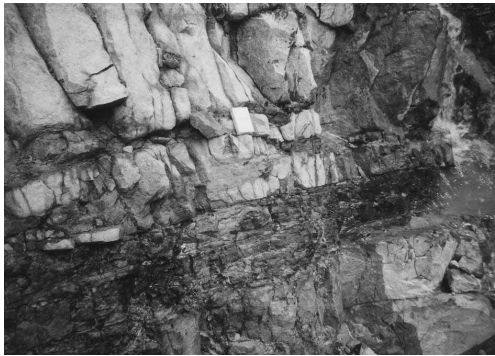
Figure 1: Bedrock of concerned area.

This area is a mountainous region and the edge of natural slope of valley. The geological timescale of this region is Mesozoic era, compounding with sandstone and shale as shown in Figure 1. Therefore, foundation of bedrock of the region tends to be fragment. Cohesive soils around this area are made by these fragment, and depositing on firm bedrock as shown in Figure 2. The deposits are

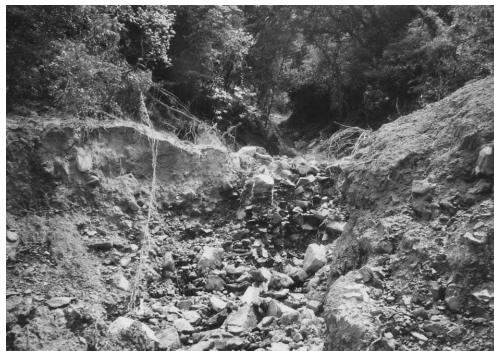
Figure 2: Sediments on mountain stream.

unstable and tend to collapse easily on a boundary of the deposits and bedrock. The deposits include weathered rocks, which collapsed from bedrock has covered the bottom of the mountain stream. Therefore, this area is likely in danger of debris flow where heavy rainfall anticipated.

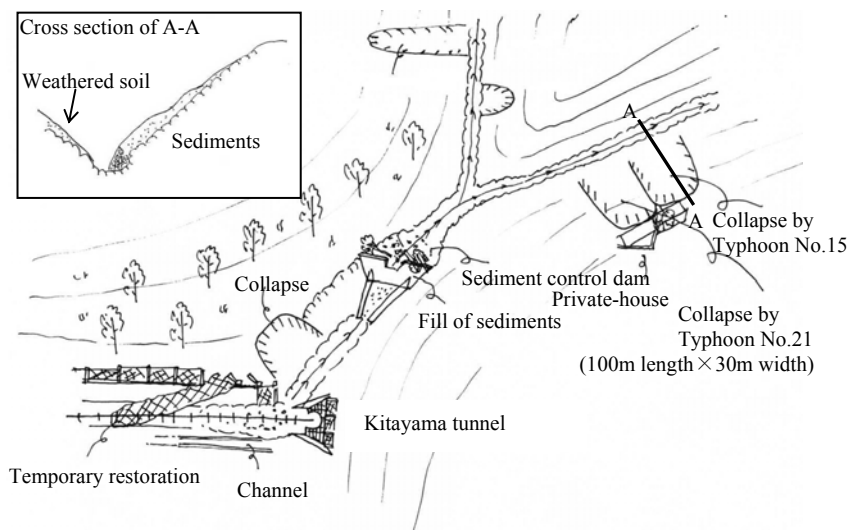
Figure 3: Schematic map around 93020 m.

Figure 3 shows a schematic map of this area with the location of slope failure caused by the Typhoon No. 21. This area lies to the north slope of a portal of Kitayama tunnel. There is a sediment control dam in the place on the upper reaches from a cut slope along the railway 50 m. Figure 4 shows the situation of sediment load right after disaster.

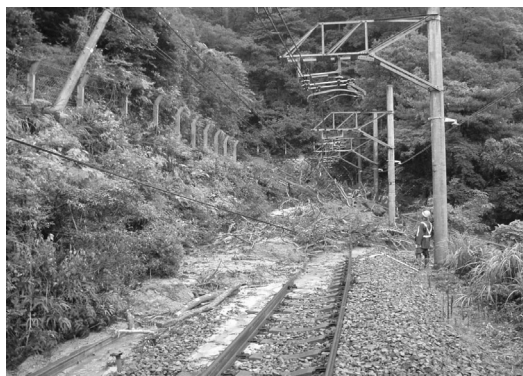
Figure 4: Situation of sediment load.

The origin of this debris flow is sediments of slope failure, which occurred at the top of mountain at the location of upper reaches from the railway 150 m. It is presumable that the sediment dammed up the mountain stream shortly, and flowed down at a burst. After the debris flow, there were still unstable sediments remained on the slope. Therefore, small rainfall would trigger another debris flow.

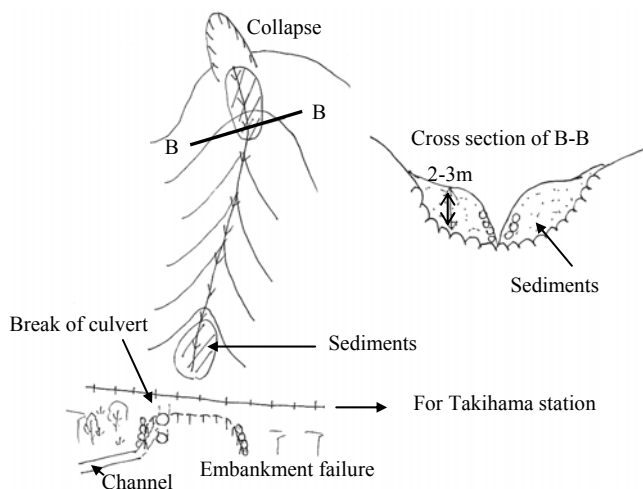
Figure 6: Schematic map around 93350 m.

Figure 6 shows the schematic map of this area and Figure 7 shows a situation of mountain stream right after disaster. In this area, embankment failures were also

evident due to stoppage of culvert under the embankment by sediments of debris flow.

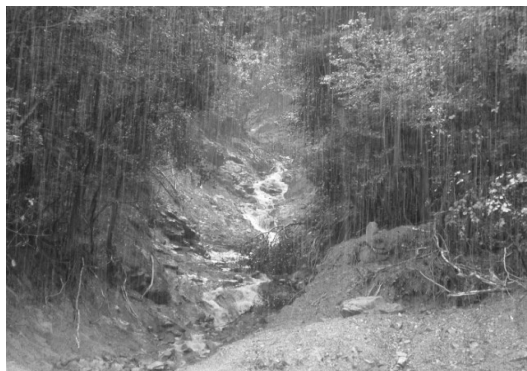
Figure 7: Situation of mountain stream.

A distance of the mountain stream was approximately 300 m, and a slope of the streambed was gradual. It is presumable that sediments and rainwater flowed down eroding deposits of the streambed.

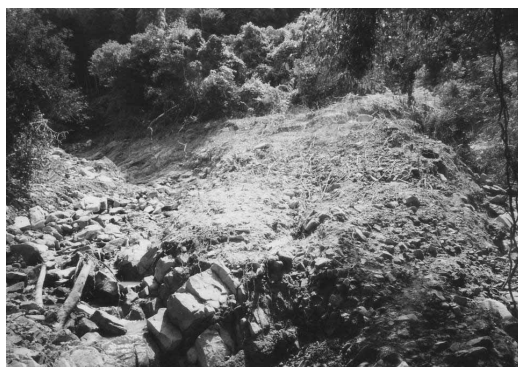
Figure 9: Thick sediments on lower part of mountain stream.

The lower part of the mountain stream is of thick sediments area as shown in Figure 9, and a trace of erosion due to debris flow was confirmed. It is assumable that rainwater involving loose sediments flowed down gradually, and it became a huge flow eroding sediments on the streambed.

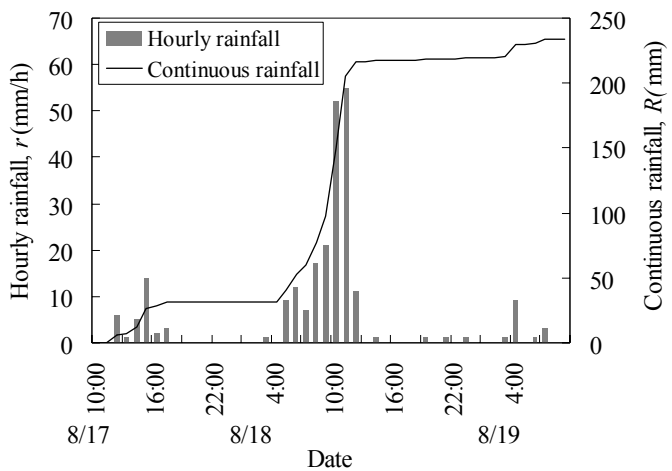
Figure 11: Hourly rainfall record caused by Typhoon No.15.

The hourly rainfall record at the occurring time of the debris flow due to typhoon No.15 and No. 21 are shown in Figure 11 and Figure 12 respectively. In case of the typhoon No. 15, the rain continued intermittently for one day, and the failure occurred when continuous rainfall of 205 mm. The maximum hourly rainfall was 55 mm/h. Similarly, the continuous rainfall was 308 mm and the maximum hourly rainfall was 58 mm/h due to typhoon No. 21. Table 2 shows the amount of rainfall indices.

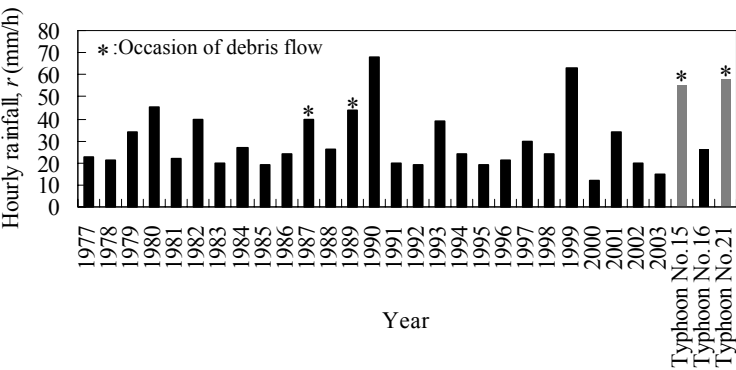
Figure 13: Maximum hourly rainfall record for each year from 1977 to 2004.

Figure 13 and Figure 14 show the maximum hourly rainfalls and maximum continuous rainfalls of each year from 1977 to 2004 respectively. By processing these data with Gumbel method, we found that the return period of 55 and 58 mm of the maximum hourly rainfalls are 30 years, and that of 208 and 308 mm of the continuous rainfalls are 4 to 5 years. These figures have also indicated the years of debris flow occurred.

It is apparent from Figure 13 and Figure 14 that the amount of the maximum hourly rainfall does not necessarily related to the occurrence of the debris flow. Similarly, there are several cases that the continuous rainfall exceeds the amount of that due to typhoon No.15 and No. 21, however no debris flow substantially occurred. These facts indicate that a combined index reflecting both of the maximum hourly rainfall and the amount of the continuous rainfall required in order to predict precisely the occurrence of debris flow.

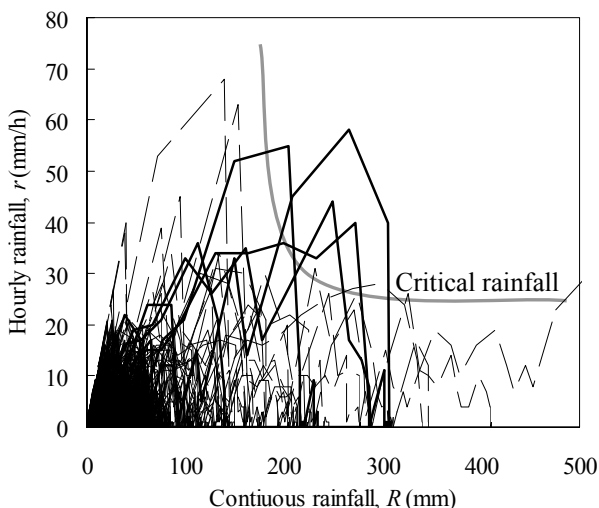
Figure 15: The measured rainfall indices from 1977 to 2004.

Figure 15 shows the relationship between hourly maximum rainfall and continuous rainfall observed from 1976 to 2003, including typhoon No.15 and No. 21 cases. The solid line in the figure indicates the records in 1987, 1989 and 2004, in which disasters due to debris flow occurred. It is highly likely that debris flow would occur from this figure in cases of continuous rainfalls exceeding 200 mm and maximum hourly rainfall is beyond 30 mm/h. It is also likely that a long duration of rainfall followed by a huge amount of rain would cause disasters due to debris flow.
