Large wood and flash floods: evidence from the 2007 event in the Davča basin (Slovenia)

F. Comiti¹, L. Mao^{1,3}, E. Preciso², L. Picco¹,
L. Marchi² & M. Borga¹

Abstract

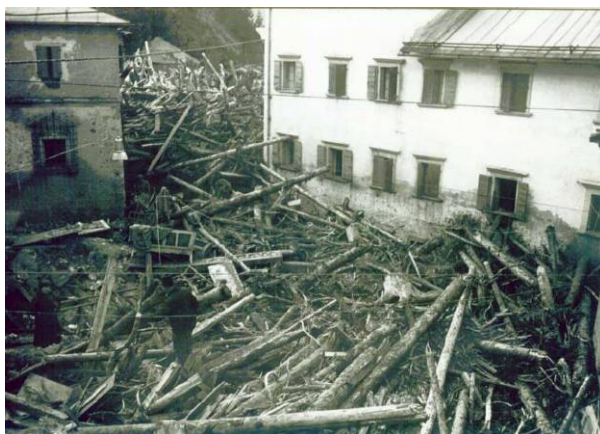
represent the most effective and dramatic geomorphic phenomena in mountain channels [5]. Indeed, natural dam-break processes – transporting huge amounts of wood (Fig. 1) – have caused some of the largest damages in several valleys of the Dolomites (Italian Alps) during the 1966 catastrophic flooding [3, 4]. The extreme magnitude of floods caused by the failure of natural dams is matched by a typically low frequency (>50–100 yr), such that these events may be easily forgotten, thus allowing unwise human occupation of flood-prone corridors. This paper presents a qualitative analysis of the geomorphic processes triggered by an intense flash flood occurred in a mountain basin of the Slovenian Alps, which featured considerable LW transport and deposition. The underlying hypothesis is that the extreme water stages observed and the damages could be ascribed – at least partially – to the collapse of temporary dams formed by sediments and LW.

Figure 1: Huge volumes of wood were transported along the Fiorentina river and invaded the small town of Caprile (Italian Alps) during the 1966 flood (R.I. >100 yr).

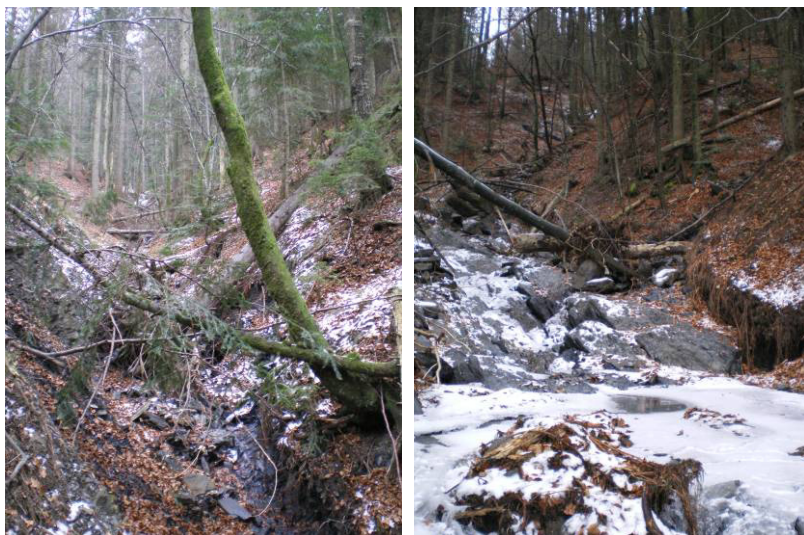
Figure 4: Steep tributaries incised to bedrock and recruited many LW elements which were too long to be transferred to the main channel.

an elevation 2.5–3 times the bankfull stage) was already present in this upper part of the basin. Also in the next downstream reaches (3 and 4), the event did not cause major instabilities in the channel. As a consequence, these two reaches lack significant wood and sediment sources adjacent to channel. Furthermore, several steep right-hand tributaries surely experienced high flow rates, but sediments and LW delivered to the main channel were of minor influence. Most of them underwent incision (up to 1 m) reaching the bedrock, with widespread bank erosion and associated recruitment of large trees, which could not be transported to the Davča (Fig. 4).

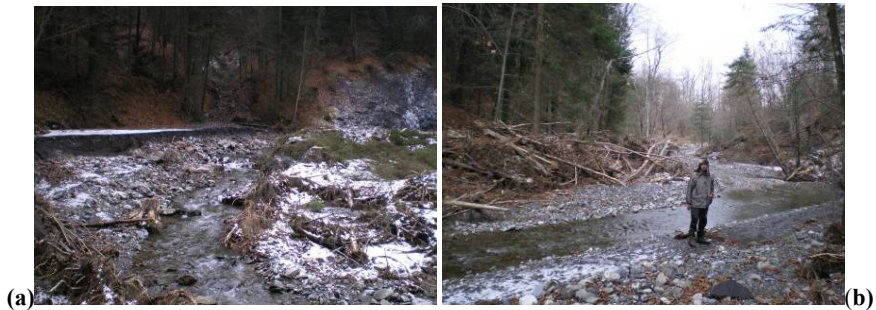
However, a road crossing (probably under-sized) between the reaches 4 and 5 likely caused backwater effects which led the channel to shift towards a forested floodplain just upstream of the bridge. Here many trees were recruited, further obstructing the bridge. In fact, there is evidence (lateral depositions, wood jams, Fig. 5(a)) that the main channel here spilled over the bridge. Downstream of it (reach 5), several huge LW jams (mostly composed of “fresh” trees) were trapped by standing trees on the floodplain and channel bends (Fig. 5(b)).

Figure 5: The effect of the bridge between reaches 4-5: (a) deposition and floodplain erosion upstream of the bridge; (b) high wood accumulations downstream of the bridge.

These jams are up to 2m high, thus testifying a very high stage for a wide (15–20 m) cross-section. A possible flow surge issued from the bridge may be envisaged, but its effect must have been limited in length due to its small height and stored volume. Downstream of a check-dam (which separates reaches 5 and 6), the channel becomes steeper and then flows within a gorge over large boulders. Several large trees (beeches and spruces) fallen from the adjacent slopes are also present, but their transport was prevented by the narrow channel width. Between the reaches 6 and 7, the slope is lower, and the confinement of the channel on the right bank is less strict. Here the peak discharge was estimated to about $55 \text{ m}^3\text{s}^{-1}$ (DS30 in Figs. 2–3, drainage area 9.8 km^2 , $5.6 \text{ m}^3\text{s}^{-1}\text{km}^{-2}$).

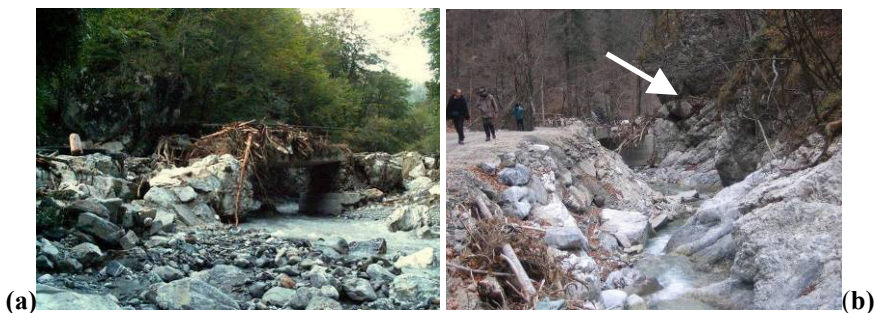
The reach ends at a bridge which was clogged by a probable combination of high water stage, intense coarse sediment transport, and floating LW supplied by nearby debris flows. Bridge clogging is indicated by upstream deposition of wood and sediment (Fig. 6). The backwater effect led to channel aggradation, forcing the stream to flow on the road.

Figure 6: The bridge between reaches 9-10: (a) from downstream right after the flood; (b) from upstream two months later. Source for a: <http://www.davca.si>. The arrow indicates the flood marks.

The road embankment and the bridge obstruction finally breached, probably causing a flow surge downstream where high-elevation (>2 m) marks were observed at channel banks. Reach 10 displays deposition of coarse sediment (up to 0.8-1 m in diameter) and further sediment inputs from the left slope (a small debris flow channel and several small landslides). Intense channel aggradation

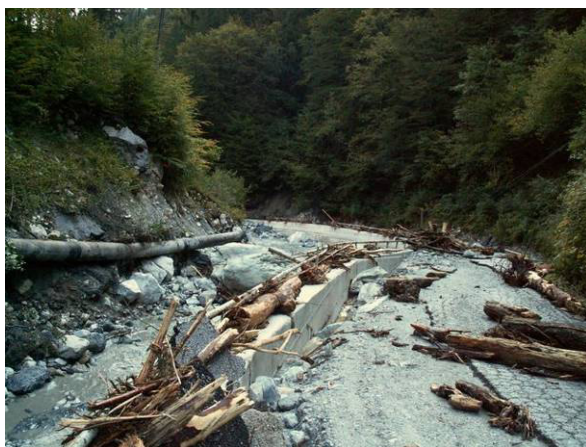
Figure 7: The narrow reach 11, featuring bank and bed erosion. Source: <http://www.davca.si>.

The steeper, narrower reach downstream (11, Fig. 7) was characterized by diffuse bank erosion and local bed incision. Peak discharge here (drainage area 21.4 km^2) was estimated around $150 \text{ m}^3 \text{ s}^{-1}$ (i.e., $7 \text{ m}^3 \text{ s}^{-1} \text{ km}^{-2}$, DS50 in Figs. 2–3).

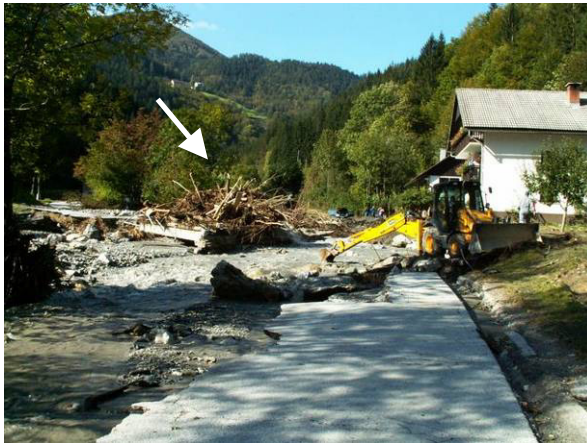
Just upstream of the confluence with the Muštrova Grapa (reach 12), in correspondence of a widening of the valley floor, the Davča aggraded considerably; bridges were buried with sediments and wood and the flow invaded the road at left side (Fig. 8).

Figure 8: Channel aggradation and channel avulsion along reach 12, with a bridge clogged by LW. Source: www.davca.si.

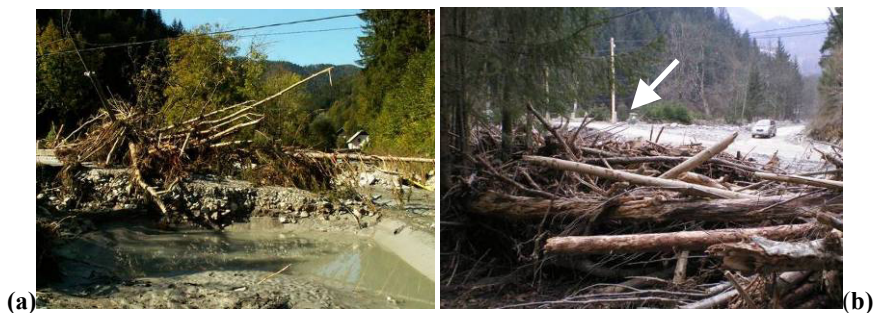
The bridge at the Muštrova-Davča confluence trapped some LW, but did not collapse because most of the floodwater was flowing on the road (Fig. 9). Part of the floating LW was then trapped by some trees at the road junction, while some accumulated against a building which was heavily damaged.

Very coarse clasts (up to 0.8–1 m in diameter) were deposited upstream of the trees, and LW jams were up to 2 m high, both indicating very high stream power values. The total LW volume was estimated around 80 m^3 , but much had been already carried away during restoration works. The longest wood elements (up to 8 m, roughly corresponding to channel width at the near upstream reaches) appeared to derive from riparian trees eroded by the flood, and the integrity of

Figure 9: The Davča at the confluence with the Muštrova Grapa: (a) the bridge – not collapsed – from downstream right after the flood; (b) the LW jams trapped at the junction (November 2007). The arrow indicates the bridge location. Source for a: <http://www.davca.si>.
