# Restoration of a degraded torrential stream by means of a flood control system: the case of Arroyo del Partido stream (Spain)

J. A. Mintegui Aguirre, J. C. Robredo Sánchez,  
C. De Gonzalo Aranoa & P. Huelin Rueda  
*Escuela Técnica Superior de Ingenieros de Montes,  
Universidad Politécnica de Madrid, Spain*

## Abstract

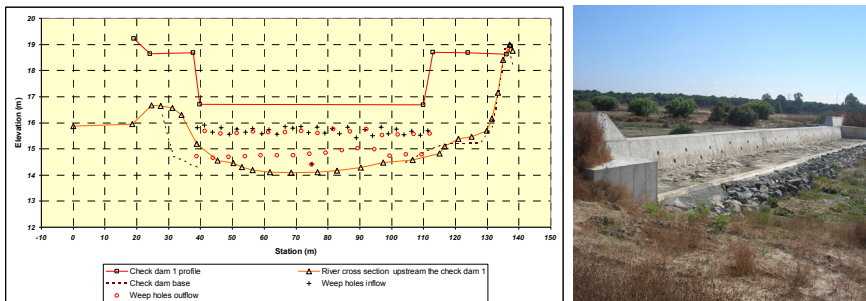
The CD1 height is 2.6 m above the current streambed. Originally the frontal spillway was 2.0 m high, 70.0 m long, and 2.0 m width, situated at an average altitude of 16.7 m. Thirty one weep holes, with 0.3 m in diameter, crossed the structure from the upstream to the downstream side, draining the water volume stored behind the structure. The weep holes were arranged in two rows (of 15 weep holes each) and a single bottom drain (Figure 2). The lateral spillway was placed immediately upstream of the structure along the left riverbank and coated with a rocky breakwater and a cyclopean concrete lining in order to prevent erosion when the diverged discharge flows into the flood-lamination-sedimentation area. The lateral spillway has a length of 140 m and its altitude ranges between 16.70 and 16.77 m.

Figure 2: CD1 elevation view (left) in 2006 and photograph (right) in July 2007.

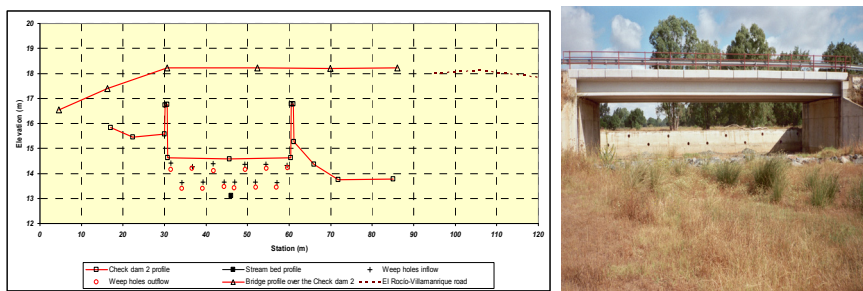
The CD2 is 1.5 m high and was built immediately upstream of the bridge over the Cañada del Pinar stream, on the road connecting El Rocío and Villamanrique (Figure 3). Its spillway is 29.5 m long, 2.0 m high and 3.0 m width, with an average altitude of 14.62 m. The structure is crossed by 12 weep holes, 0.3 m in diameter, draining the volume stored behind the check dam, arranged in two rows (of 6 weep holes each).

Figure 3: CD2 elevation view (left) in 2006 and photograph (right) in July 2007.

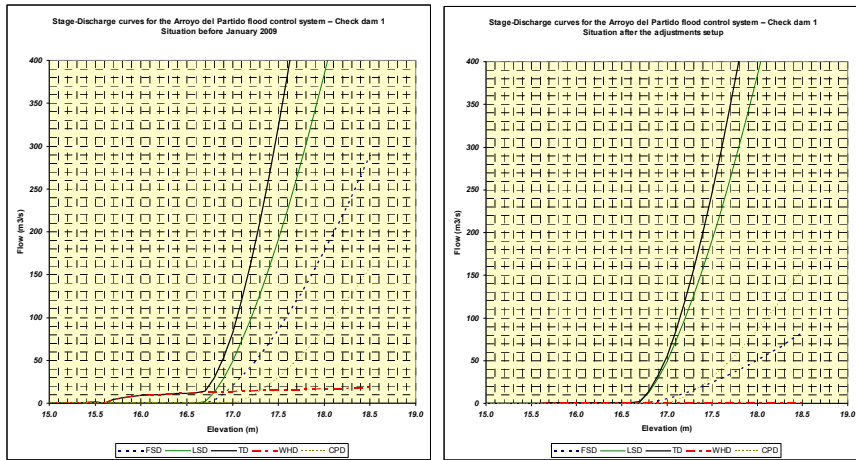
The initial design of the CD1 (built in 2006) was tested, and it was found that the control system performed efficiently for major floods, but did not prevent minor flooding and problems related to sediments deposition in the eastern surroundings of El Rocío village, placed at the edge of the marshes. The stabilization of the new alluvial fan, formed over the marshes, was not solved either, because the flow reaching there was still too high. Moreover, the floods did not flood, as expected, the area devoted for that purpose. In these circumstances, as a step towards implementing the necessary adjustments of the CD1, the stage-discharge curves of the Flood Control System were determined at the CD1 and CD2. We only show here the stage-discharge curve at the CD1 (Figure 4, left chart), being the only one that suffered corrections.

Figure 4: Flow allocation ( $\text{m}^3 \cdot \text{s}^{-1}$ ) at the CD1 among the different discharge sections: left chart, with the initial design (2006), and right chart after the adjustments in January 2009. Frontal spillway discharge (FSD), Lateral spillway discharge (LSD), Total discharge (TD), Weep holes discharge (WHD), Cañada del Pinar discharge (CPD).

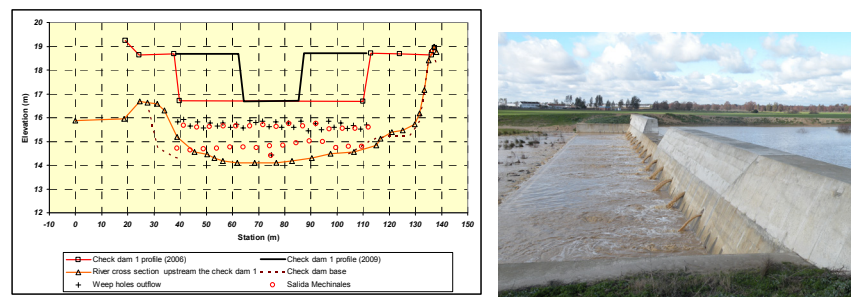
The results of the first flood were surprising. The pressure of the flow dragged the gravel blocking the weep holes through them, becoming those last operative again, as shown in the photograph in figure 5. The estimated flow distribution at the CD1 in these events, is shown in the Table 2.

The photograph in figure 5 shows the situation of the CD1 at 13:00 h (local time) on February 2<sup>nd</sup> 2009, during the flood that started the previous day. At that time, the estimated hydrograph (figure 6) points out a flow rate of  $15 \text{ m}^3 \cdot \text{s}^{-1}$ . This value matches with the stage-discharge curve at the CD1 at the same time, as shown in the photograph in figure 5, where all the weep holes were draining at their maximum capacity and there is no discharge over the frontal spillway threshold.

Figure 5: Left: CD1 elevation view with the final frontal spillway design. Right: Photograph of the CD1 at 13:00h on February 2, 2009, after the flood of the previous evening (image courtesy of C. Urdiales, DNP).

The adjustments of the CD1 were carried out after the summer of 2008, and were operational at the beginning of 2009. Their aim was the reduction of the flow crossing the CD1 to The Arroyo del Partido channel through its front face. With that purpose the following measures were implemented: a) to modify the initial frontal spillway section (2006), decreasing its draining surface, b) to cover the weep holes with gravel, delaying the discharge through them during floods.

Accounting these modifications, the new frontal overflow section became trapezoidal, 20 m long at the base and 24 m long at the crest, maintaining a height of 2 m (Figure 5). The new stage-discharge curves of the Flood Control System at the CD1, after the modifications are shown in Figure 4, right chart.

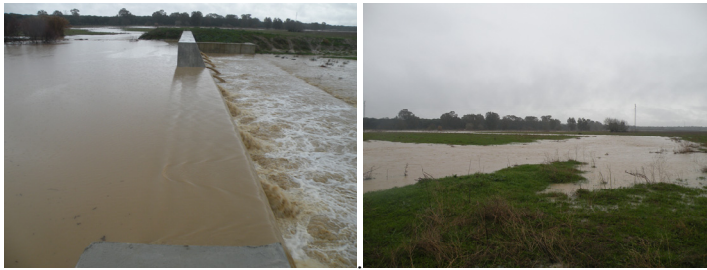
Figure 7: Flood in the Arroyo del Partido stream at 13:10 h local time on February 5 2009. Left: flow distribution at the CD1. Right: the flood flows downstream over the flood-lamination-sedimentation plain.

The left photograph in Figure 7 shows the flood on February 5<sup>th</sup> 2009 at the CD1, at 13:10h (local time). As the hydrograph shows (Fig. 6), the stream flow at that moment was about  $65 \text{ m}^3 \cdot \text{s}^{-1}$ , where  $20 \text{ m}^3 \cdot \text{s}^{-1}$  crossed the check dam front face ( $15 \text{ m}^3 \cdot \text{s}^{-1}$  through the weep holes and  $5 \text{ m}^3 \cdot \text{s}^{-1}$  over the spillway threshold). The remaining flow,  $45 \text{ m}^3 \cdot \text{s}^{-1}$ , were diverged to the flood-lamination-sedimentation area over the lateral spillway, as shown in the same photograph, and ran downstream over the floodplain, as shown in the right photograph in Figure 7.

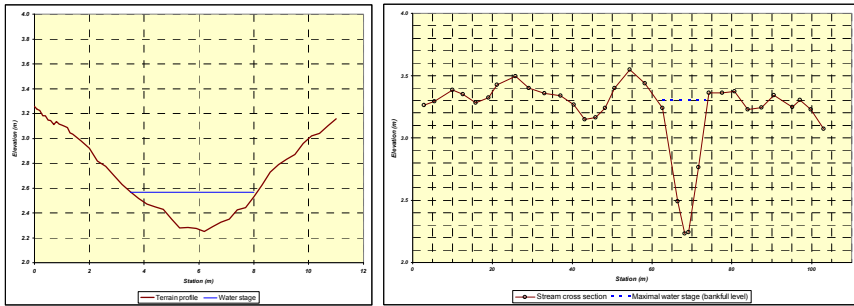
flow towards the marsh. With the current Monitoring, it was detected that after the CD1 was constructed, which reduced substantially the flood flow reaching El Rocío village, a recovery of the Arroyo del Partido stream has been produced compared to the period between 1982 and 2006, especially regarding the recovery of the morphology of the former drainage system (caño), which was already lost. This fact ratified the modifications made to the CD1 to achieve the hydraulic and hydrologic restoration of the last reach of the Arroyo del Partido stream. Several cross sections along the last reach of the stream prior to the marsh inflow were levelled for confirmation. One of them is shown in Figure 9. The graph on the left corresponds to a  $0.30 \text{ m}^3 \cdot \text{s}^{-1}$  flow. It was checked that in that situation the new alluvial fan was stabilized. The maximum evacuation capacity of this caño was estimated in  $4 \text{ m}^3 \cdot \text{s}^{-1}$  (right graph in Figure 9), and this value was considered in the A3 for the CD1 frontal spillway rectification. As a first approach, it was estimated that this flow corresponds to the bankfull stage of the channel, i.e. the evacuation capacity related with the dominant channel forming flow, linked with its compensation slope (García Nájera, 1943). This last was determined, by means of direct field survey, in  $0.0016 \text{ m} \cdot \text{m}^{-1}$ . Accordingly, it was considered that for flow rates under  $4 \text{ m}^3 \cdot \text{s}^{-1}$ , the sediment supply to the marsh remains beneath a moderated limit, since the flood remains into the drainage channel, and the sediment transport is essentially restricted to suspended load. Above this value, the best option is to permit the flood expansion across both overbanks. For this purpose it is necessary to ensure enough space, moving away any protection wall to the outer limits of the predictable flood expansion. In this way, the shear stress is insufficient to erode the banks and sweep away sediments into de marsh.

Figure 9: Left: Arroyo del Partido cross section, on the last reach prior to the marsh inflow, gauged on October 17 2008. Right: the same cross section, assuming a  $4 \text{ m}^3 \cdot \text{s}^{-1}$  flow (bankfull level).
