Prevention of transformers' damage in HPP with double generating units connected to GIS via HV cables

V. Silbermann

*Department of Electrical Systems and Networks,
Fichtner Consulting Company, Germany*

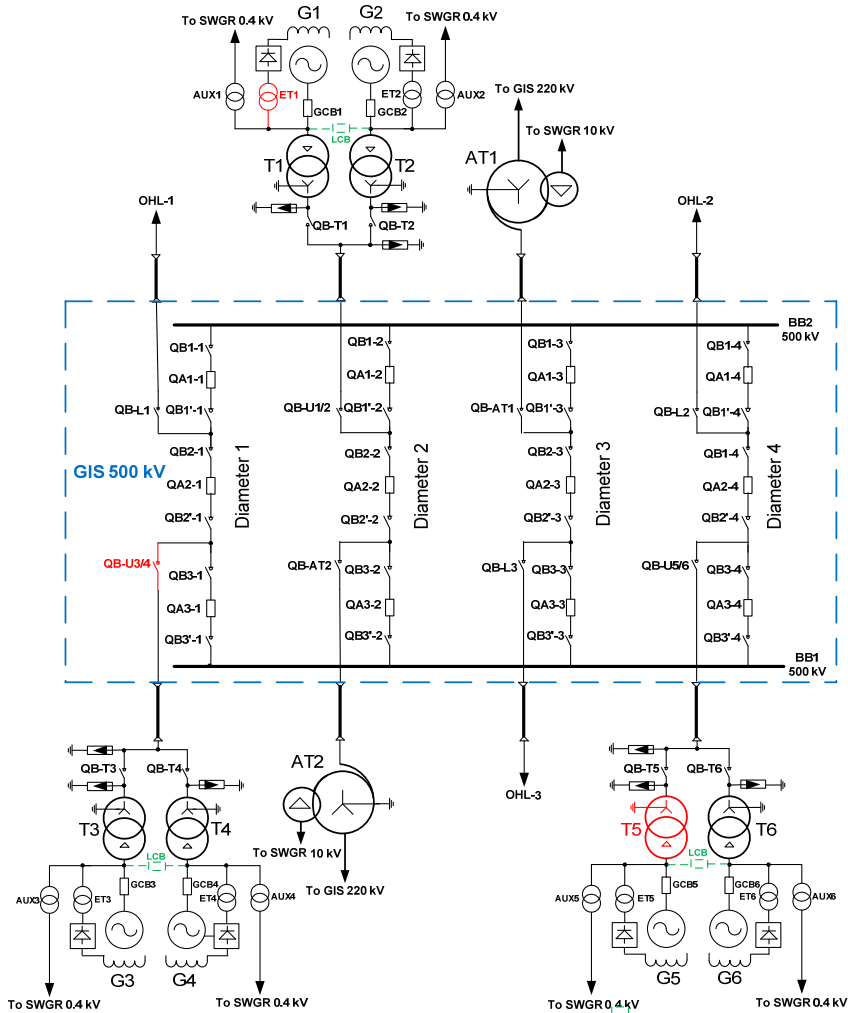
have been replaced the corresponding AISs with analogous circuitries. The 500 kV part of electrical scheme of this HPP is shown in Fig. 1, where GIS equipment is shown within dotted blue box and all damaged elements are shown in red. The protection of corresponding elements against over voltage are performed by means of standard surge arresters ZnO Class 4 with $U_c = 581$ kV.

Figure 1: Single line diagram of electrical part 500 kV of HPP.

- Transformer T1 which was operated at idle was tripped by the transformer differential protection and also by current cutoff protection of tapped transformer ET1. With this the whole DGU 1/2 was shut down. It was found that the tapped exciter transformer ET1 (630 kVA, 15.75/0.4 kV) was irreparably damaged (the high voltage connections of this transformer to the unit G1-T1 were melted and disconnected from the unit). Generator transformer T1 was also checked by insulation tests, but it was found to be undamaged and put back into operation again, together with Generator 1 and the new exciter transformer.

- Transformer T5 was tripped by the transformer differential protection. With it the whole DGU 5/6 was shut down. It was found that the phase “A” of its HV winding was irreparably damaged, and it was out of operation.

1. As shown above VFTOs in the circuitries like that depicted in Fig. 1 only arise during switching actions (on and off) on such L-R-C circuits by operation of any transformer at idle. It means that the performance of necessary switching actions (on and off) on such L-R-C circuits by circuit breaker would avoid the occurrence of the VFTO peaks to a great extent due to its short opening time (approx. 20 ms). Disconnectors in GIS have an opening time of about 500 ms. This means that the probability of transient voltage damage during opening the circuits by circuit breaker is about 25 times lower if tis done using a disconnection switch. Hence all switching actions in 500 kV cable circuits with or without idle running transformers (both on and off) shall be performed only by circuit breakers as a general measure. The cable disconnectors may be operated only when the corresponding cable is discharged. The fast earthing switches in 500 kV GIS should be used for this discharging.

4. It can be also recommended that additional load circuit breakers (LCB) would be installed between LV windings of DGU transformers (shown in Fig. 1 as dotted green lines) if the breaking capacity of the existing generator circuit breakers allows such an increase of short circuits values at LV side of these transformers, should be installed. These LCBs shall be switched on in the DGU with one transformer at idle before any commutation in HV circuitry of HPP and switched off upon accomplishment of these commutations.

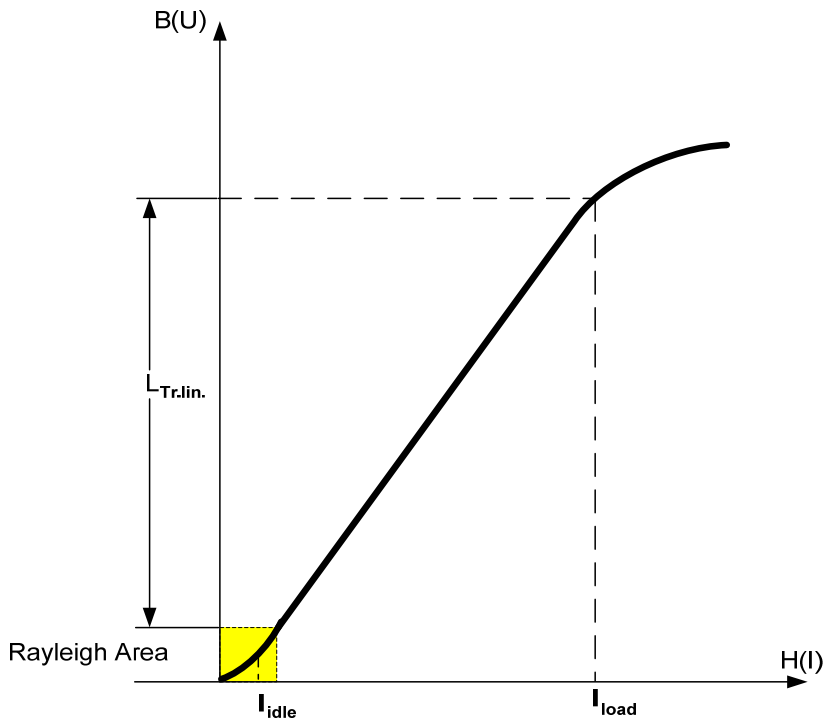
Figure 2: Typical magnetizing characteristic of power transformer.

The Rayleigh Area (yellow field) is an area of low magnetic fields of magnetizing characteristic of the transformer core. The behaviour of ferromagnetic materials in this area is described by the Rayleigh law, i.e.

For the transformer sheets the Rayleigh area covers the segment of the magnetizing characteristic till the magnetic field strength takes on the value 0.01 A/m, i.e. until the currents in the 500 kV winding about 5 A. This means that the idle currents of unit transformers (about 2 A on the side 500 kV for 400 MVA transformers) are located within Rayleigh area, and the transformer inductivity will be essential non-linear in accordance with (2). Consequently, the L-R-C circuit consisting of cable capacity and the transformer at idle will be non-linear as well. Taking into account that high frequency over voltage impulses will arise during any commutation of preliminary charged HV cable [2] and that these impulses will be branched out through whole GIS, the processes in the L-R-C circuit consists of capacity of 500 kV cable, non-linear inductivity and resistance of transformer at idle and the grounding system of HPP will, in principle, be oscillating. These oscillating processes that arise along with commutations in GIS can also lead to the resonances in each non-linear L-R-C circuit. Unfortunately, as pointed out in [3] the consideration of the processes taking place inside the winding is a difficult task, as it is impossible to access windings of operating equipment. Obtaining the required parameters by calculation is also extremely difficult because of the complexity of the calculations and the lack of data on the windings and insulation system geometry. Hence these oscillating processes can only be estimated qualitatively. However, it is possible to measure the frequency characteristics of transformers' windings to determine the resonance frequencies and the magnitudes of VFTOs peaks. Such measurements for the block transformer 25 MVA, 110/15 kV were performed and studied in [4] and it was shown that by introducing such VFTOs in the transformer winding their magnitude can be quadruple of the voltage at the transformer terminals. And if it is even assumed that due to resonance in this L-R-C circuit the magnitude of over voltage, that arose during the investigated event, was double the value recorded at the transformer terminals, the voltage magnitude within the transformer winding will exceed 1160 kV, i.e. the level of the impulse test voltage. And the issue is exacerbated by the fact that the shape of these over voltages measured by research in Russia [3] differs substantially from the standard wave of test voltage and the slope of voltage curve can attain 450 kV/ μ s. This greatly exceeds the standard lightning impulse voltage of 1–5/50 μ s as specified in [5] and it is also above the highest impulse voltage level for 500 kV equipment of 1550 kV peak as stipulated in [6].
