Non-destructive investigation of structural elements of the “Altes Museum” in Berlin

Ch. Maierhofer¹, Ch. Köpp¹, M. Hamann², Ch. Hennen², L. Binda³,
A. Saisi³ & L. Zanzi³

Abstract

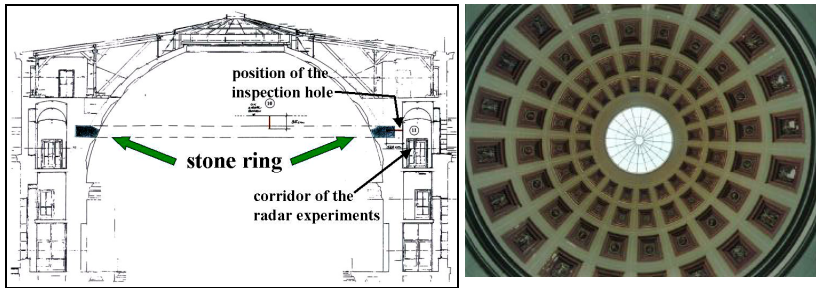
Figure 2 left shows the assumption of the architects regarding the existence of a stone ring embedded inside the brick masonry structure supporting the dome. The objective of the investigations was to validate this assumption and to derive as many information as possible regarding the morphology of the ring. Thus, radar measurements had been carried out in reflection mode.

Figure 2: Left: Structure of the supposed reinforcement stone ring and position of the investigations. Right: View to the cupola showing the waffles.

The waffles visible at the inner surface of the upper part are made of gypsum stucco (figure 2 right). According to the available documents during the reconstruction the loose surface of the porous bricks had been cut down for about 3 cm. On the inside surface, a Rabitz granting has been mounted usable as plaster lath base. This granting has been fixed with anchors, which are passed through the masonry structure. The ends of the anchors are exposed on the outside of the cupola.

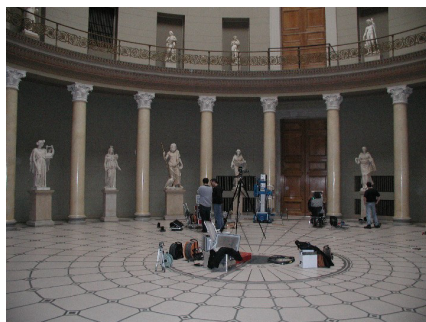
One of the main aims was to find out differences between old and new parts of the floor. Additionally, voids below gypsum or cement screed had to be detected.

Figure 3: Floor of the rotunda during the measurement campaign.

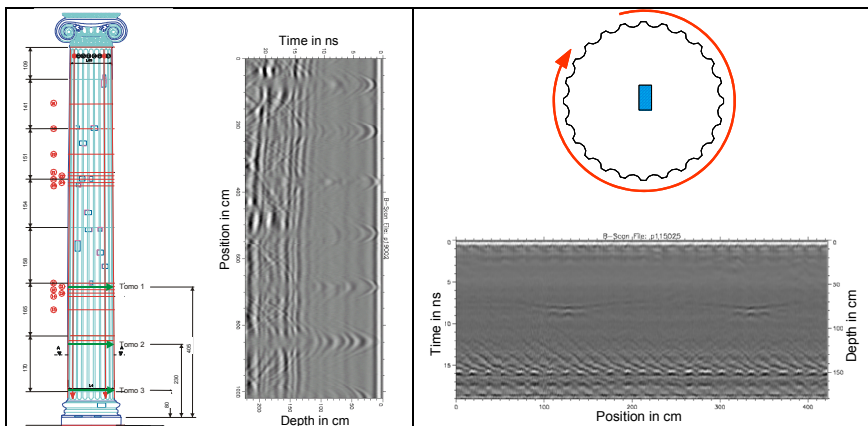
For getting an overview traces in direction of the longitudinal axis (vertical) of the selected column were recorded with the 900 MHz antenna along the whole height (10.2 m). A measuring wheel mounted to the antenna performed path recording. Figure 4 shows one of these radargrams. Clear signals related to the surface and to the backside reflection can be detected. The travel time of the backside echo increases when going from top to bottom corresponding to an increase of the diameter of the column. Close to the surface reflection, hyperbolas occur representing the reflection of the joints between the different drums. Due to the high intensity of these reflections, it is assumed that these joints contain plumb layers that were used as a non-seizing compound for the alignment of the column drums.

For detailed investigations on the joints between the drums, horizontal traces at different areas close and far from the joints were recorded. The measurements were performed radial along the surface of the column with the 1.5 GHz antenna. One of these radargrams below a joint is shown in the bottom of figure 4. Due to the cannelures the backside reflections appears in a wavelike shape. Noticeable reflections can be detected at a depth between 70 and 75 cm. The position and intensity of this reflection is changing with the angular position of the antenna around the column (trace of antenna: 360°). The reflections at opposite antenna positions (180°) are similar. From this reflection profile it can be concluded, that in the middle of the drum below the joint, a rectangular hole exists (with a length of ca. 7 to 10 cm and a width of 2 to 3 cm) which was used for mounting, see figure 4, top. This hole was only located at the top of each drum and was presumably used for mounting and alignment of the drums. There were no hints to metal compounds as pins between the drums.

Figure 4: Left: Investigated column (left) and radargram of a vertical trace (right) recorded along the total height of the column with the 900 MHz antenna. The hyperbolas are related to the joints between the drums. Right: Top: Rectangular void in the upper part of each drum used for transportation and alignment. Bottom: Radargram of a horizontal trace recorded with the 1.5 GHz antenna in the upper part of one of the drums.

In summary, with radar, the joints between the drums could be located very easily, which possibly contain plumb layers between the joints. Related to the connections between the single drums, metal compounds like pins could be most probably excluded. At the top of each column, a rectangular hole is expected which was used for mounting and alignment of the drums. With radar reflection as well as with sonic tomography (not shown here), the repaired areas could be located. But it was not possible to determine the depth of these structures.

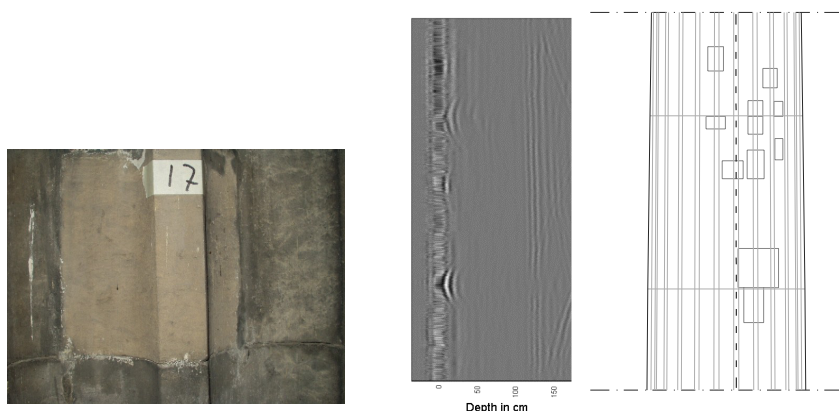
Figure 5: Left: Detail of a repair intervention. Right: Vertical trace across an intervention piece.

Some of the traces intersect positions where repair interventions have been made in the past as shown in figure 5. The radargram shows the result after the removal of the background and the amplification of the signals. This profile crosses two joints, which are indicated by two diffraction hyperbolas in the radargrams as explained above. Additionally, a near-surface signal can also be received from a repaired area crossed by the profile. This means that the repairing material has dielectric properties sufficiently different from the stone of the column so that the radar signal is modified.

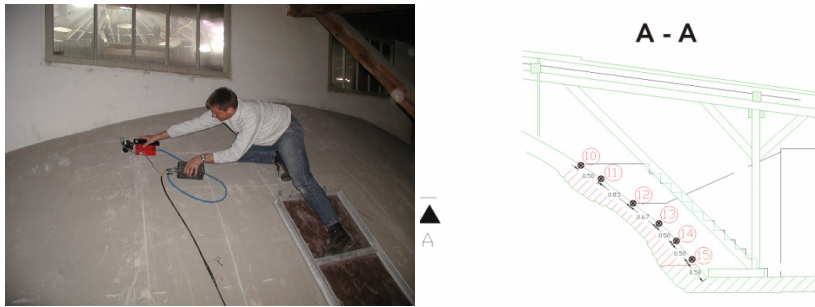
For the investigation of the inner structure and construction of the rotunda cupola several measurements have been performed starting from the outer side of the cupola as shown in figure 6. The measuring area had a size of about 2.95 m x 3.00 m and was tested with the 900 MHz and 1.5 GHz antennas.

Figure 6: Left: Photo of the radar measurements at the cupola of the rotunda. Right: Cross section with radar traces of one part of the cupola.

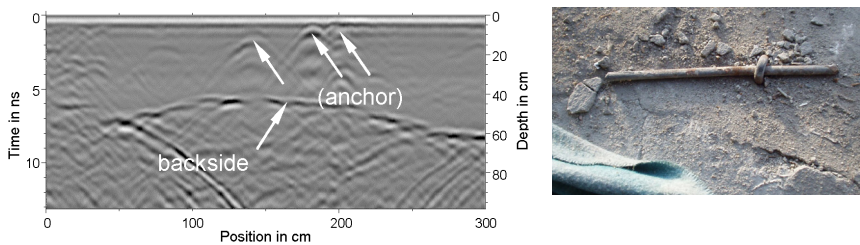
For the presentation of results one selected radargram performed with the 1.5 GHz antenna (vertical trace) is shown in figure 7. The backside of the cupola is clearly recognisable. The thickness of the cupola varies, depending on the position of the measuring trace (see figure 6 right) above the single waffles. Additionally, reflections (hyperbolas) could be detected close to the surface, which indicate metallic bars and thus probably the anchors.

Figure 7: Left: Radargram of a vertical trace at the cupola recorded with the 1.5 GHz antenna. Right: Dissected anchor.

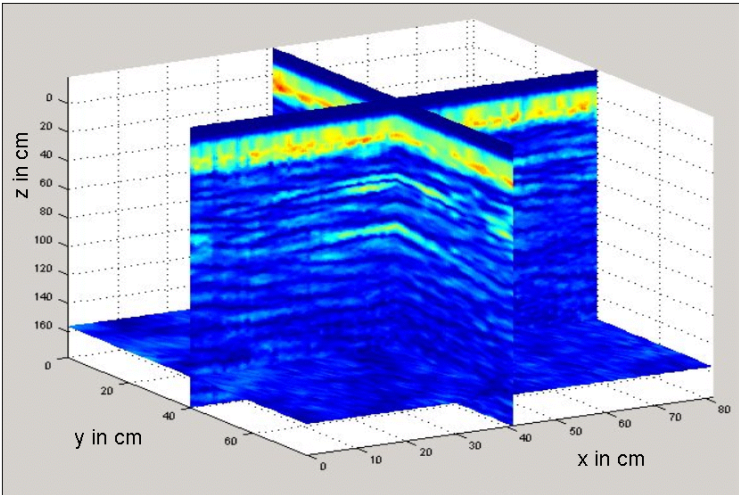
For a more reliable interpretation of the radar images, the experiment was executed in 3D mode by collecting a number of dense parallel profiles on an area of about 80 cm x 80 cm. The data were processed with a 3D software obtaining a 3D data volume that confirms the existence of the stone ring (figure 8). The two reflections observed at about 45 and 80 cm were respectively interpreted as the reflection from the stone ring and from the interface separating the first and the second stone layer of the structure.

Figure 8: Cross-sections of the 3D radar data showing two main reflections at about 45 and 80 cm.

During the drilling procedure it was noticed that the former drilling penetrated the sandstone ring for almost 11 cm. The superstructure of the wall was determined with the endoscope inspection at this drill hole as described in Table 1. The texture of the sandstone changes in the depth of ca 86 cm as also observed in the radar data. Joints inside the sandstone could not be detected.

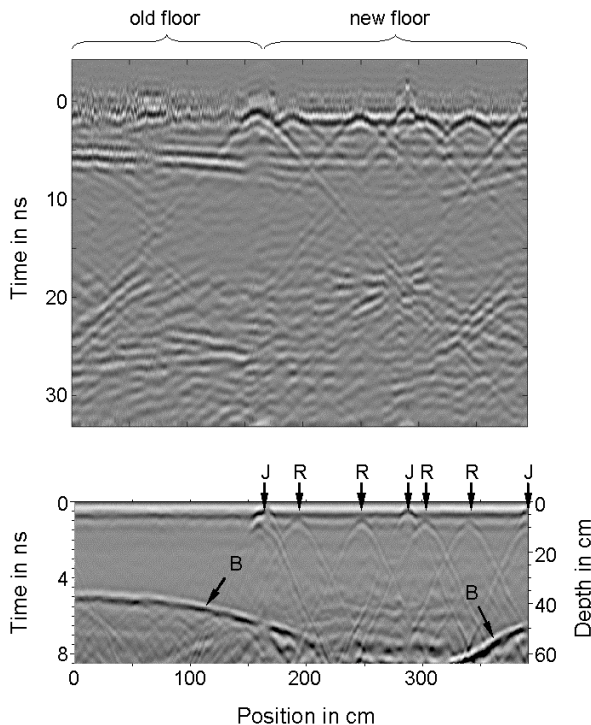
With radar and impact-echo, the structure and inner condition of selected parts of the floor were investigated. In the following, only the radar results are presented. In figure 9, two radargrams recorded with the 1 GHz (top) and 1.5 GHz antennas (bottom) along a profile that pass over the original and new floor are presented.

Various hyperbolas appear very close to the surface in the new pavement. The occurrence pattern of the diffractions is the following: a hyperbola in the joints (F) and two hyperbolas inside the concrete slabs (B) are representing metallic rebars. Further reflections observed in all radargrams can be related to the bottom side of the floor and the ceiling of the cellar. Due to the complex arch construction of this floor, this back side reflection appears at a different depth. The layered structure of the floor cannot be resolved in any of the radargrams. Thus, the difference of the radargrams recorded in the reconstructed and in the original area is given only through the presence of the reflections from the rebars.

Figure 9: Radargrams recorded with the 1 GHz (top) and 1.5 GHz (bottom) antennas along a trace with original (left) and new (right) floor.
