# Contribution of radar measurements to the inspection and condition assessment of railway bridges – case study at a historic masonry arch bridge in Oleśnica/Poland

Ch. Trela, J. Wöstmann & S. Kruschwitz

*Federal Institute for Materials Research and Testing (BAM), Germany*

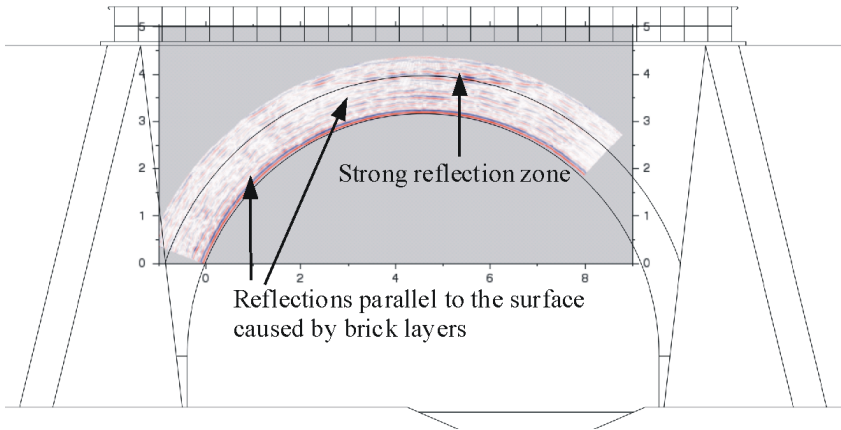
Measurements from the inner part of the arch, below the bridge, show only backwall reflections near the ceiling, shown in Figure 4. This strong reflection at approximately 12 ns is visible at the horizontal profile over the whole width of the span, shown in Figure 5. The strong reflection hyperbola at 4.5 m could be caused by an internal spandrel, but could not be confirmed by other measurements so far.

Figure 4: Radar measurement with the 900 MHz antenna on the vertical profile V6m at the ceiling of the arch; radargram with radial positioned traces and topography with the schematic contour of the bridge.

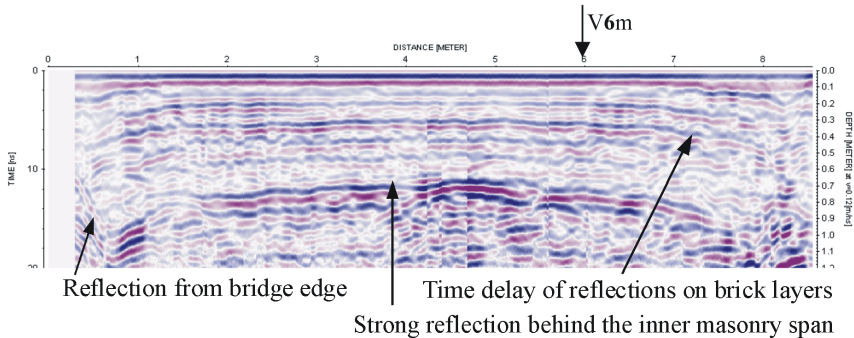
Figure 5: Radar measurement with the 900 MHz antenna on the horizontal profiles at the ceiling of the arch with marked reflections and crossing profile V6m.

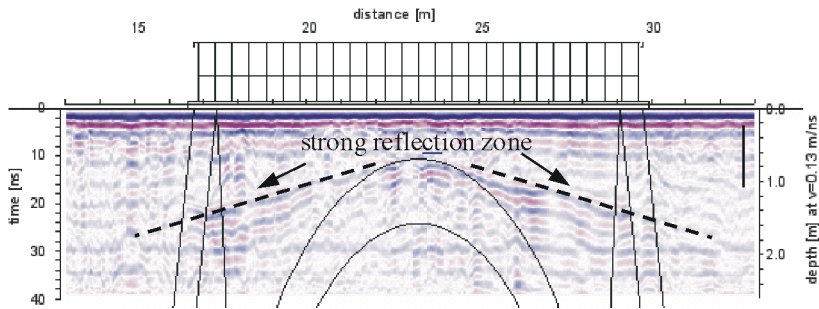
Radar measurements from the top of the bridge in Figure 6 allow a tracking of the strong reflection away from the midpoint of the bridge and could be interpreted as the course of the abutment of the bridge. The abutment seems to be thicker than 3 m. Such thick abutments at historic masonry bridges are not unusual (Stromer [4]).

Figure 6: Radargram of the 500 MHz antenna over the bridge with the schematic contour of the bridge; the assumed back wall of the abutment is marked with dashed line.

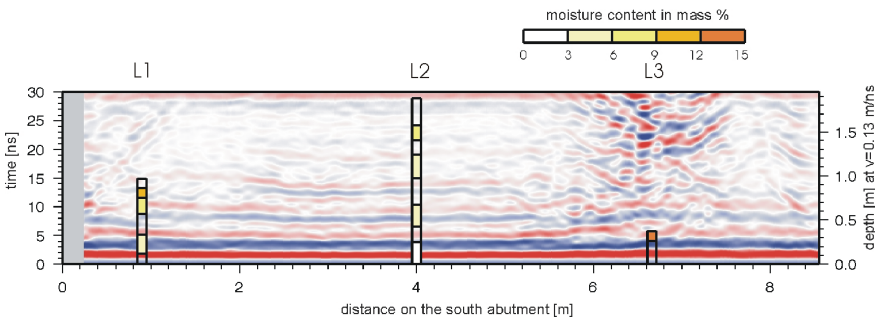
Figure 7: Radargram of the horizontal profile H5 recorded with the 500 MHz antenna and results of the moisture content estimation on certain core samples at the south abutment in 1.20 m height.

Figure 7 contains the horizontal profile H5 at the height of 1.2 m at the south abutment and the results of the moisture content estimation of some core specimens from the boreholes L1, L2 and L3. Strong reflections and the time delay of the reflection horizons correlate well with the increased moisture content in the depth, especially the area between 5.5 and 7.5 m and near the edge at 1 m. At borehole L3, at 6.66 m already after the first, rather dry brick of 25 cm, a wet brick was met and no further drilling was possible. At the second core sample of this borehole L3 a maximum moisture content of 14.33 mass percent was estimated. The observed time delays of reflection horizons at the

beginning and end of the radargrams relate to increased moisture at the edges of the bridge, see moisture content in Figure 7 at borehole L1.

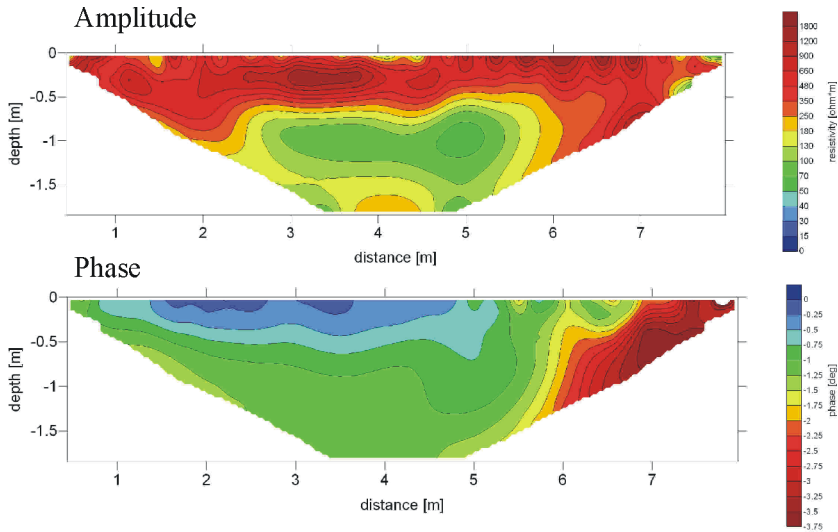
The area between 5.5 and 7.5 m with strong reflection in the radargrams correlates well with the decreased thickness of the area with high resistivity in the SIP inversion result in Figure 8 and could be caused by wet and deteriorated masonry. Both the analysed amplitude and phase of the resistivity are characterised by changes after 5 m distance.

Figure 8: SIP inversion result of the amplitude (top) and phase (bottom) of the horizontal profile at the south abutment.

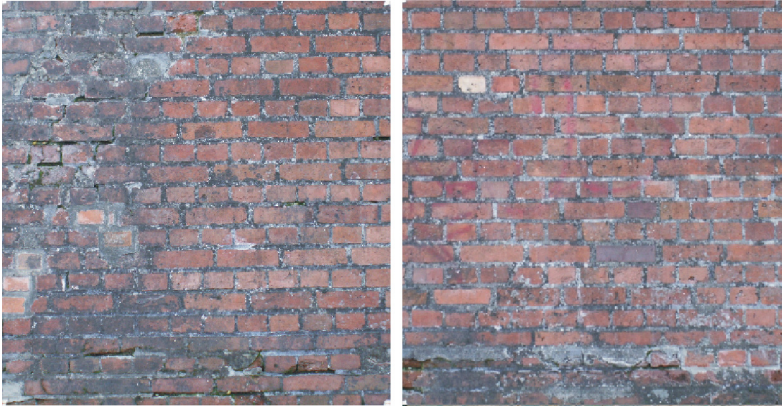
To investigate the crack distribution in the masonry with GPR in more detail, an automated scanning system was applied to get more accurately positioned data in a shorter time. Two testing areas of 1.6 m x 1.6 m at the left wing wall were selected in Figure 3. As shown in Figure 9, testing area 1 exhibits the stronger deteriorated area with visible open cracks especially in the left upper part and in the first lower brick layers and areas of repaired brickwork (new bricks and mortar).

Figure 9: View on the brickwork of the radar testing area 1 and testing area 2 (1.6 x 1.6 m) at the left wing wall.

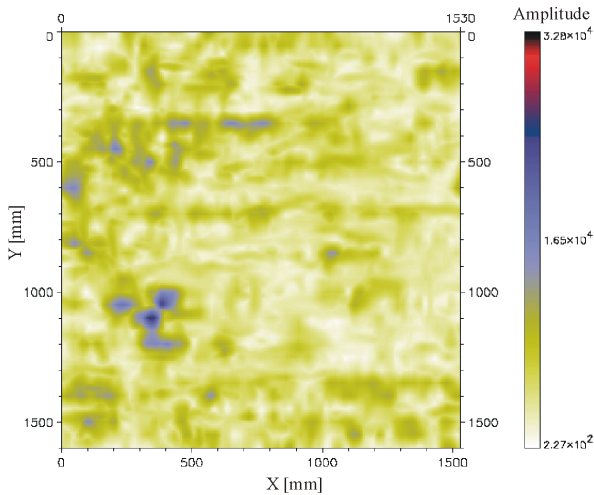
Figure 10: Times/depth section (C-Scan) at 14.5 cm of the testing area 1 after 3D FT SAFT reconstruction and data fusion of horizontal and vertical lines.

This processing sequence allowed the creation of high-resolution depth sections (C-Scans). An example of the testing area 1 is shown in Figure 10. At a depth of 14.5 m, after one stretcher course, reflections of individual bricks are visible. The strongest reflections correlate well with areas of open cracks and the repaired area at the left side.

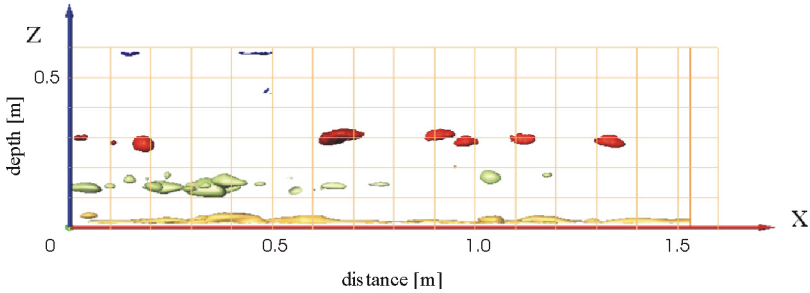
3D visualisation of threshold values in different depth intervals with the AMIRA toolbox in Figure 11 shows that no tracking of cracks to the depth is possible. Strong reflections, marked green and red, correspond only to the brick geometry of the first brick layer (stretcher or header course).

Figure 11: XZ-plot (B-Scan) of the 3D-visualisation of threshold values in different depth intervals of the testing area 1 after reconstruction and data fusion.
