CAUSES OF DETERIORATION OF OTTOMAN MOSQUES

MARIA LOUKMA & MARIA STEFANIDOU

Laboratory of Building Materials, School of Civil Engineering, Aristotle University of Thessaloniki, Greece

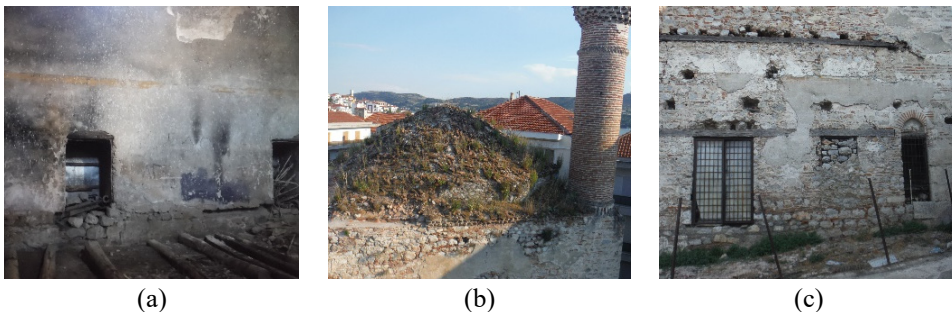
(window frames, metal railing) (Fig. 2(a)). There are no sufficient elements for the flooring material and the way the building's foundation were made. The plaster is saved in moderate condition where there are areas both externally and internally in the building, keeping only a small percentage of its colour decoration [2].

The building presents problems of deterioration from moisture and vegetation growth. The main problem lies in the roofing of the building where the external tile loss of the dome and the internal generated cracks, combined with the collapse of parts of the octagonal drum lower the mechanical resistance and make the construction more vulnerable to deterioration agents. In these places becomes easier the penetration of rainwater, favouring the development of vegetation, resulting in degradation of building materials (Fig. 2(b)).

On the walls recorded small cracks, vegetation into the joints and loss of wood joins, while in northwest masonry problems are more extensive (Fig. 2(c)). Cracks were detected at the minaret, both on the northwest side, and in contact with the bulk of the building.

Figure 2: Koursoum Mosque. (a) Interior view; (b) The roof of the mosque; (c) Northwest side view.

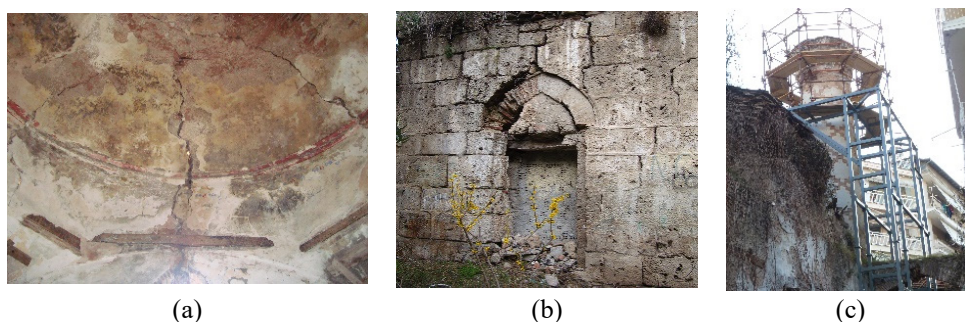
Today, the building is in poor condition with damages to the structure. Main causes of deterioration of the monument is the extensive vegetation, up to trees that have grown and the loss of tiles at the dome that led to wide cracks (Fig. 3(a)). In addition, the presence of a tree trunk in southern corner of stonemasonry has resulted in the disruption of the structure and increased the stress of the whole building (Fig. 3(b)). At the interior, loss of coating, weathering of building mortar and disruption of construction mainly in areas that come in contact with the floor are recorded.

Figure 3: Orta Mosque. (a) Cracks in the interior; (b) Disruption of the structure; (c) Scaffold around the minaret.

Around the 1980s, as a temporary measure to protect the monument an internal wooden scaffold was placed in the four corners of the building, while the summer of 2017 a metal scaffold was placed around the minaret due to deviation from the vertical (Fig. 3(c)).

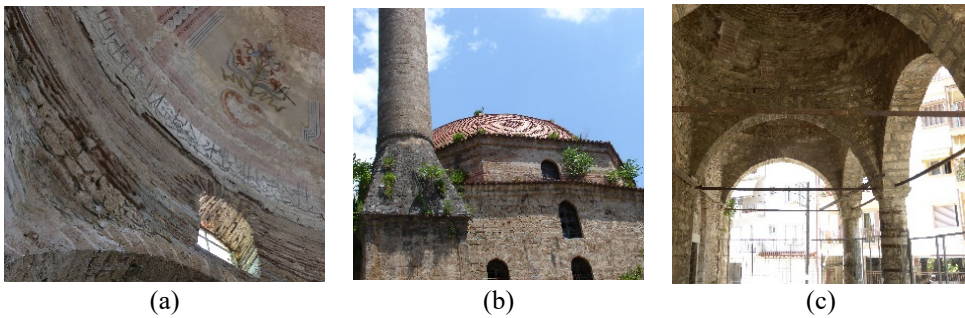
It is kept in relatively good condition, facing problems mainly because of moisture and vegetation. At the interior, the intense presence of moisture leads to detachment of coatings and the weathering of building materials (Fig. 4(a)). The presence of moisture and the growth of the biological agent is continuous and is deteriorating due to the loss and detachment of the roof tiles (Fig. 4(b)). The main problem occurs at the attachment point of the wall with the north-east domes of the portico. In the context of openings, in pendentives and in the drum of the dome some cracking appears. In the portico, due to water penetration, detachment of mortar and bricks is observed at the domes (Fig. 4(c)). Finally, the interventions made with cement over a large area, altering the form of construction and create additional problems of alteration of building materials.

Figure 4: Geni Mosque. (a) Detail of the interior; (b) Part of the exterior front view; (c) Part of the portico.

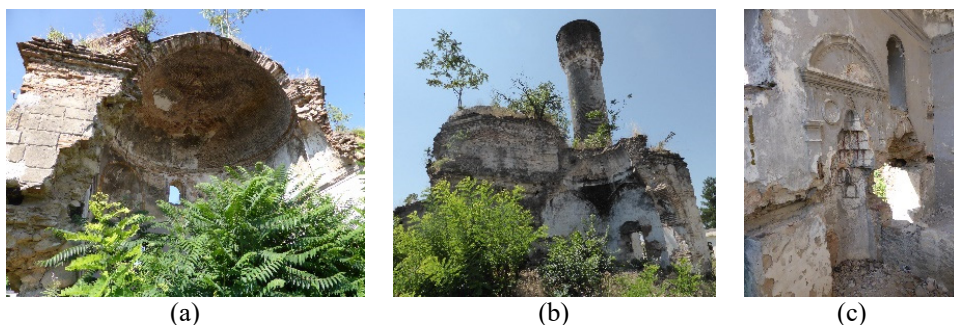
Today, the monument faces severe problems of deterioration due to the loss of structural material (Fig. 5(a)). The destruction of north-east side, part of the two in touch walls and large section of portico (Fig. 5(b)) resulted in the disruption of the masonry structure and increase the probability of a total collapse. Cracks on walls and peeling of mortar (Fig. 5(c)) in combination with environmental conditions and vegetation make the monument's preservation even worse.

Figure 5: Ahmet Bey Mosque. (a) The loss of the structure; (b) View of the portico; (c) Detail of the interior.

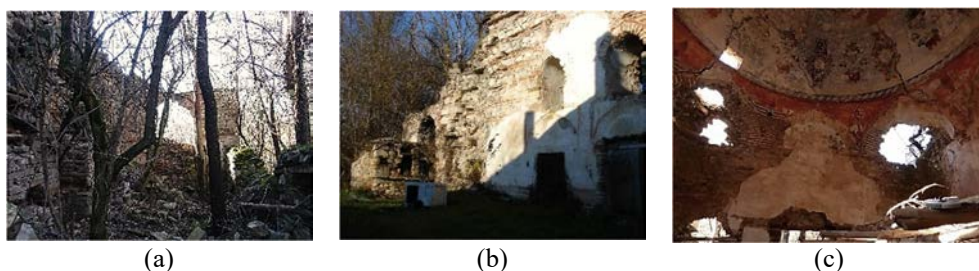
Figure 6: Mosque in Exochi. (a) The position of the portico; (b) The position of the minaret; (c) Detail of the interior.

The building faces problems of pathology that have disrupted the masonry structure due to the loss of the portico (Fig. 6(a)), the destruction part of north sided prayer space and part of the external corner of the particular space in the joint with the portico and the minaret (Fig. 6(b)). Material loss and cracking is also recorded, in two northern pendentives in the dome (Fig. 6(c)), drum and smaller on the walls. At the interior of the building painting decoration is preserved to a satisfactory degree and externally plaster is preserved in many surfaces. The inflow of water into the interior of the monument due to loss of material combined with the environmental conditions and vegetation accelerate the weakening of construction and alteration of building materials.
