Failure characterisation of Ti6Al4V gas turbine compressor blades

Abstract

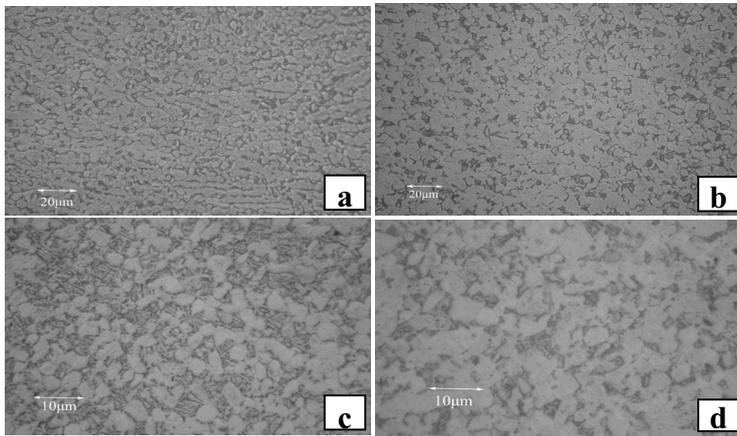
and airfoil with different work hours are presented in Figure 3. It is consisted of predominantly equiaxed α grains, lamellar transformed α plates, and fine intergranular β phases. It should be noticed that this microstructure is common in Ti-alloy compressor and fan blades, with equiaxed portion providing good tensile ductility and hence good resistance to crack initiation, while the lamellar portion is responsible for increasing resistance to crack propagation.

Figure 3: Microstructure of the fractured blades: a,b) root & c,d) airfoil; a,c) 1st & b,d) 2nd fractures.

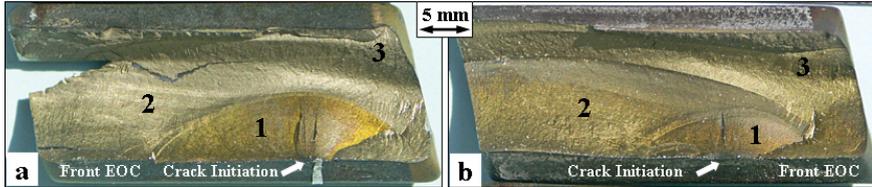
Figure 4: Fracture surfaces of the: a) 1st and b) 2nd failure. Note that three distinct regions are numbered and the main position for crack initiation are identified by an arrow.

Figure 4 shows macro-fractography images of the 1st and the 2nd failures. Three different regions are remarkable in each fracture surface. In the first and second regions, beach marks are clearly detectable. Moreover, several radial lines can be revealed in each fracture surface. The position of the main crack initiation from the front edge of contact (EOC) of both blades are shown (Figure 4). It is seen that the characteristics of the fracture surfaces and the position of crack initiation are more or less similar for both failures.

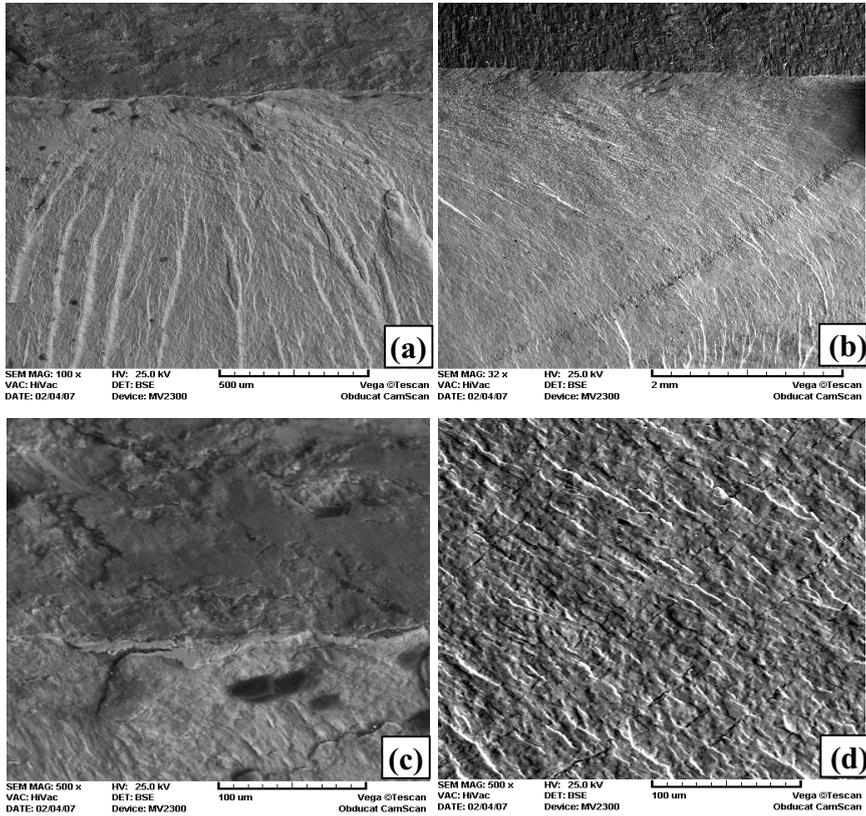
Micro-fractography tests were performed on different fracture surfaces as shown in Figure 5 for the 1st fracture. Figure 5a shows the main crack, beach marks and radial lines in region 1 of fracture surface. Figure 5b illustrates the fatigue appearance in region 2. The image of EOC and multiple micro crack initiation are observed in Figure 5c. The brittle fracture mode can be clearly seen in the fracture surface as shown in Figure 5d.

Figure 5: Micro-fractography of the 1st fracture surface: a) region 1, b) transition to region 2, c) EOC, and d) brittle manner of material.

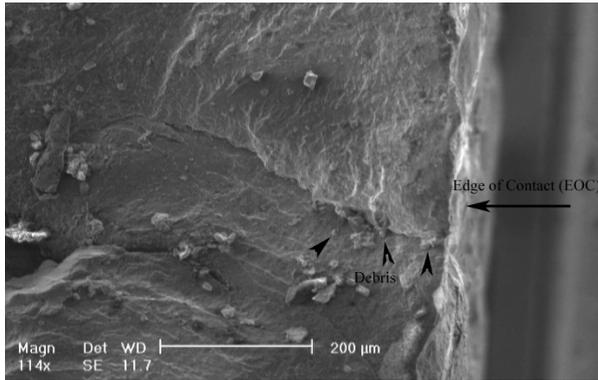
Many debris particles as an indication of wear were found on EOC and in the mouth of cracks (Figure 6). EDS analysis (Table 5) of the debris particles showed a high amount of oxygen confirming oxidation of Ti during the service, which is responsible to form abrasive TiO₂ particles in the fracture surface. Debris also shows some Fe content coming from the steel disk.

Figure 6: Micro-fractography of the 1st cracked blade fracture surface showing the appearance of main crack and compact debris in mouth of crack.

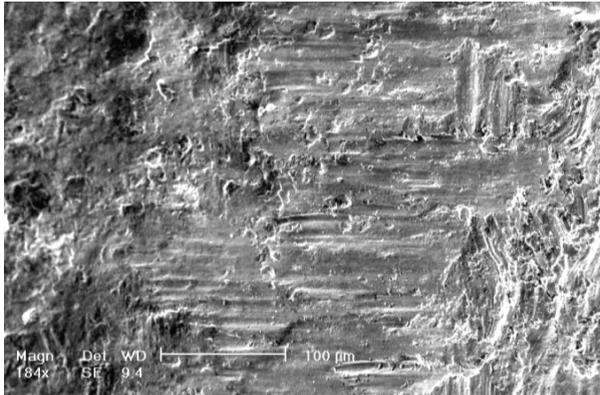
Sever sliding and rough surfaces were observed in EOC in the blade roots as shown in Figure 7. It is believed that the coating of blade root and disk in the contact region were damaged making these surfaces so rough which can directly influence the crack initiation. The results of roughness measurements are listed in Table 6. As it can be seen, the maximum surface roughness is achieved in the EOC region.

Figure 7: Micro-fractography of the 2nd fracture surface showing sliding marks on EOC.

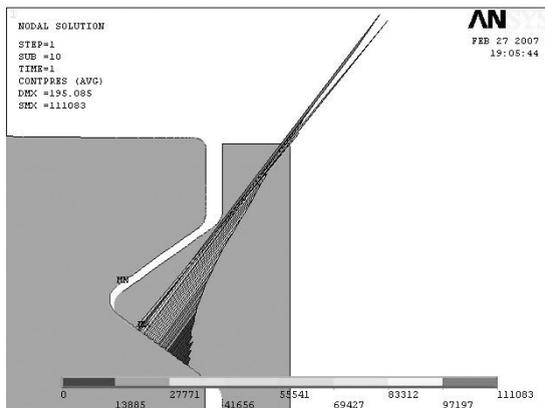
Figure 8: Contact pressure distribution in the contact surface.

In the stress analysis, the centrifugal, contact and aerodynamic forces were applied to the model. Figure 8 indicates the high contact pressure at the EOC between blade dovetail and wheel dovetail. Figure 9 shows the von misses stress distribution and stress concentration in the contact surfaces. It can be seen that the maximum stress of about 195 MPa has achieved in the corner on EOC, the position that is in agreement with the experimental characterisation. It was concluded that this stress concentration has been caused by either unsuitable curvature ratio of the disk dovetail, incorrect design of the blade or tight contact between the blade root and the disk in dovetail region. It seems that the aforementioned factors as well as abnormal vibration have caused the fretting fatigue failure of the 9th stage compressor blades. The simulation model is under development to consider the fatigue feature of the aerodynamic force as well.

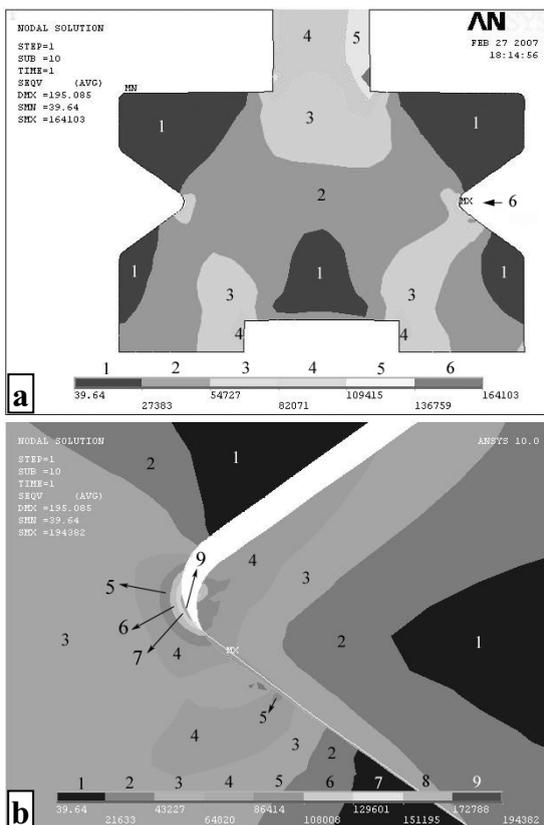
Figure 9: Distribution of von misses stress in the a) blade, and b) contact region of disc and blade.
