# A microstructural study on the high temperature oxidation, carburization and sulfidation of HK 40 and Incoloy 802

I. Caminha<sup>1</sup>, C. Barbosa<sup>1,2</sup>, I. Abud<sup>1</sup>, S. Santana de Carvalho<sup>1,2</sup>,  
F. C. de Souza Coelho dos Santos<sup>2</sup> & M. de Jesus Monteiro<sup>1</sup>

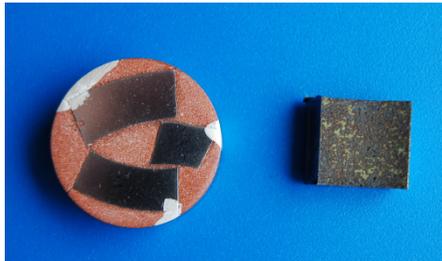
Samples of stainless steel and superalloy used in the pyrolysis stage of polymeric materials fabrication are presented in figure 1. In this image sample 81 (mounted: left) and a sample of the inner surface of the tube (right) with greenish stains are displayed. Several similar samples were received and analyzed. Two types of metallic materials were used in the fabrication of the tubes: HK 40 stainless steels (25% Cr and 35% Ni) at the input of the system and Incoloy 802 (35% Cr and 45%Ni) at the output (higher temperatures: 35% Cr and 45%Ni) of the system.

Figure 1: Samples: after metallographic preparation (left) and as received (right).

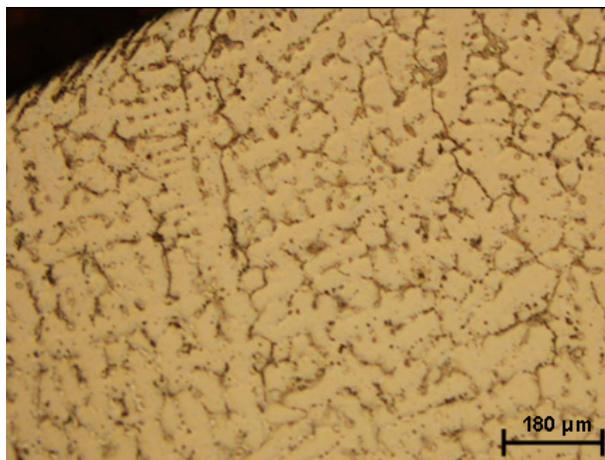
Figure 2: Microstructure of sample 81 (inner surface) – optical microscope.

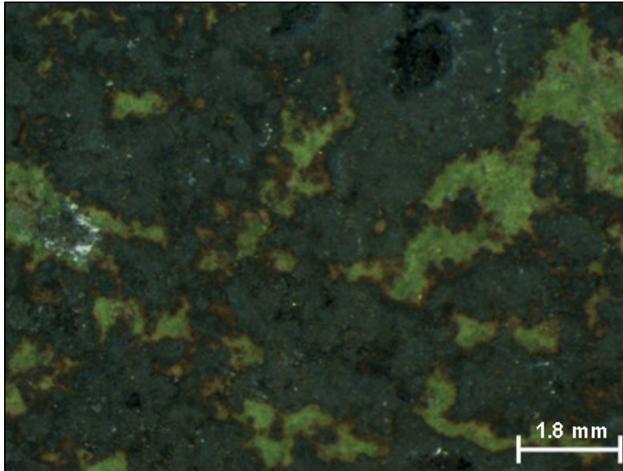
Figure 3: Inner surface of sample 81 with greenish stains: stereomicroscope.

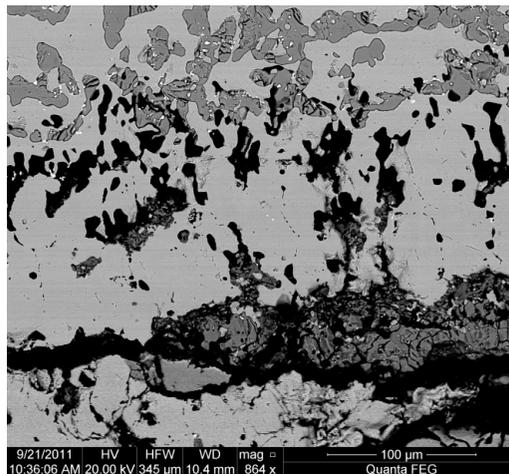
Figure 4 shows the aspect of the microstructure of sample 66 observed in a field emission scanning electron microscope (FESEM) with backscattering electrons. Figure 5 presents the regions where EDS analysis was performed and the EDS spectrum corresponding to region 6.

Figure 4: SEM BSE image sample 66 inner surface, output.

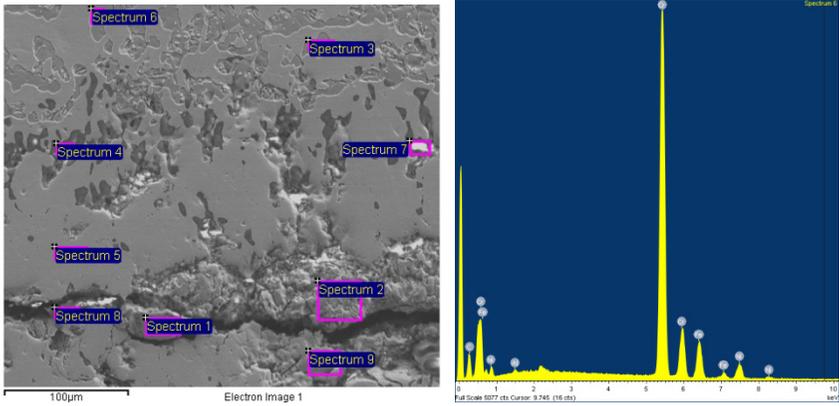
Figure 5: Regions selected for EDS analysis: sample 66 inner surface, output (left side) and EDS spectrum obtained from region 6 (right side).

Several particles were observed and analyzed by an EDS device installed in the FESEM: mainly oxides, carbides and, in just some instances, sulfides (samples 66, 82 and inner surface with greenish stains, as shown in figures 5, 7 and 9, respectively). In these samples, and also in sample 81 (not shown in this paper), the presence of sodium (Na) was also identified.

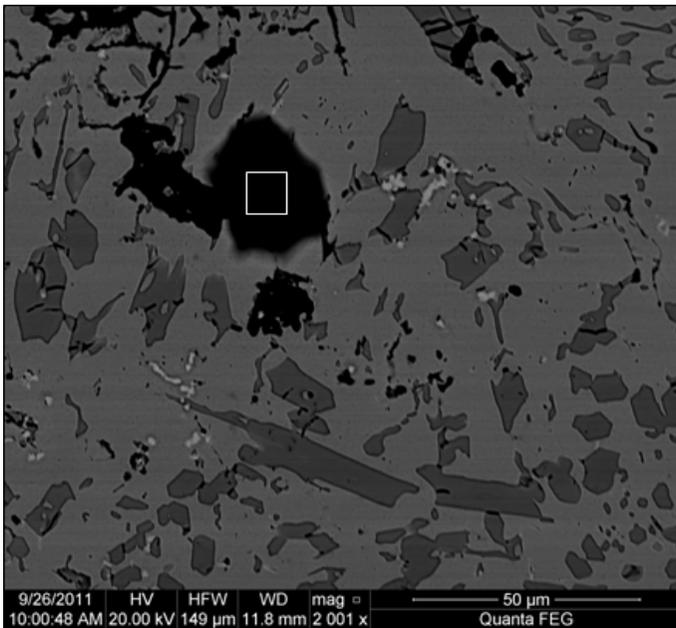
Figure 6: SEM backscattering electrons image of region with S rich particles. Region of sample 82 subjected to EDS analysis: indicated by a rectangle (inside).

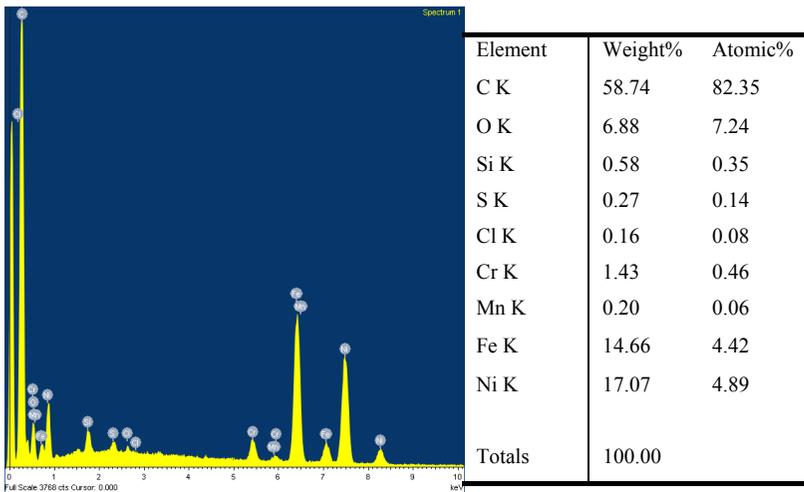
Figure 7: EDS spectrum analysis: S rich particles in the region indicated by rectangle Figure 6.

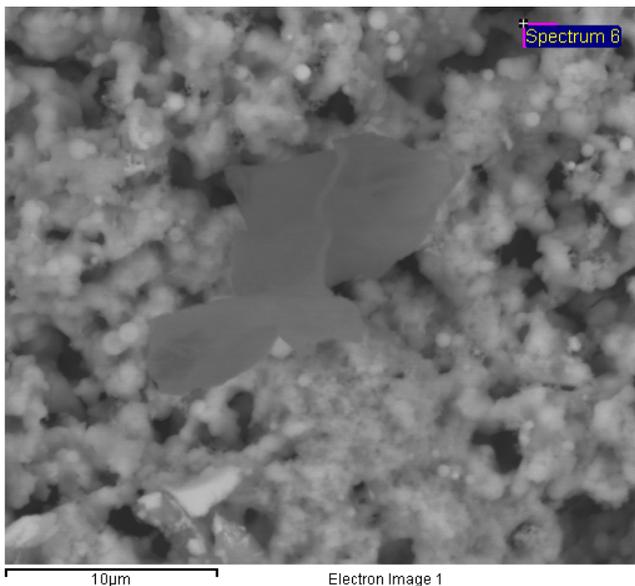
Figure 8: Sulfur rich particle in another region: inner surface of sample 82 with greenish stains.

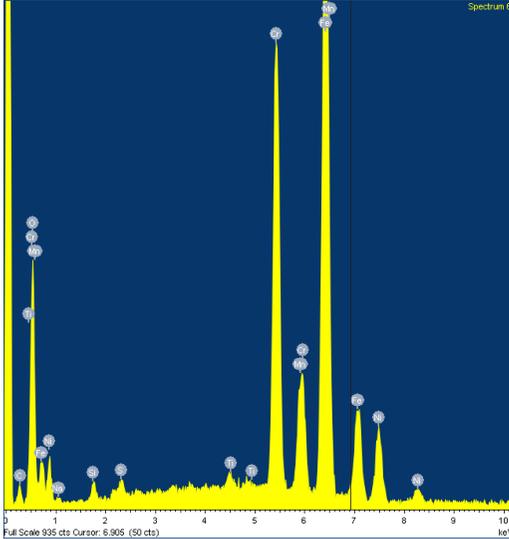
Element	Weight%	Atomic%
C K	3.27	10.83
O K	10.39	25.85
Na K	0.36	0.63
Si K	0.44	0.63
S K	0.28	0.35
Ti K	0.32	0.27
Cr K	22.01	16.84
Mn K	4.71	3.41
Fe K	49.74	35.45
Ni K	8.47	5.74
Totals	100.00

Figure 9: EDS spectrum obtained from region 6 (previous image in Figure 8): sample 82 surface with greenish stains.

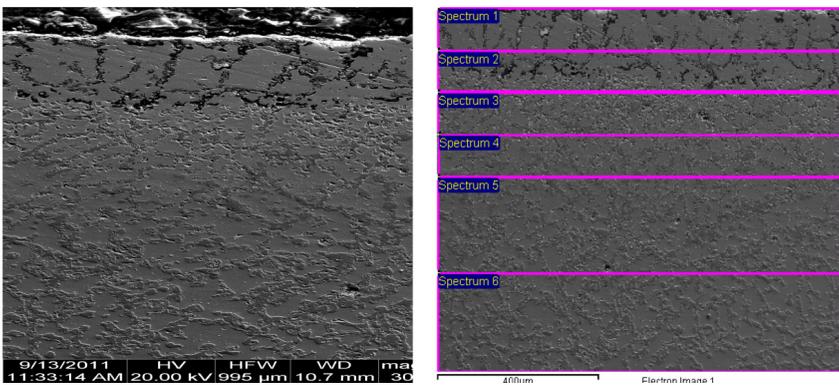
Figure 10 presents a SEM image with different layers forms the surface to the inner region of the sample and figure 11 the corresponding EDS microanalysis with C and Cr contents in each region.

Figure 10: SEM image with different layers from the surface to the inner region of the sample 73 inner surface.

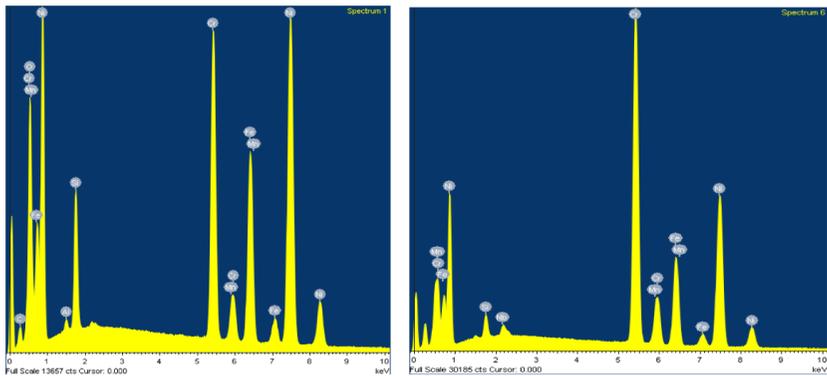
Figure 11: EDS microanalysis spectra, layers 1 (surface) and 6 (inner layer) from the sample 73-11-1P inner surface.

In nearly all analyzed samples the chromium depletion was observed, from the middle region of the sample to its surface. As an example, in sample 73 (figure 11) the chromium content diminishes from 39.38% in the middle region to 18.28% in the surface, while in sample 74 it varied from 25.67 to 12.58% in the respective equivalent regions.

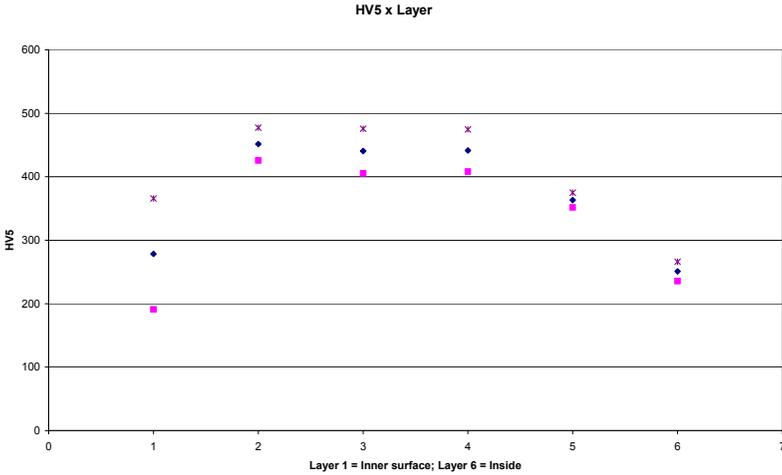
Figure 12: Hardness (HV5) variation along the 6 layers: 1 inner surface, 6: inside the tube.

This plot shows a clear tendency: the hardness of the inner surface (layer 1) is relatively low and when the distance to this surface increases the hardness value also increases. Then it reaches a steady level (layers 2 to 4) until at some distance it starts to diminish (layers 5 and 6), reaching on layer 6 a slightly harder value than layer 1.

Hardness variation across the different layers of the material can be interpreted in this way: in the surface (layer 1) there are several cracks that affect the indentations. According to the literature [11], the propagation of cracks leads to energy release, thus lowering stress levels, which can contribute to hardness decrease. Therefore, it is not unexpected that hardness values are lower in this region than in other layers. In the following layers (2 to 4), placed more distant to the surface, hardness is kept in a higher level that nearly does not vary along these layers. It seems that the carbon enrichment in these layers can lead to the formation of carbides that can harden these layers, where cracks were not seen. In the fifth layer hardness starts to decrease. Probably in this region the distance to the surface is large enough to diminish the carbon enrichment and this tendency is still more evident in the sixth layer, the most distant from the surface, where the hardness is still lower, probably due to still lower carbon content.
