## **An assessment of the rate of siltation in Jibia reservoir, Jibia, Katsina state**

Y. O. Yusuf & F. Yusuf

*Department of Geography, Ahmadu Bello University, Nigeria*

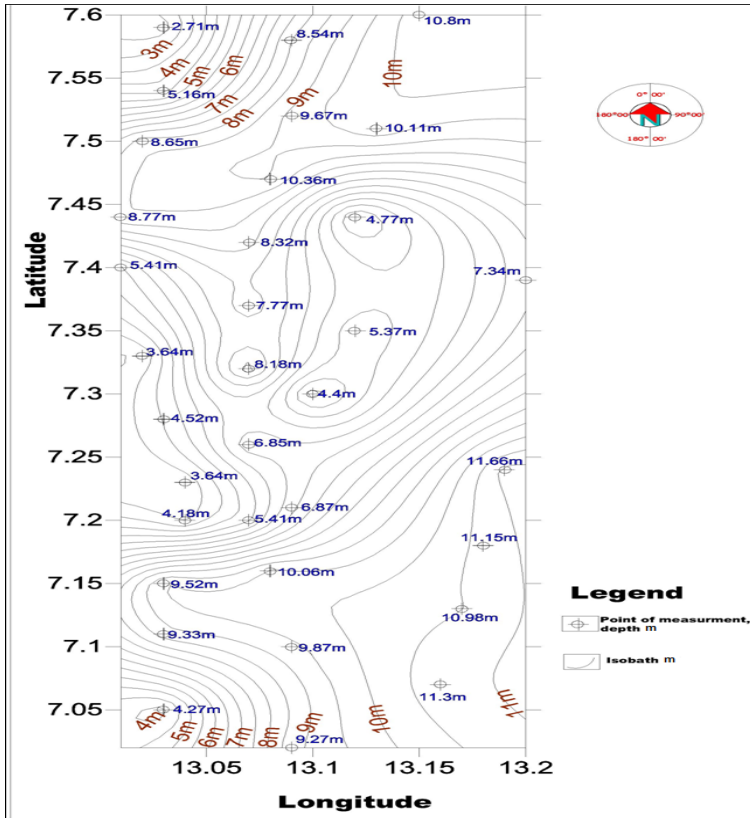
sampling points in the reservoir where the deepest point is showing depth of 11.66m and the lowest point of about 2.71m. The data on table 1 was used in constructing the contour map of the reservoir depth, showing the depth represented by isobaths and the coordinates as presented in Figure 3.

Figure 3: Remaining depth of Jibia impounding reservoir.

When the lake was constructed in 1991, its maximum depth was about 21m. The area of the catchment area was 3666 km<sup>2</sup>. The result obtained in this study during 2011 onset of the rainy season reflects a maximum and minimum depth of about 11.66m and 2.71m and an average depth of 7.57m. This indicates that present water holding capacity is 13.43m and 7.57m has been lost to sedimentation and this translates into an annual loss of 0.379m. The data shows that Jibia dam has incurred about 36.05% storage loss since 1991 (see Figure 4).

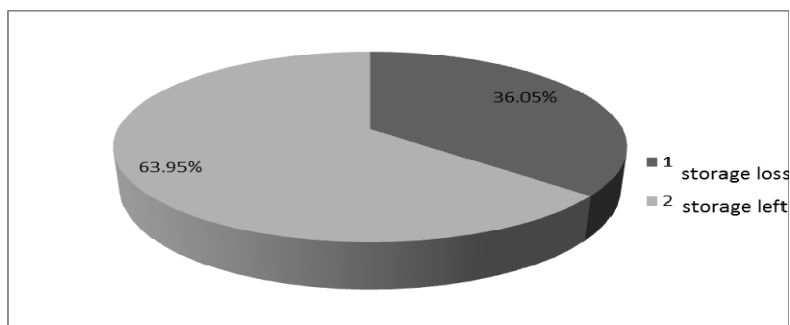
Figure 4: Pie chart showing the storage loss and storage left in Jibia dam.

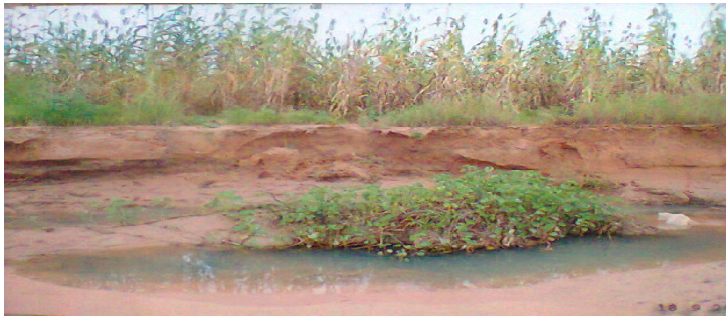
A major factor that contributes to the high sediment yield in the Jibia reservoir is soil erosion over the catchment area; the land use in the study area is one of the causes of erosion. Large part of the watershed is under cultivation and often disturbed, and can be easily detached by runoff which is subsequently transported into the reservoir. Farmers were observed ploughing very close to the reservoir peripheries that might contribute much loose soil (easily erodible) that is transported over a shorter distance to reach the reservoir.

However, large part of the study area has gentle slopes with few steep slopes found in the watershed peripheries that contribute to a higher run off velocity, leading to deeper gully incisions at the lower slopes.

Figure 5: Gully erosion in the Jibia dam's drainage basin.

As stated by Mahmood [4] and Rawat [16], intuitively the first method of reducing reservoir siltation would be to reduce sediment yield from the basin upstream by watershed management. This includes afforestation, land use change and construction of micro structures to trap sediments. Sharma [17] also stated that sediment yield could be reduced by 65-94% through promotion of vegetation instead of bare soil and by 70% with construction of check dams in the reservoir.

Workers such as Morgan [18] and Yusuf [19] have described approaches to soil conservation based upon agricultural practices and mechanical methods of reducing soil transport. That is; by reducing or banning farming activities and also bush burning, which is a factor causing continuous soil erosion due to the exposure of the soil surface to agents of denudation which contributes heavily to sediment yield around the catchment area.

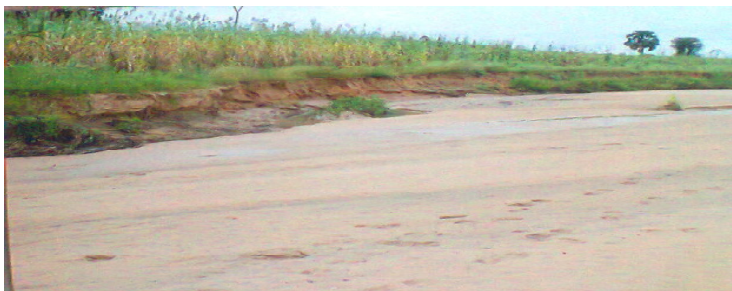
major sediment sources by soil and water conservation mechanisms have also accelerated erosion and consequently increased the sediment yield. The dams toe drains as explained in the research problem, whose function is to discharge all bottom outlet releases and seepage into the main river channel, no longer functions properly, hence leading to trapping of sediments in the bottom of the reservoir with no way of releasing them. Due to the nature of soil, which is generally loose and sandy, erosion through run off and wind, make the drains become silted up (see Figures 5 and 6). 50% or half the design discharge volume is wasted to the siltation. Some areas that are virtually water logged are not even identifiable as they are over grown with giant plants. Others are lost to gully erosion while some were completely flattened or levelled by animal trespasses.

Figure 6: Sediment accumulation in Jibia dam's drainage basin.

Removal of sediment deposits by dredging or excavation, although it is a costly operation which may be justified in this circumstance by the economic

value of the water and the impossibility of replacing lost reservoir capacity. The excavated silt should also be disposed properly for the improvement of surrounding agricultural land.
