Spatio-temporal distribution of slope failures in the Western Ghats of Kerala, India

S. Sreekumar & A. Aslam

*Department of Geology and Environmental Science,
Christ College, India*

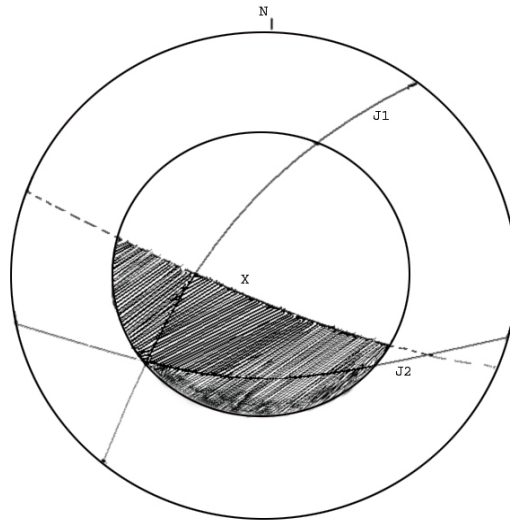
Figure 2: The orientation of the joint planes that confined the slide debris and the friction angle of the rock are illustrated in the equal area projection.

ranges from 1 to 3.1m. The terrain is characterized by isolated rocky tops with near vertical slopes. The general downward slope of the profile is 48° towards East. The entire hill slope is under cultivation, barring the rocky tip. The vegetation patterns include mixed crops containing plantain, pepper, coconut, and jack fruit tree. Four major joints traverse the profile with gapping ranging from 1 to 2 cm. The major joints have attitudes of 51° N (J1), 32° N 90 E (J2), 22° N 90 E (J3) and 80° N 90 E (J4).

The angle of internal friction decreases when water infiltrates into joint planes of rocks. The blockade of water seepages along the joints for rainwater harvesting purposes has created excess pore pressure across the weak planes of weathered rocks and it triggered the slope failure.

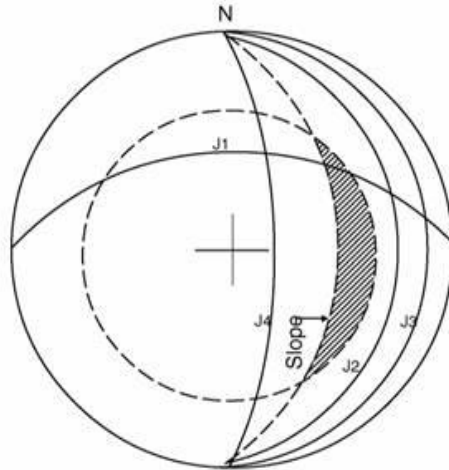
Figure 3: Stereo plot of four major sets of joints and their relationship between general hill slopes and the angle of internal friction of the rock.

The geometrical analysis indicates that the failure that occurred is a type of plane failure. The joint along which the slide occurs (32° N90E) is oriented parallel to the general slope (fig. 3).
