Actions, diagnosis and territorial management of the disaster in the city of Lorca after the earthquake of May 11, 2011

Abstract

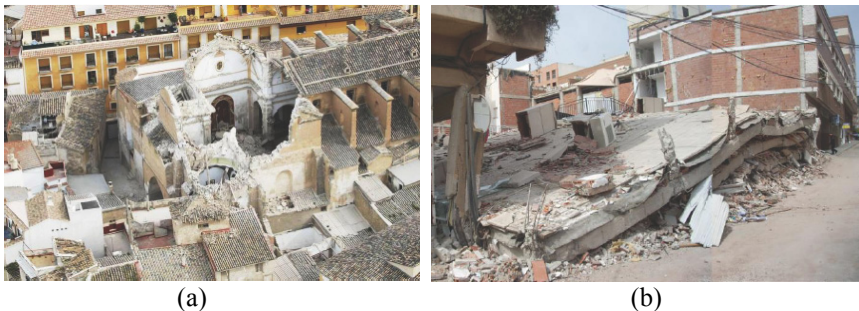
An estimated 80% of homes were to some extent damaged, with over 1300 having to be demolished in the following months. However, this distribution of damage was quite heterogeneous and upon analysis did not relate to only seismic parameters. In addition, it should be noted that despite the high number of homes affected, only one building actually collapsed during the earthquake (Fig. 3).

Figure 3: (a) Church of Santiago. (b) Building collapsed in La Viña.

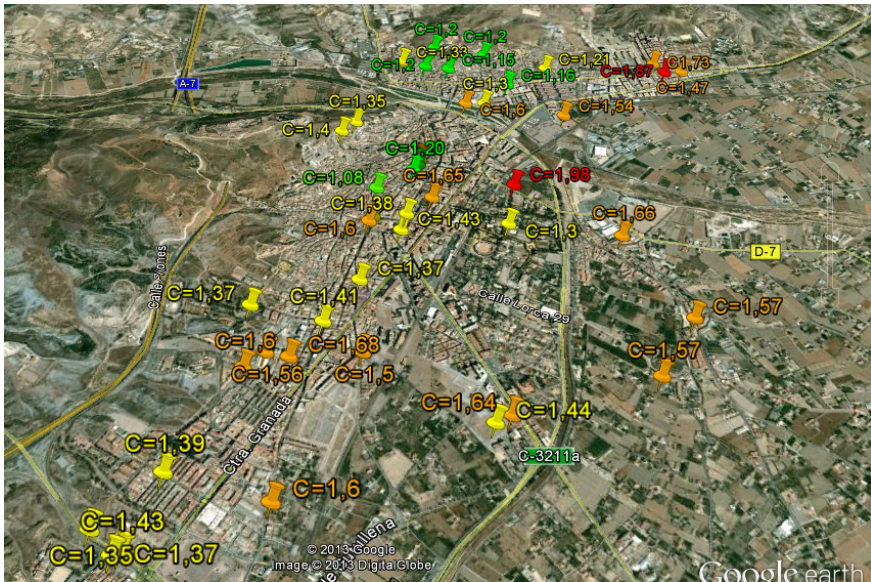
of the terrain makes it possible to distinguish four soil types. A simple interpolation of this parameter, based on the high number of existing geotechnical studies in the town of Lorca (Fig. 4) allows us to elaborate a zonification that explains certain results of the earthquake.

Figure 4: Inventory of terrain amplification factors in Lorca.

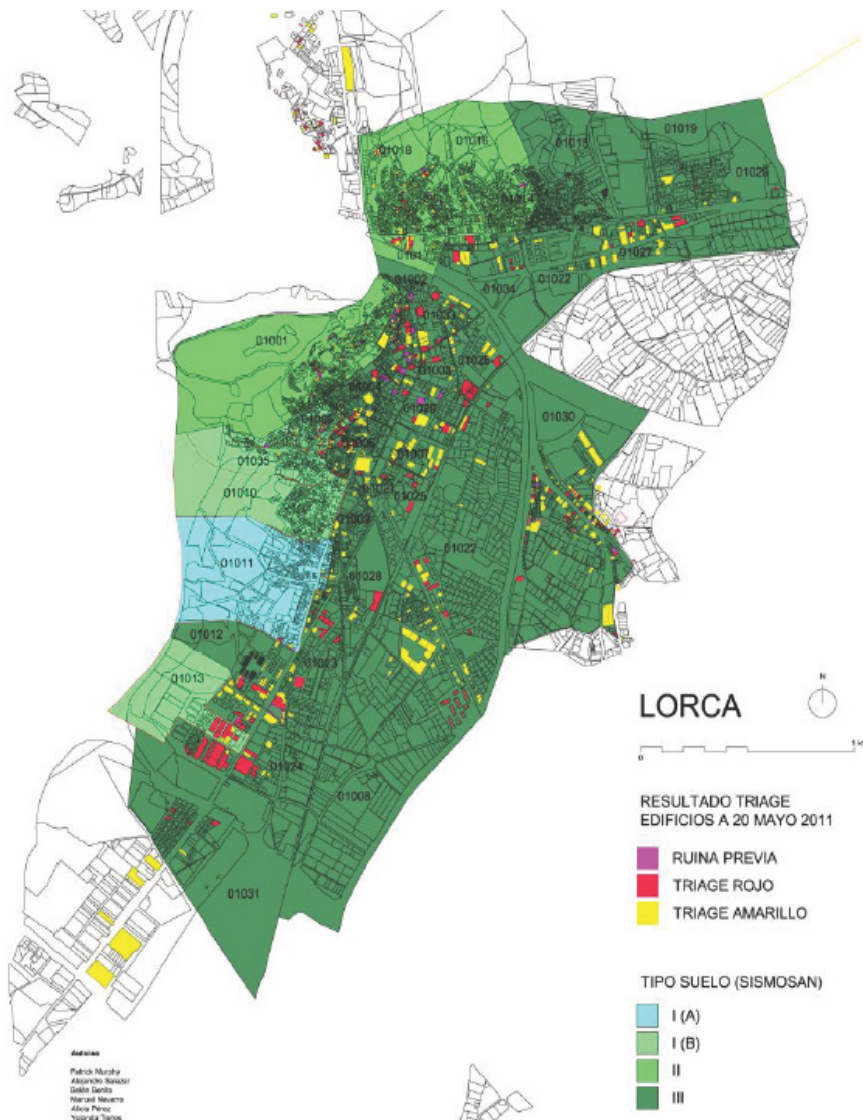
From this data, a map overlay of soil characteristics versus damage intensity can be implemented (Fig. 5). An analysis of the incidence of damage out of the total number of buildings for each soil type shows a clear increase in damage to the soil type III, referring to Guadalentín sedimentary deposits. This explains cases such as that of the neighbourhood of San Fernando, where the 232 homes from the nine buildings in the neighbourhood had to be completely demolished because of the serious damage.

Globally, it should be highlighted that damage was analyzed in a total of 5155 buildings in the metropolitan area of Lorca. Of these, 889 (13% of the total) were initially classified to be yellow or red level. Damage is interesting in some census districts of La Viña neighbourhood, such as the 1013th and 1024th districts, with percentages of damaged buildings of 41% and 40% of the total number of buildings of each district. Others, such as the 1004th census district, which is representative of the historic city centre, suffered damage classified in yellow or red in 16% of its buildings. This case is explained by the parameter classifying the constructive type rather than the soil type.

There are also districts in which the parameter governing the level of damage is basically associated with the topography, such as the neighbourhoods of San Diego and San Cristobal. In some cases, such as the 1027th district, leading to the Avenue of the Armed Forces damage was to over 40% of all the buildings.

Figure 5: Overlapping of damage over soil types (source: Sismozon).

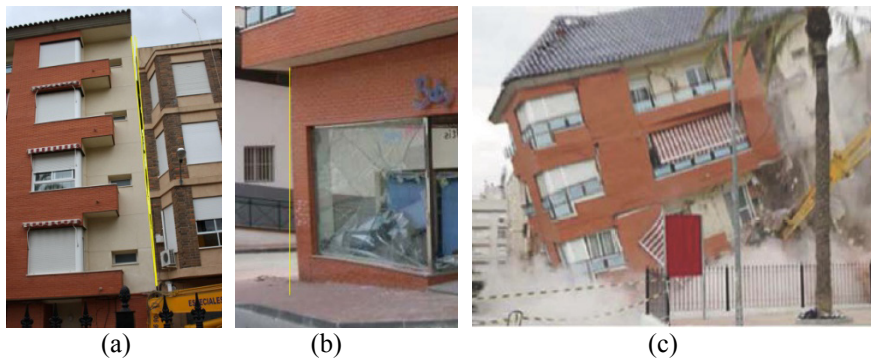
Based on the experience gained in this earthquake, the UPCT has proposed a quick aftershock assessment form to ensure safety [4]. The building located in the Aprendices Square had an unexpected collapse during its demolition due to the damage on the ground floor and first floor (Fig. 6). It had, according to its evaluator, only serious damage in facades and the fall of part of the breastplate housing, causing the financial ruin of the building.

Figure 6: Building in danger of collapse. Evidence of crashes in (a) joint between buildings and (b) corner pillar. (c) Collapse.

According to the proposed form, this building would be a level 4 (very high) estimated risk of loss of global stability and level 2 (moderate) non-structural risk. Therefore, it would be classified as a potential collapse (black colour), as it has at least one level 4 classification (Fig. 7).
