Remedial works against debris flows after floods in the State of Vargas, Venezuela

Abstract

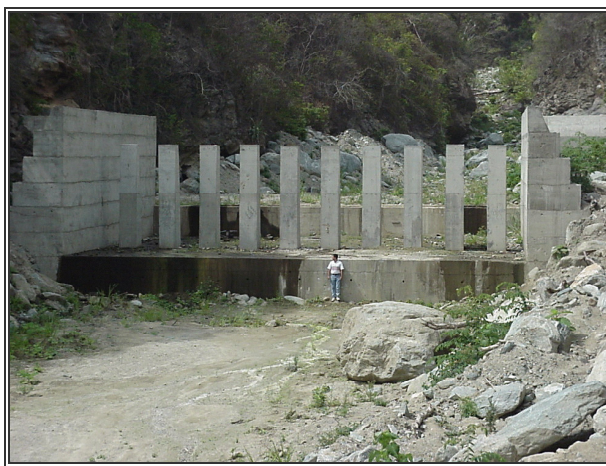
Both the weir and the canalization were built in concrete. The open selective weir (Fig.1) was to retain large debris (average diameter $d_m \geq 0.80$ m) and to let the fines flow through. The steep gradient and low roughness of the concrete channel downstream was to allow the fines to flow till the outlet section into the sea.

Figure 1: Guanape Weir (September 2001).

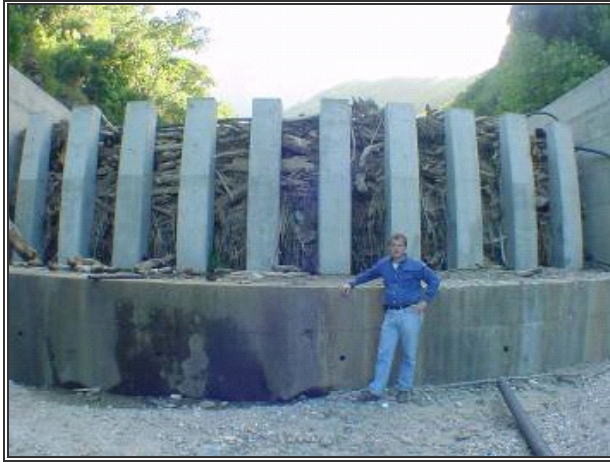
However, in January 2002 observations showed that the weir's "teeth" were already clogged by branches and fine sediments, holding up the fine sediments, causing a total siltation upstream (Fig. 2).

The cause is to attribute to the dense vegetation and to the massive presence of fine sediments ($d_m < 100\text{mm}$), easily erodible even with low to medium discharges.

Therefore the selective weir did not significantly perform as expected since it unexpectedly needed frequent maintenance on the upstream reaches, undesirable for the extra costs and related aspects. Even the downstream canalization, designed with gradients steep enough to enable sediments to flow till the sea, did

Figure 2: Guanape Weir (February 2002).

Based on the observations made in 2002, the selective weirs did not turn to be effective, the reason being primarily due to an improper location, deemed too far downstream on the water course. They would have been likely to perform better if they were located on the middle-high upstream part of the river basin. The alternative solution identified for the low-medium river reach was therefore to build a series of closed weirs instead, in order to progressively retain the fine debris.

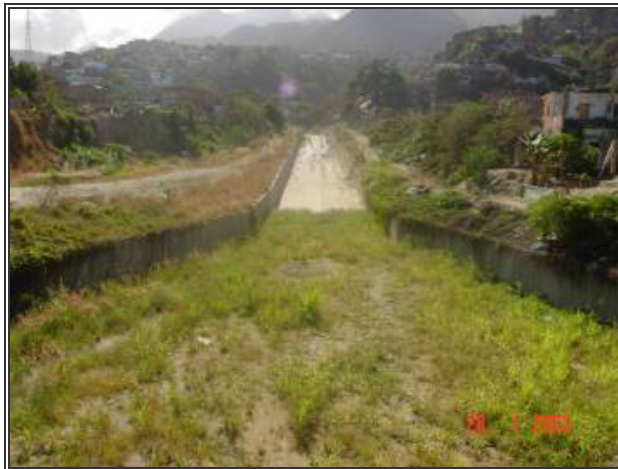
not provide the desired results. The reduced gradient in its downstream reach (Av. Soublette) reduced the flow velocity favoring sedimentation (Fig. 3), and a loss of channel flow conveyance.

Figure 3: Canalization of the Guanape creek (January 2003).

As alternative to the downstream canalization a stepped structure was considered, to reduce the overall river gradient and progressively dissipate the flow energy [5–7]. The structures consisted in gabion channelling works with banks and bottom with variable gradient by means of sills. This option was deemed as the most cost effective and the most compatible with the

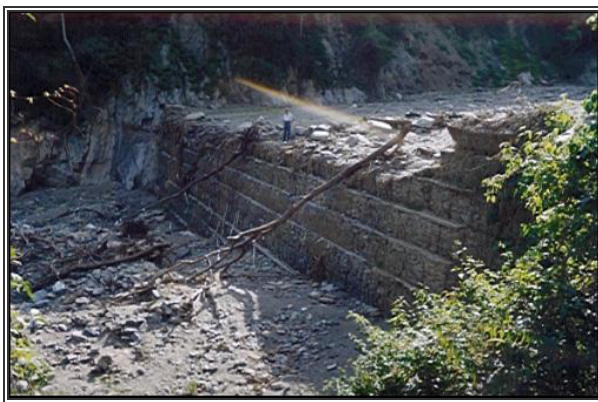
both the weir and the entire watershed were only partially affected by damage, since the weir was able to dissipate part of the flow energy when approaching the urban area. Originally designed for a discharge of $70 \text{ m}^3/\text{s}$ ($T_r = 100$ yrs), during the flood the weir underwent an estimated flow of about $120 \text{ m}^3/\text{s}$ (173% of the design value) (Fig. 4).

Due to the heavy debris, the structure was damaged by excessive abrasion just on the top 2m out of its total height of 10 m, that is for just 20% of the total height, equivalent to just an 11% of the total volume.

Figure 4: Curucutí weir after the December 1999 flood. The structural damage observed was just on the crest and on the wings.

In order to minimize the abrasion phenomena caused by debris and mud flows, the experience showed that it is advised to protect the surfaces directly exposed with masonry or reinforced concrete.

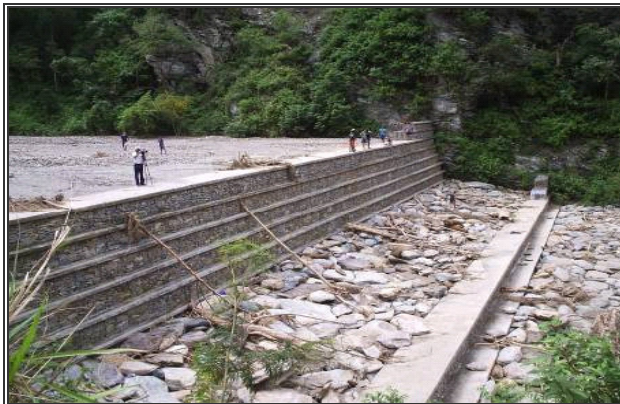
Since continuous rainfall precipitations had occurred from the month of April till December 2004 (Fig. 6) at the time when the event occurred in February 2005, the soils were saturated resulting in a run off exceptionally higher than the one occurred under normal circumstances. As mentioned earlier, between 2002 and 2003 several control structures had been built along the Curucutí, Osorio, Piedra Azul, Camurí Chico, San José di Galipán, Macuto e Anare creeks. The structures did not show significant damage and performed satisfactorily in relation to the discharges and to the amount of debris (Figs. 5–7).

Figure 5: Curucutí Weir. (March 2005.)

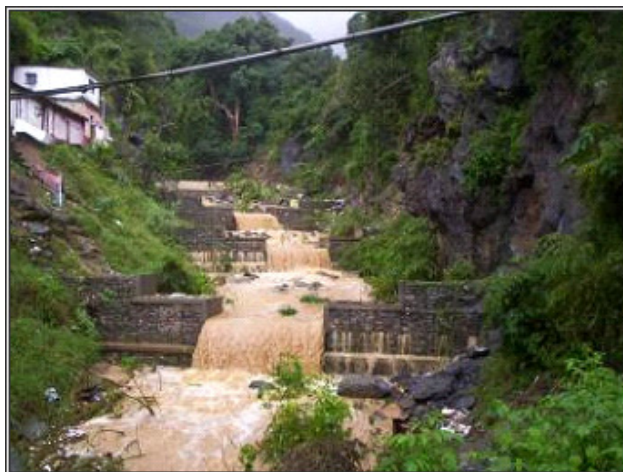
Figure 6: Upstream view of the sills on the Osorio creek. (February 10th, 2005.)

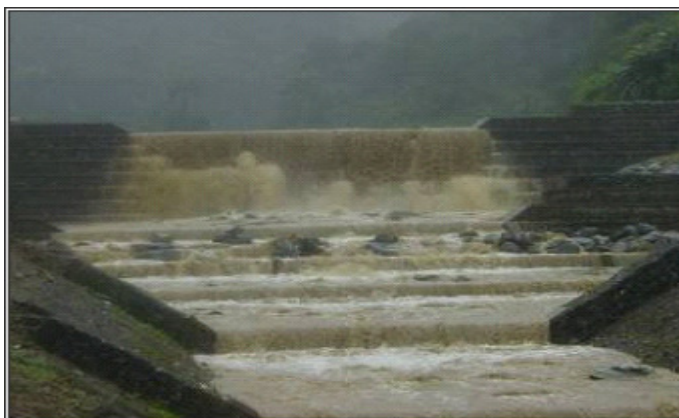
Figure 7: Weir on the Macuto creek. (February, 10th, 2005.)

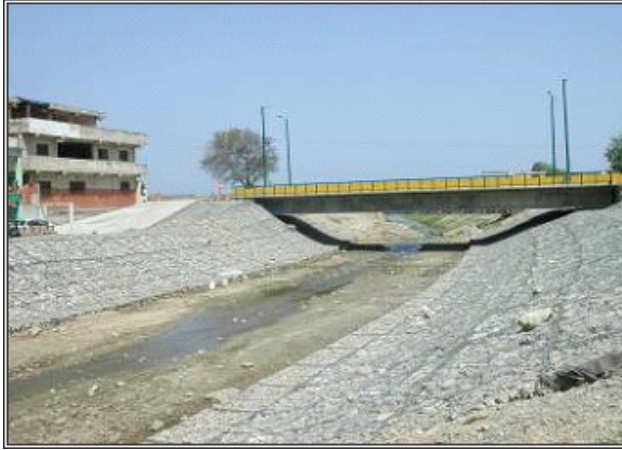
Just before the peak of February 10th, 2005, on January 8th and 9th a first flood peak hit the Anare creek. Since the river reach upstream from the weir structure was unprotected, the flood favored a meandering effect which resulted in severe erosion and underscoring on the right bank, causing relevant deterioration to the main roadway infrastructure recently rebuilt. (Fig. 8)

By hitting right river bank, the flood left the upstream end of the existing canalization vulnerable, amplifying the damages occurred later by the February peak, and creating a sub-flow under the lining which then caused the protection on the right bank to collapse.

Figure 8: Canalization of the Anare creek near the bridge. (September 2002.)

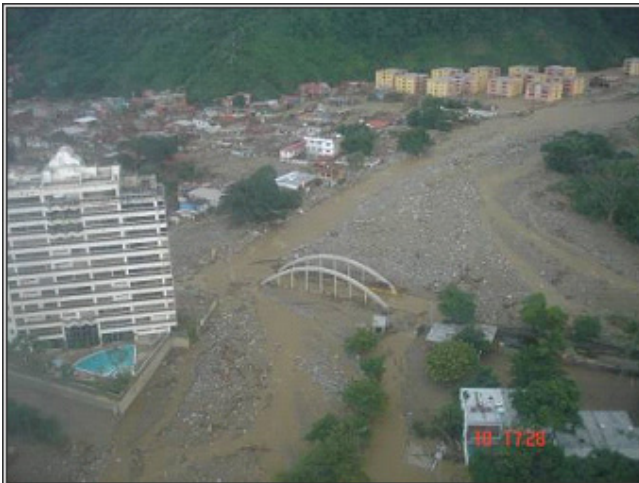
In those basins where no training works had been built for lack of funds, much more severe damages occurred. This was the case of the Quebrada Seca, Naiguatá and Camurí Grande creeks. Damages were caused by the large river siltation, until water overflowed the banks (Fig. 9).

Figure 9: Aerial view of the region in proximity of the Camurí Grande bridge. The river siltation and flooding effects on the banks can be observed. (February 2005.)
