# Building failure in South Tel Aviv: case study

## Abstract

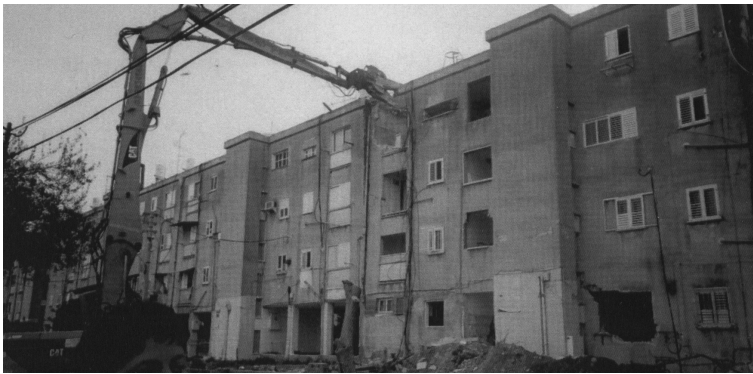
The building (fig. 1, 2) is located in the southern part of Tel Aviv (fig. 3).

Figure 1: General view of the building.

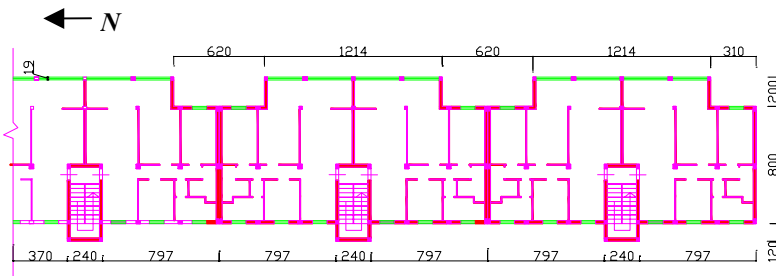
Figure 2: Plan of typical floor (fragment).

The building, of 4 stories, is 90.7m long, 7.0m wide and 11.5m high is divided into 5 sections by means of 4 expansion joints (fig. 1, 2). Each section has a staircase serving 2 apartments every story, no elevators. Underground shelters are located below the first floor and are shared by 2 sections from their 2 staircases. The expansion joints are not cutting the shelters. The structure is made of reinforced concrete, flat slabs 15cm thick, as well as the roof, columns 30X30 cm spaced 2.8m on the alongside and 3.8m across. The walls are made of concrete block 20cm thick while the partitions are made of 10cm concrete blocks. The foundations are reinforced concrete piles cast in-situ. Thus the building seems to be stable and with sufficient rigidity.

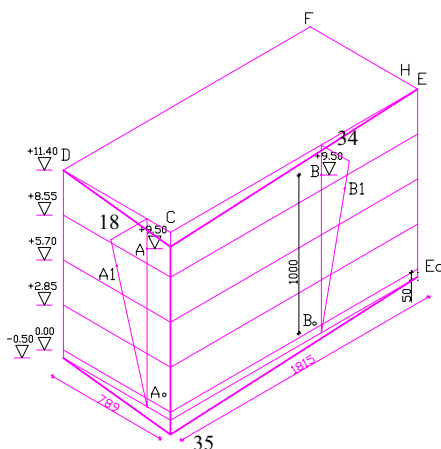
Only one of the sections failed namely the southern one, to the first expansion joint, 18.2m long. This section was demolished by municipality order.

Figure 4: Scheme of the structure deformations.

The whole structure was checked before the failed section was demolished in order to investigate the reasons of the failure. The failure was expressed by large settlements of the south-east corner and along the southern wall. As a result the whole section was inclined to the south and to the east. The horizontal deflections of the top of the building were measured to be 18cm to the south and 34cm to the east (fig. 4). The maximal settlement, at the south-east corner, was calculated to be about 35cm. It is worth noting that those settlements and deflections are far from the allowable values and the acts taken by the municipality were justified. No apparent settlements and damages were detected at the other 4 sections of the building. As an exception a crack was found that opened at the expansion joint that continued it downward. That may be explained by the excessive load imposed on this part of the shelter due to the settlement of the section. The floors of the upper flats were inclined but no visible damages to the concrete skeleton were observed. This means that it can be considered, together with the concrete blocks of the walls and partitions as a rigid box. Near the expansion joint where the section was supported by the shelter, damages in the columns, beams and especially in the partitions were observed (fig. 5) because of the rigidity of the shelter that didn't allowed further settlement, as one unit, of the building. The concrete was tested and found to be above B20. The steel content, as was discovered in the debris, was sufficient. According to the structure analysis it may be concluded that the super structure was stable and capable to withstand the loads imposed. The reason for the large settlements must be found, therefore, in the building foundations.

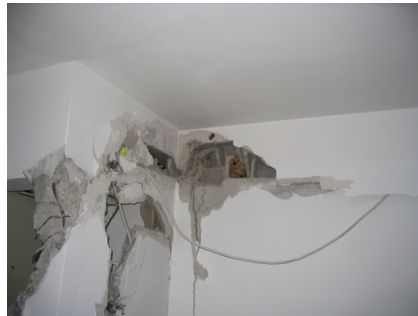
Figure 5: Cracks in structure elements – details.

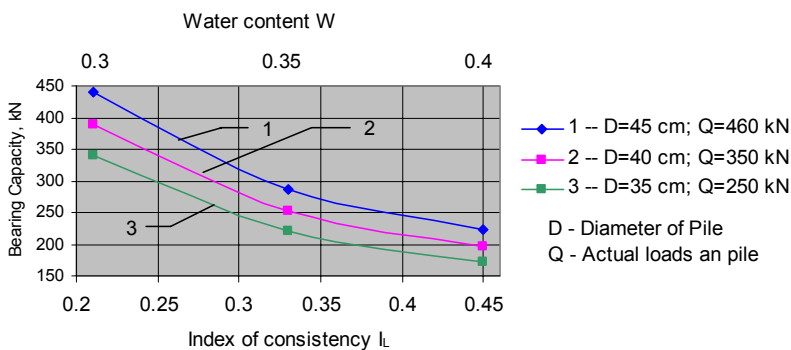
Statically analysis of the foundation, based on the soil tests, the measurements of the dimensions of the building, was carried out, in order to evaluate the safety factor of it. The actual loads on the piles were calculated and the bearing capacity of the piles was established based on friction stress based on the water content of the soil (fig. 6). In the diagrams one can see the dependency of the bearing capacity of the piles on the Index of Consistency ( $I_L$ ). The values of the soil friction for different values of  $I_L$  were taken from [2]. The respective water content is also shown in the diagrams. It was found that at water content  $W=0.3$  the capacity of the piles is sufficient to carry the actual loads (safety factor  $SF=1$ ) but for  $W=0.33$  it drops to 80% and for  $W=0.38$  it is only about 60% of the actual load. Actual measurements and geometrical calculations show that the maximal vertical settlement was ~35cm, five times the permissible settlement for

reinforced concrete structure which is  $S_U=8\text{cm}$ . The permissible relative difference in limited settlement  $(\Delta S/L)_U$  is 0.002. In our case this value was between 0.03 to 0.04 [3].

Figure 6: Functional dependence of Bearing capacity of the piles and Index of consistency.

As the piles were already under designed, the reduction of capacity due to increase of the water content disturbed their delicate state of balance. At the same time, the residual deformations due to vibrations caused by the heavy traffic on the adjacent regional road contributed, also, to the large settlements of the building.
