# **The lessons learned from conducting a condition survey on unsealed roads surfaced with marginal materials in the Iringa region, Tanzania**

R. R. Mwaipungu & D. Allopi

*Department of Civil Engineering and Surveying,  
Durban University of Technology, South Africa*

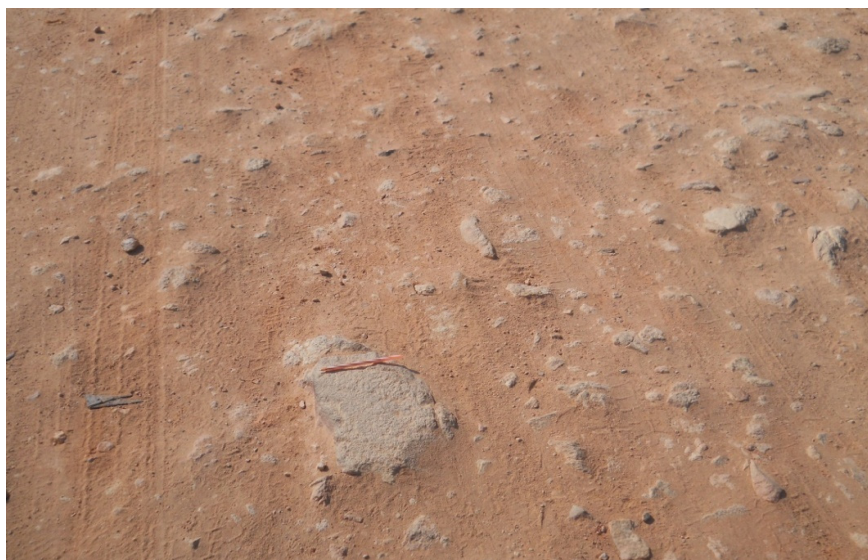
4) *Stoniness-loose and embedded*. Stoniness is the relative percentage of material in the road that is larger than the recommended maximum size of 37.5 mm (Pearson [6]). Stoniness was assessed by estimating the extent and severity. Figure 1 shows the variation of stones sizes in a gravel wearing course. The Figure reveals a lack of control at the source of gravel materials before being delivered to the site.

Figure 1: Stoniness embedment showing the variation in sizes of stones used for gravelling.

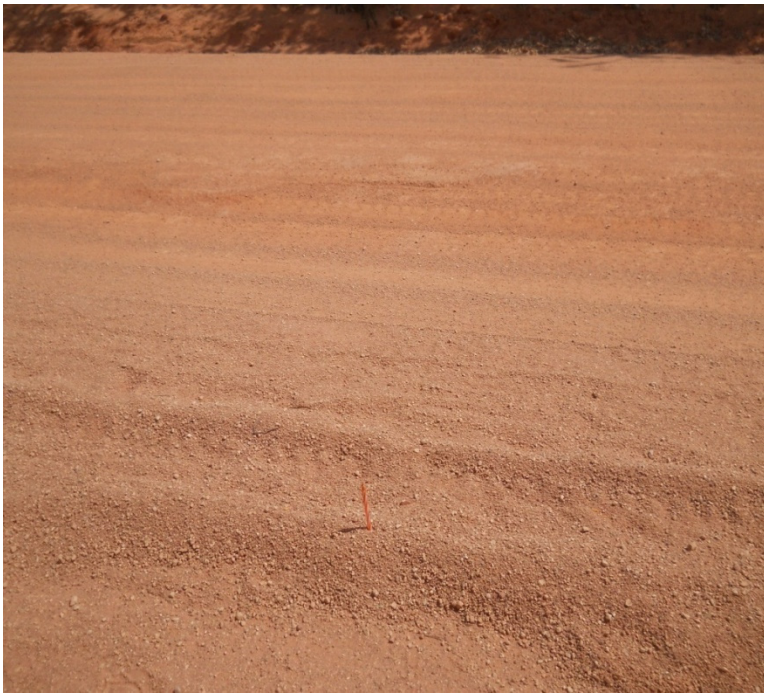
6) *Loose material*. This is formed by the ravelling of the wearing course material under traffic. It is mainly caused by a deficiency of fine material due to lack of cohesion, a poor particle size distribution (e.g. gap grading) in the wearing course materials; and inadequate compaction (Pearson [6]). Loose material was assessed by estimating its thickness variation across carriageway. Figure 2 shows the extent of ravelling in one of test sections along Iringa-Msembe road.

Figure 2: The extent of ravelling along Iringa-Msembe road.

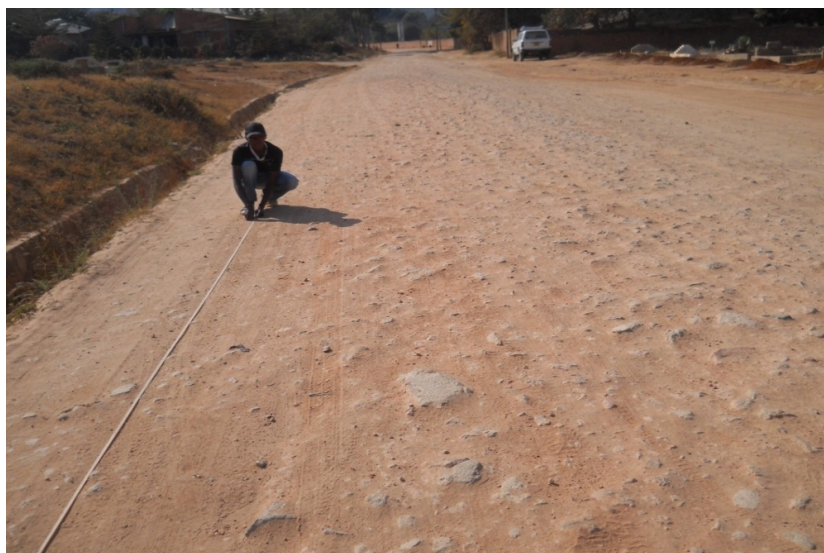
The Don-Bosco road is under the management of Iringa Municipality Council. Generally, the road is being graded once annually. The traffic volume on this road is heavy, particularly during burial ceremonies as it accesses one of the major and busy grave yards in the municipality. Within two to three months after grading the road reverts to a bad condition.

The prevalent distress on this section is stoniness embedded, which start to protrude just weeks after grading and force vehicles to seek refuge on the shoulder or pedestrian walkway as shown in Figure 3.

Figure 3: Stoniness embedded on Don-Bosco road.
