EVALUATION OF GEOMECHANICAL FEATURES AND STABILITY FOR THE RECOMMENDATIONS AND REHABILITATION OF THE HUMBERTO MOLINA HOSPITAL, ZARUMA, EL ORO, ECUADOR

ABSTRACT

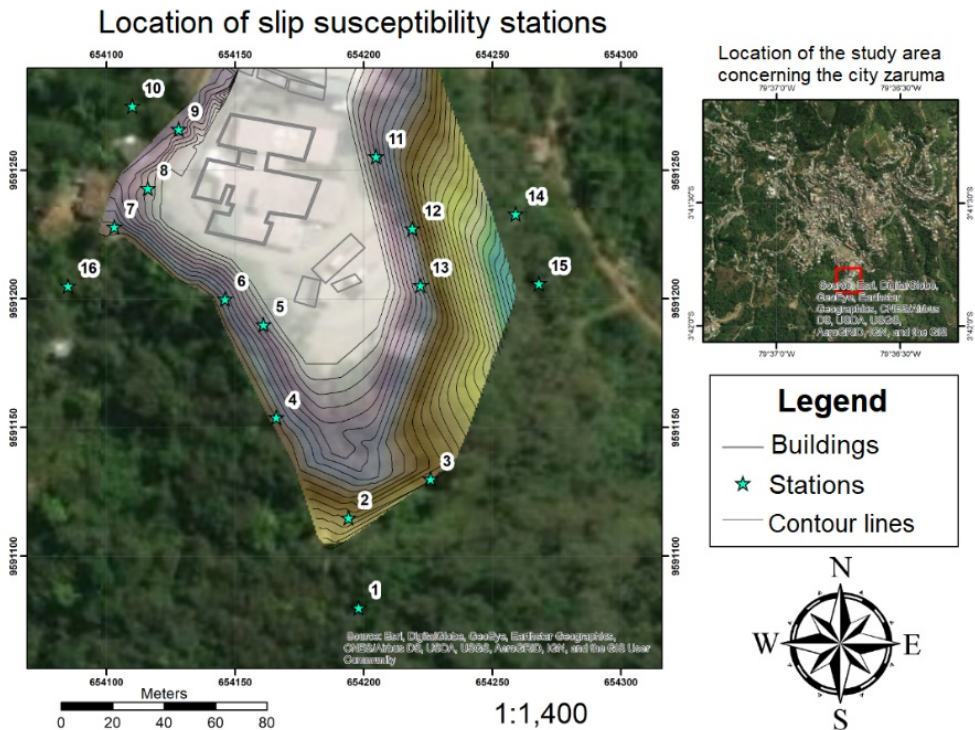
Figure 4: Location of the geomechanical stations with respect to the contour lines.

The conditions present in the study area were evaluated and a preliminary characterization was made, based on the results previously obtained in the field visits and studies carried out in the area. This allowed us to obtain criteria on the sectors most prone to a mass movement and the factors that can most influence it. From this, the geotechnical stations were chosen (Fig. 4) and the main parameters to be considered in the slippage susceptibility analysis were defined.

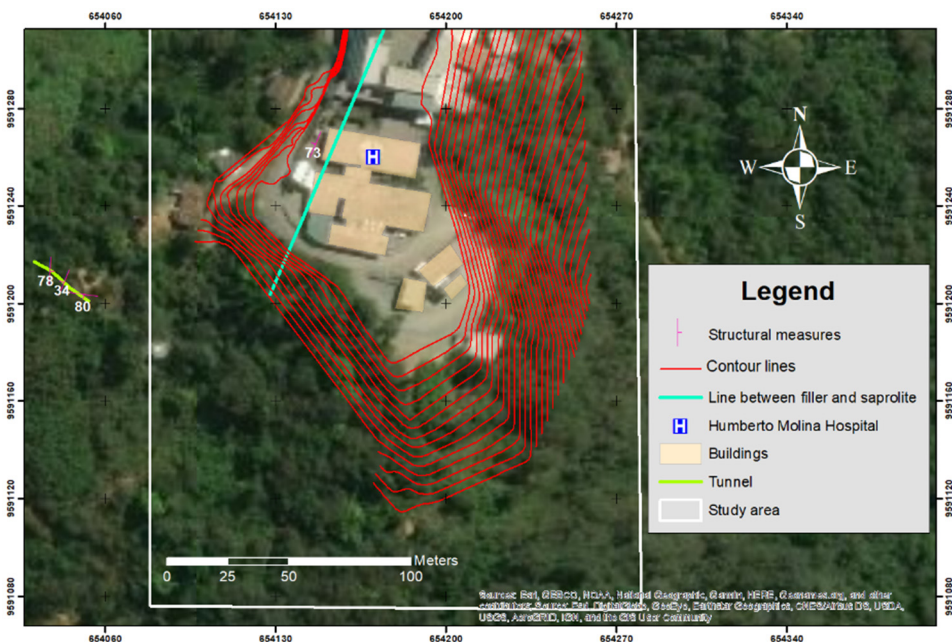
Figure 5: Structures measured map in the study area.

During the field trips made in the study area, the main geological structures were identified, determining the boundary between the filler material on the west side and saprolite on the east side of the hospital, with structural measures of $N203^{\circ}/73^{\circ}SE$ (Fig. 5). Also, the tunnels survey near the area was carried out, finding a tunnel to the SW of the area with direction $N120^{\circ}$, approximately 24 m deep, 1.60 m high and 0.80 m wide. Weathered volcanic rock could be observed (volcanic transformed into saprolite) with different families of decimetric fractures, filled with quartz with centimeter thickness. Intense fracturing was evident, highlighting three families of main discontinuities, with structural measures of $N3^{\circ}/78^{\circ}SE$, $N202^{\circ}/34^{\circ}NW$, $N98^{\circ}/80^{\circ}SW$ (Fig. 5).

In the case of lifting existing tunnels, it was possible to lift a tunnel approximately 25 m deep with an N120° direction, determining its lithology as a fractured saprolite with three main families of discontinuities that present directions of N3°/78°SE, N202°/34°NW, N98°/80°SW, decimetric separations and centimeter fillings. Also, it was possible to determine using field observations the boundary between filler material and saprolite, with direction N203°/73°SE.

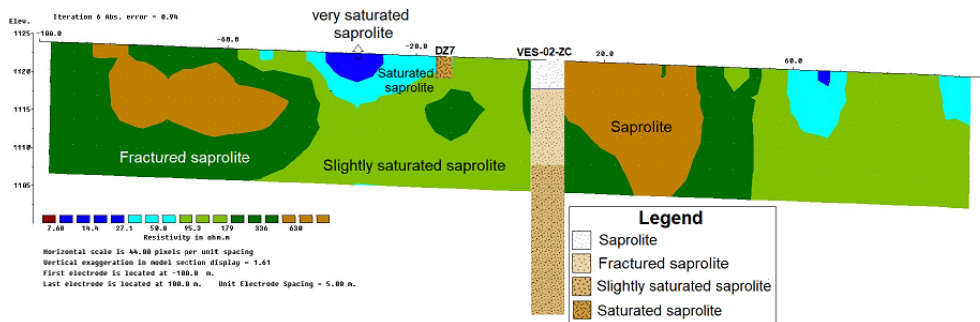
Figure 6: Correlation between tomography (GT-01-ZC), sounding (VES-02-ZC) and DZ7 drilling.

Based on the areas of interest located in the geophysical prospecting, the two drillings DZ7 and DZ8 were made (Fig. 3), 10 to 15 m deep respectively (Figs 6 and 7), to directly determine the lithology below the study area.

As a result, the presence of fully weathered saprolite was obtained, colored between reddish-brown, orange-brown until yellowish-brown, from very fine granulometry on the surface to medium-coarse granulometry at the end of the drillings.

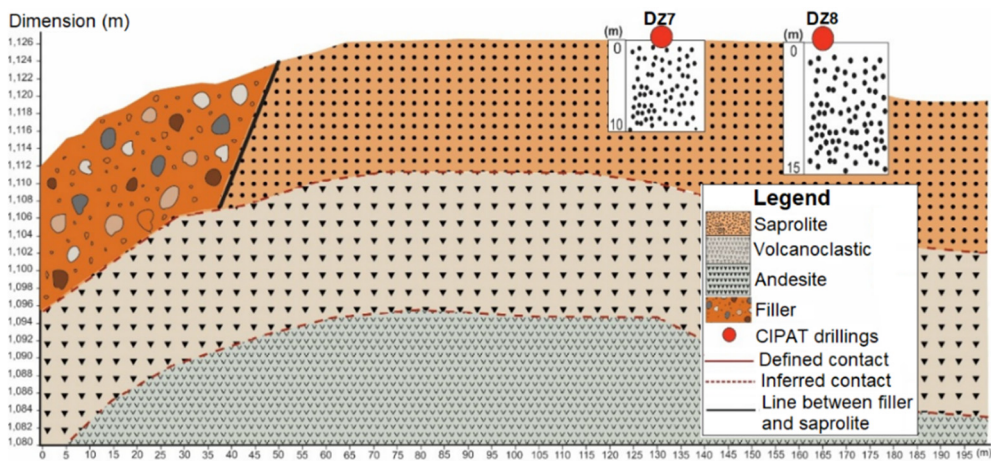
Figure 7: Relationship between perforations and geological profile.

From the campaigns carried out of vertical electrical surveys, electrical tomographies, drillings, and calicatas, the thickness of the underground geological structures was determined, recognizing and distinguishing the different layers corresponding to a fully weathered saprolite, of shades that vary from light brown to reddish, fine to coarse granulometry, presence of subvertical fractures oxidized fill and centimeter separations, with saturation percentage greater than 40% in most cases. With the help of the correlation of the existing perforations and those made in this investigation, it has been interpreted that the saprolite layer overlaps volcanoclastic rocks of thicknesses between 15 and 20 m and this, in turn, is overlying volcanic rocks, mainly andesite's of thicknesses between 20 and 30 m.

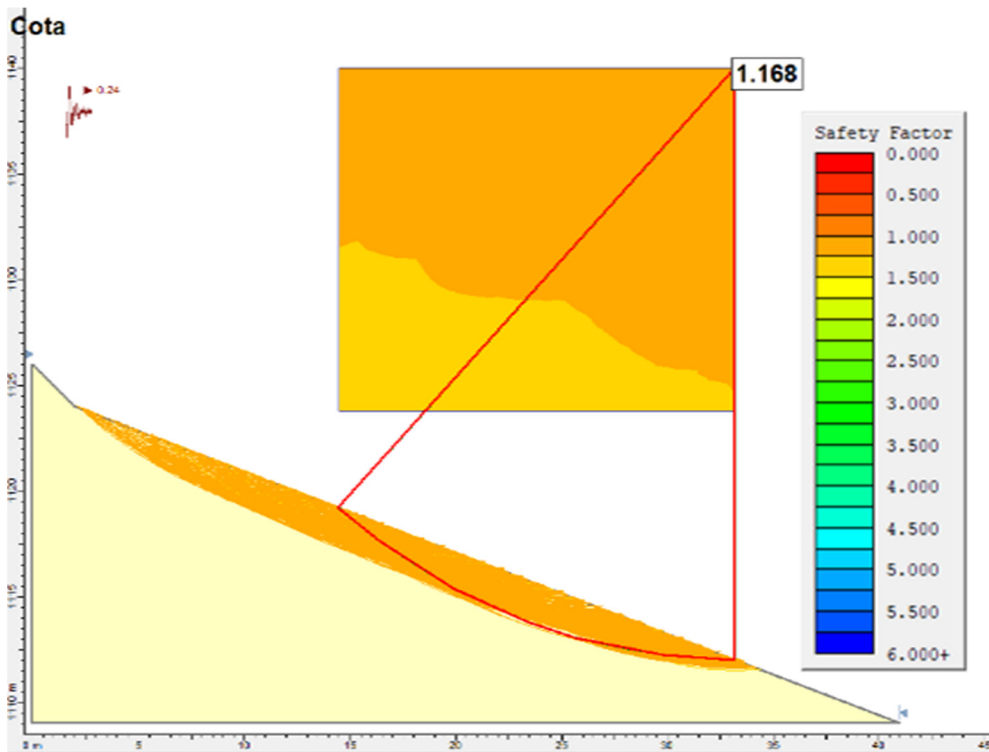
Figure 8: Safety factor calculation with seismic coefficient in the slide software.

Several runs were performed on the SLIDE software using the Spencer method to calculate the safety factor, considering the seismic coefficient, the value of 1,168 was determined as the lowest (Fig. 8).

Considering the seismic coefficient of Zaruma, the safety factor in the SLIDE software was calculated, obtaining a value of 1.168, which is considered stable under normal conditions, according to Morante et al. [14]. But according to the standards established in case of human losses and considering the case of the hospital, the safety factor values considered stable are greater than 1.5. However, with the information analyzed in geophysics and the soil quality parameter in the susceptibility analysis, the material found in the subsoil is of good quality. If some type of landslide were produced, these would be superficial, of small magnitude and not in the surroundings.

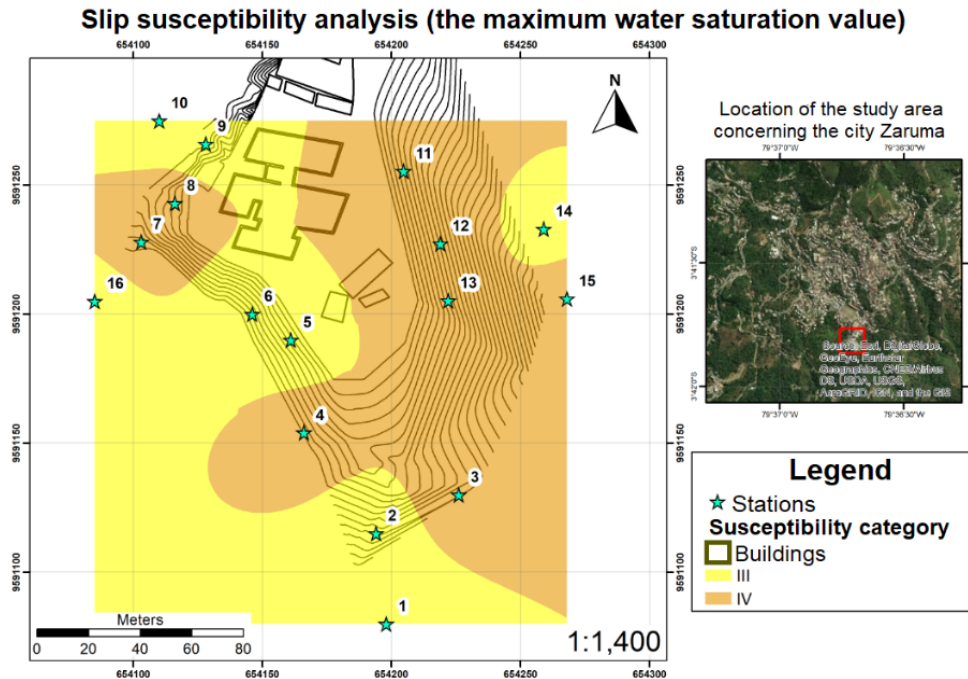
Figure 9: Slippage susceptibility map for a maximum water saturation value.

Zoning of the study area was carried out, based on the extreme water saturation situation in the slope, assigning this parameter the highest assessment (Table 3). Subsequently, heat maps were created where the behavior of the terrain could be observed according to its slippage susceptibility (S.S) grade. Finally, the susceptibility map was obtained (Fig. 9), where the yellow zone represents category III, correspondingly to stable conditions and systematic monitoring. While the orange zone that corresponds to category IV, it covers most of the contour lines of the study area, which represents potentially unstable conditions.

- A more regional study is recommended as this study limits the area of analysis.
- Due to the susceptibility analysis, it is recommended to carry out the control of rainwater drainage through ditches and drainage pipes, since it is known that the slope consists of filled materials (pushed to the slope), also to the control of the sewage water.
