# GEOMECHANICAL EVALUATION OF THE OLÓN CLIFF FOR STABILIZATION PRE-DESIGN OF THE BLANCA ESTRELLA DEL MAR SANCTUARY, SANTA ELENA, ECUADOR

Olón commune has one of the quietest and safest beaches on the Ecuadorian coast, among its tourist attractions stands out the “Blanca Estrella de Mar” sanctuary, which is located on a cliff approximately 40 m high. This sanctuary is part of the route of the seven churches in the Santa Elena Peninsula, which is continuously visited by tourists. Nowadays, the erosion caused by the wind, added to the rain and strong waves that hit the base of the Olón cliff directly and the anthropic activities affect the slope stability, in which block detachments have already been reported, generating risk to people and the foundations of the buildings of the place. The aim of this research is to evaluate the stability of the slope by means of the geological and geomechanically characterization for the proposal of the pre-design of the stabilization measures. The methodology of this work includes four phases: (i) drone topography and systematization of information; (ii) geological and geomechanically characterization of the area; (iii) evaluation of the stability

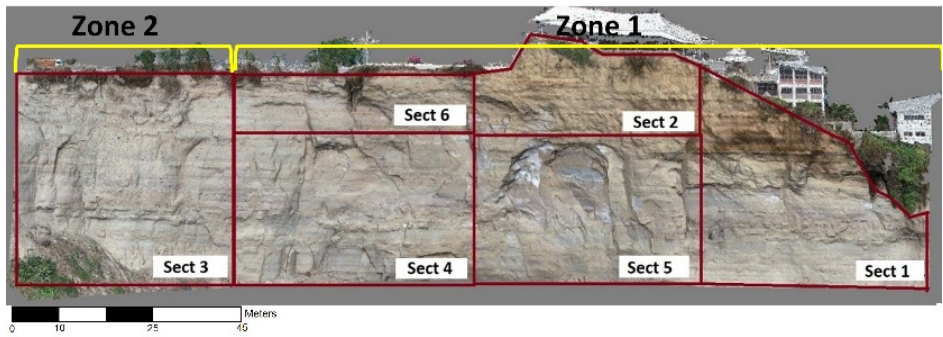
Figure 4: Subdivision of the three-dimensional model of the slope into zones and sectors.

Considering the height of the slope, its location and conditions, a three-dimensional model was made, with the help of images with resolution (20 MP), captured with Drone (Phantom 4 Pro) and its “Flight System” (Figs 4 and 5). This model allows us to obtain the topography of the sector, as well as the identification and measurement of fractures present. To perform the geomechanical characterization, the slope has been divided into two zones considering its change of direction and diving, each zone is divided into sectors based on the conditions that present (presence of water, load, vegetation cover). Finally, a sampling of the different types of rock is performed to perform geomechanical tests and subsequently obtain the rock quality designation (RQD) index (%).

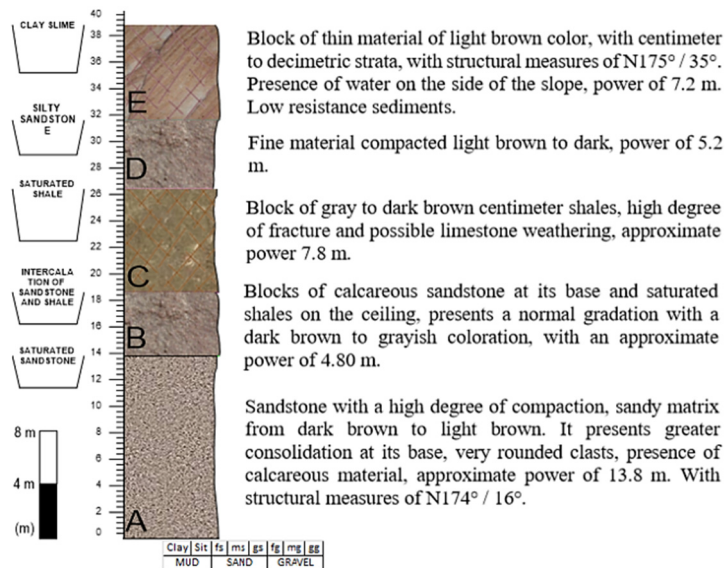
Figure 7: Stratigraphic column of the Olón cliff.

Through the information collected in the field, the stratigraphy presented by the escarpment was identified based on the description of lithics ranging from fine to medium grain sandstone with dark to light brown clasts, presence of whitish limestone weathering; to saturated shale with a high degree of fracturing, located in the sector with the highest fracture of the slope. The stratification has a general diving direction of N174° and a diving direction of approximately 16°. The slope consists of five units which add a total power of 39 m (Fig. 7).

The geological characterization indicates the presence of materials associated with resistivities of sedimentary lithics of fine to medium grains, possibly saturated and high degree of weathering and compaction. The slope consists of five units having at its base medium grain sandstone with evidence of erosion, followed by an intercalation of calcareous sandstone and shale with a fine to medium granulometry, underlies a very fractured fine grain shale unit. Next, we have a block of silty sandstone with fine to medium grains and finally the clay silt unit consisting of fine grains and presence of water weathering due to the rainwater drainage system located next to the slope.

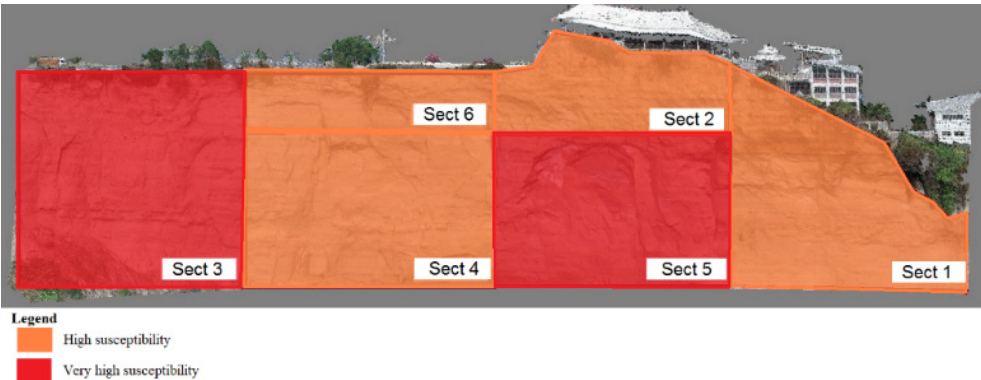
Figure 8: Detachment susceptibility evaluation to normal conditions.

In normal conditions we obtained that a very high susceptibility was obtained for sectors 3 and 5 (Fig. 8) while in extreme conditions a very high susceptibility was obtained for all sectors, except sector 2.

By analyzing the compilation of methods proposed by [15]–[18] who conducted an evaluation of conditioning factors and triggers, which allow obtaining the degree of susceptibility, a very high susceptibility was determined for sectors 1, 2, 4 and 6 under current conditions. These values match the lowest real safety factor value obtained (0.907), which indicates instability conditions according to Melentijevic [22].

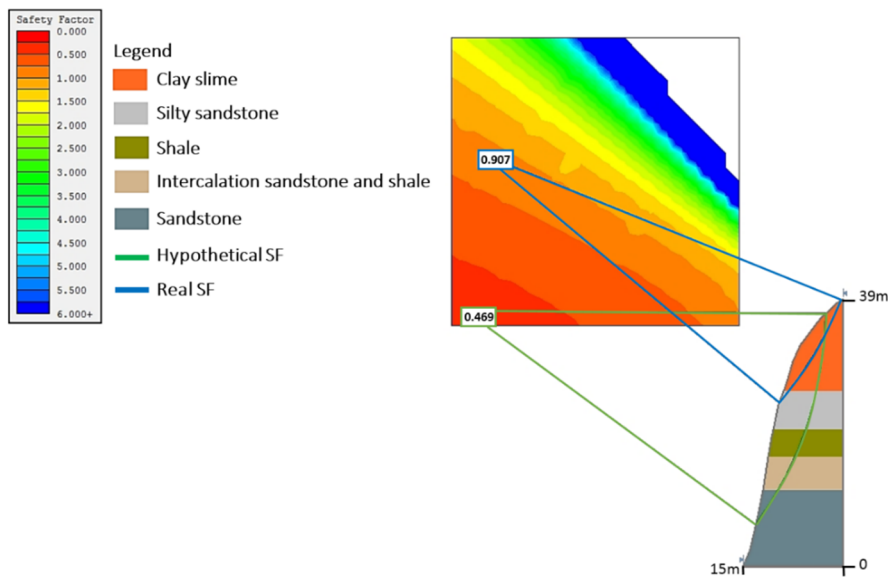
Figure 9: Safety factor obtained for zone.

Table 9 shows a summary of the results of susceptibility obtained for each sector under current and extreme conditions in relation to the real and hypothetical safety factor, considering the surface that tends to suffer a block detachment. Fig. 9 shows the lowest result of safety factor obtained in profile 1 (zone 2).

The safety factors obtained for the 6 profiles chosen to indicate that the most critical value was 0.907, this value is related to the degree of susceptibility obtained for each sector, generating confidence in the results previously obtained.

Based on the geomechanical properties and the conditioning and triggering factors that favor the instability of the slope studied, it is recommended to determine a stabilization plan that includes anchors distributed uniformly with an angle of 30° from the horizontal considering the subhorizontal dip of the strata with a shotcrete layer that acts as a stabilized front finish. In addition, a drainage system that allows the discharge of rainwater into the slope should be implemented.
