# STRUCTURAL (PHYSICAL–TECHNICAL) VULNERABILITY OF LOW-INCOME HOUSING IN THE FACE OF SUBSIDENCE IN URBAN AREAS: CASE STUDY OF THE ERMITA ZARAGOZA NEIGHBORHOOD, IZTAPALAPA DISTRICT, MEXICO CITY, MEXICO

GUSTAVO ALONSO BACA-SÁNCHEZ, BERTHA NELLY CABRERA-SÁNCHEZ  
& MILTON MONTEJANO-CASTILLO

Escuela Superior de Ingeniería y Arquitectura Unidad Tecamachalco del Instituto Politécnico Nacional, Mexico

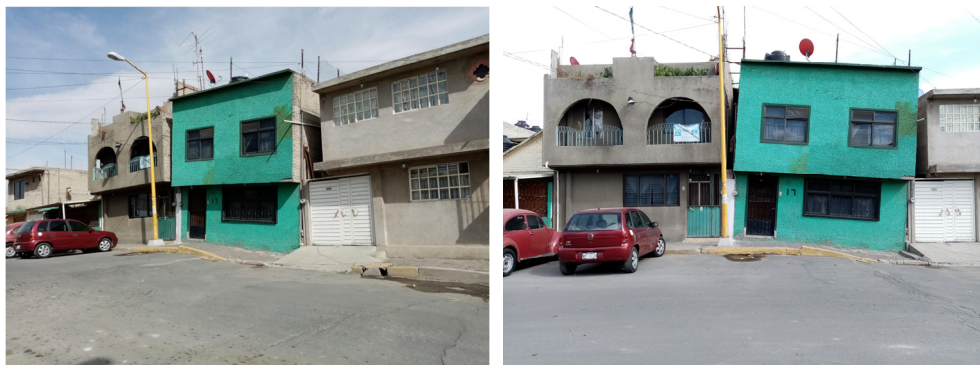
not justify the choice of reinforcements used and do not consider the effects already caused due to subsidence and cracking of the soil, so they adversely affect the structural vulnerability of property (see Fig. 3).

Figure 3: Affectation of soil cracking in modified housing. Loss of verticality. UH Ermita Zaragoza neighbourhood. (Source: Alonso Baca, 2021.)

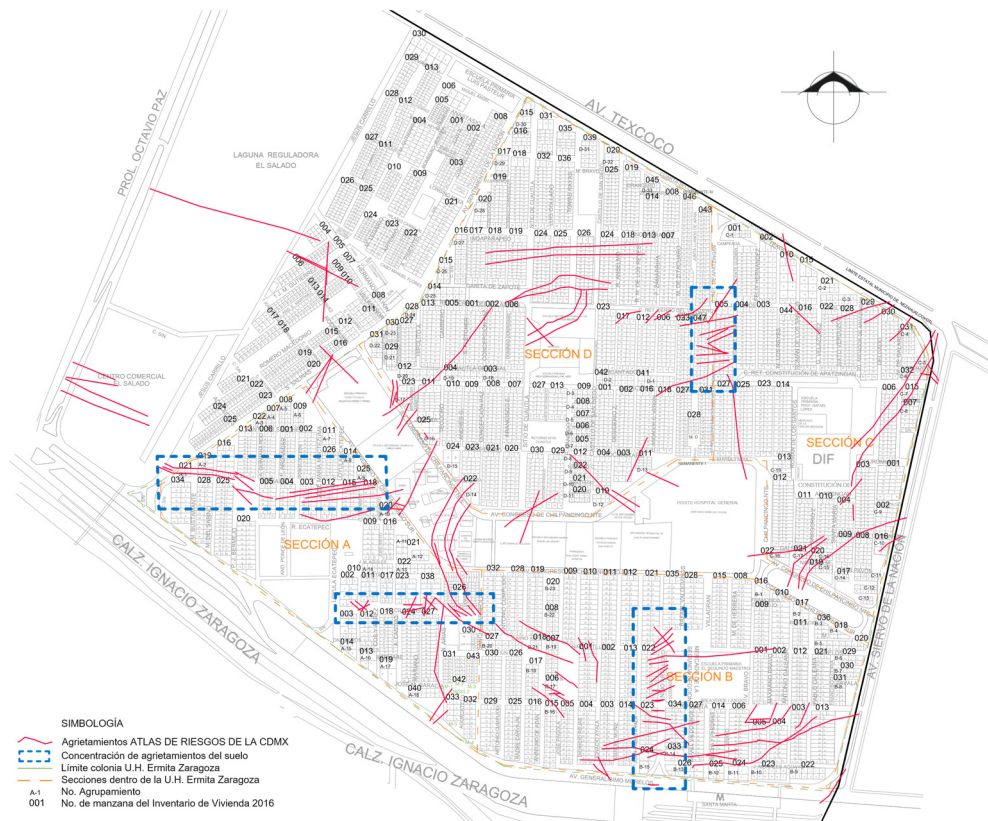
Fig. 4 shows soil cracks indicated by the risk atlas in Mexico City [11]. Blue polygons specify the areas with concentrations of these cracks and that apart from the fact that they are easily visible from the roads, they represent a greater affectation to the houses.

Figure 4: Identification of areas affected by soil cracking. UH Ermita Zaragoza neighbourhood. (Source: Prepared by Alonso Baca based on the Risk Atlas in Mexico City [11].)

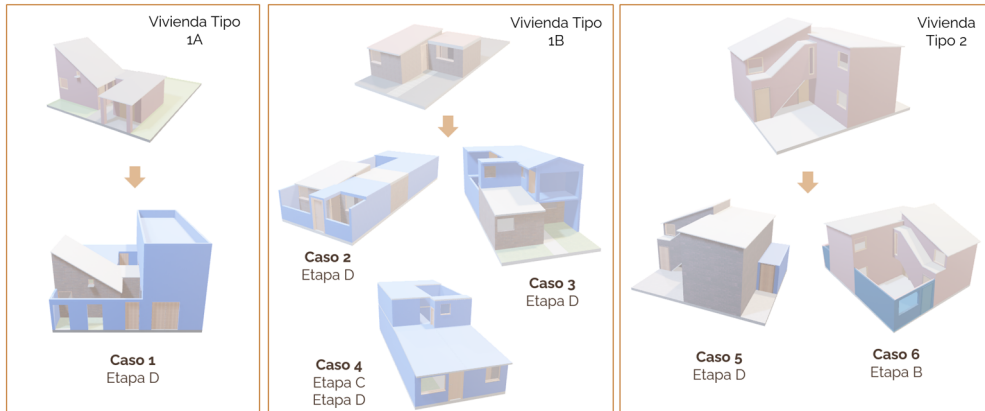
Figure 7: Original typology and expansion of the house in case studies. (Source: Prepared by Alonso Baca based on field work, 2021.)

For case 1, the transformation stage refers to stage “D” of expansion and aesthetic transformation, still distinguishing part of the original house.

For cases 2, 3 and 4 the transformation corresponds to stage “D” of enlargement with different dimensions, while in case 2 it has been limited in the horizontal direction only. In case 3, it has also been conducted in the vertical direction. In case 4, the house is the only one that has lost its original typology by expanding horizontally towards the front, which is why it is considered a completely transformed house.

For cases 5 and 6 of typology 2, they have a lower degree of transformation, unlike all the previous cases. In case 5, the expansion was limited to a utility room at the back of the lot (stage D) and in case 6, occupants only delimited the façade and the back of the house with a perimeter fence (stage B).
