## Slope instability along some sectors of the road to La Bufadora

### Abstract

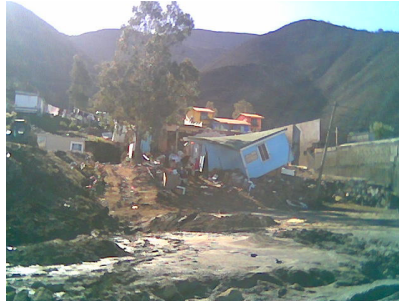
During the winter of 2007, runoff water from the storms reached high velocities due to the steep and burned bare slopes lacking the vegetation to hold the soil in place, resulting in flooding and mudslides in the lower areas (Figure 5)

Figure 5: Flooding at the Esteban Cantú communal land in Punta Banda.

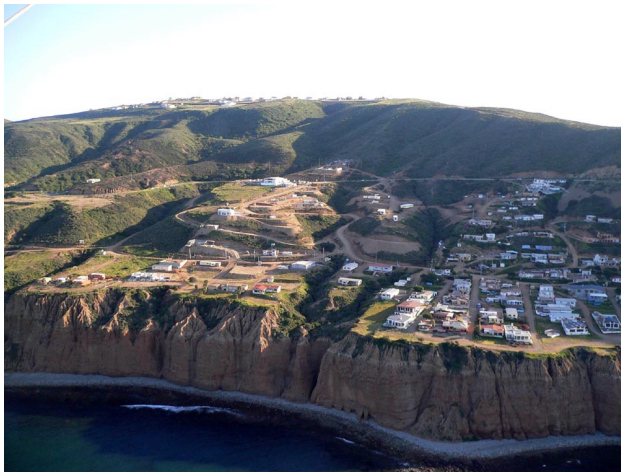
Evidence of anthropogenic impact was found where the addition of loads due to the presence of a tourist housing development on the edges of the hillsides were built in areas where loess and sand forming hills are present (Figure 6), causing additional sliding. In this sector, 4m. of the road to La Bufadora have sunk approximately 5 cm in two years and earthquake swarms have been registered (CICESE [3]).

Figure 6: Tourist Housing near the area of El Rincón de las Ballenas where normal faulting and erosion due to rain precipitation are present, adding a risk to the residents.

In addition, it is strongly recommended as a preventive measure to avoid any building or development at least at a minimum distance of 50 m. to the superficial trace of any fault.

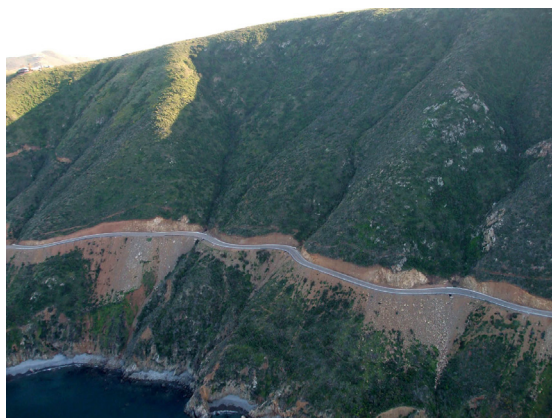
rainfall delivers great volumes of water. Two of the pipes found were already blocked. It was also found that the cracking of the road is due to the lack of a good soil compaction and the sliding is the result of the removal of the natural vegetation cover by dropping debris material onto the side cross section (Figure 8) destabilizing the hill.

Figure 8: Aerial photograph showing debris material dropped to the hillside.

To achieve the development of the infrastructure activities on La Lobera it is important to consider the immediate reforestation of the landscape and to protect the remaining one, as a mean to solve problem areas which have been already modified, to protect the hillsides and avoid natural hazards mainly in the rainy season.
