A case of sustainable conservation

S. Sajeve

3 The church of the Elias Prophet at Voskopojë: the whole of the proceedings put into place for the conservation of the monument

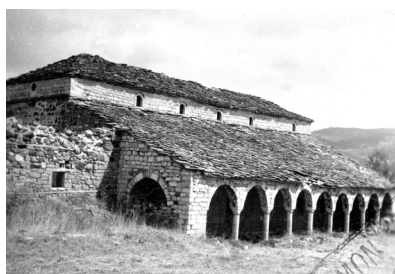
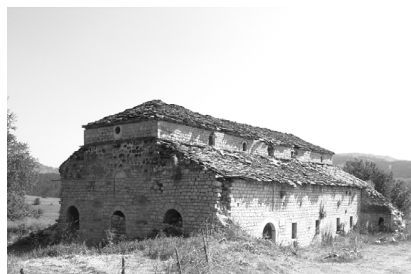
Figure 4: The church Profeta Elia, (a) in an image (not given) from the archive of IMK. (b) today's image.

The particular study of the environment confirmed, in terms of risk, information corresponding to the national data in regards to seismic potential: 6.9 M [4, 5]. The manifestation of the seismic events is visible on the structure of the church in the form of a framework of the cracks in the built part, as can be seen in the displacement of certain elements constituting the wooden carpentry of the roof.
