Diagnostic strategies for the repair intervention on churches damaged by earthquakes: the Toscolano Maderno Monumental Complex

L. Binda¹, S. Lagomarsino², S. Podestà², A. Saisi¹ & C. Tedeschi¹

Abstract

This paper describes the methodology applied to two churches of the Garda area damaged by the 2004 earthquake in order to define the repair intervention. After interpretation of the damage causes, based on an accurate onsite survey and documentary research, the intervention strategies were supported by an onsite testing campaign.

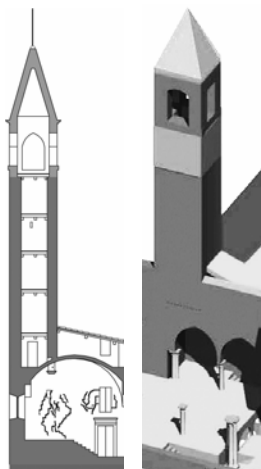
Figure 4: Detail of the bell-tower section and localisation.

The preliminary phase gave important information on vulnerable points and construction anomalies: in the case of St Andrew's the bell-tower load, built in a second time, rests on the apse walls and on a column (Fig. 4).

The bell tower, finally, built after the church, showed, from the beginning of its construction, a clear vulnerability for the interaction with the church. On fact, it has caused an increase of the compressive stress on the original church walls. The masonry arches of the church in fact, support the southwest wall and part of the northwest wall of the belfry. Such structural situation has determined a significant load increase, especially on the second column of the presbytery and on some parts of the apse and presbytery walls. It is worth noticing that the presbytery column showed, immediately after the belfry construction, an increase of the compressive stress level and, therefore, it was object of a retrofitting intervention, based on the insertion of a steel confinement on the column.

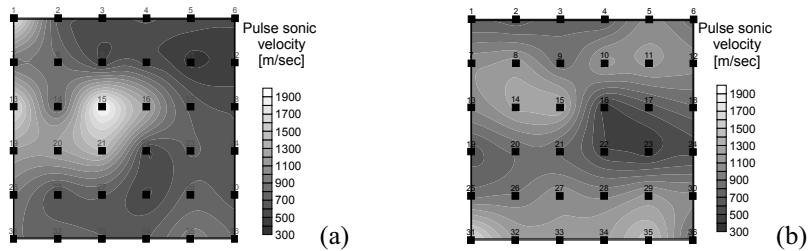
Figure 5: Sonic test results: (a) St Andrew's and (b) Immacolata church.

Fig. 5 shows the results of sonic tests and double and single flat jack on the St Andrew's and Immacolata church. The behaviour is very different: the St Andrew's church is characterised by better behaviour and probably higher strength (Fig. 6) but with an apparently lower compactness of the material, as appear from the average low value of the sonic test. This fact was explained only after a local inspection.

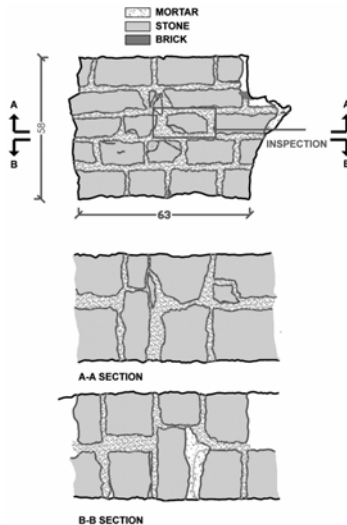
Figure 9: Immacolata: section reconstruction

In contrast, the Immacolata church, with an even more irregular external texture, had a better connection between the leaves (Fig. 9).

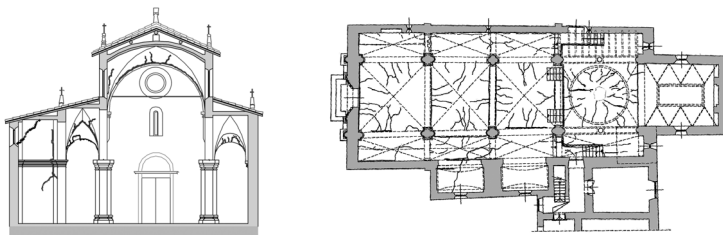
More complex is the situation on St Andrew's church (Fig. 12), due to the several interventions during the centuries. The surveys have singled out that the seismic event has caused a limited crack pattern, increasing, in many cases, historic failures.

In detail, the Authors have focused their attention on the widespread crack state of the central nave vaults of the presbytery and of the apse. The crack pattern on the vaults is strictly connected to the presence of a reinforced concrete slab on the vaults extrados. The stiffness of this structural element determines a shift of the stress state on the stiffer structure (reinforced concrete slab), decompressing the original masonry vault. The reduction of the compression state level in the vaults, in occasion of the seismic action, caused a widespread and articulate crack pattern which cannot be associated with a defined collapse mechanism, but with the presence of this new vulnerability indicator. Moreover, the damage surveyed in the transversal arches of the aisles can be correlated to the major vulnerability of these elements in comparison to the transversal arches of the central nave. They are, in fact, the only elements of the church without steel tie-rods.

Figure 12: St Andrew's. Crack pattern of the vaults.

For the nave vaults and the presbytery walls (in correspondence of the belfry), the Authors have planned the repair of the crack patterns through gout injections. Although the seismic improvement of this kind of solution cannot be synthesized in the value of a collapse multiplier, its effectiveness is connected to a better continuity in the masonry.
