Evaluation of the structural behaviour of historic masonry buildings by using a sonic pulse velocity method

F. Casarin, M. R. Valluzzi, F. da Porto & C. Modena
*Department of Structural and Transportation Engineering,
University of Padova, Italy*

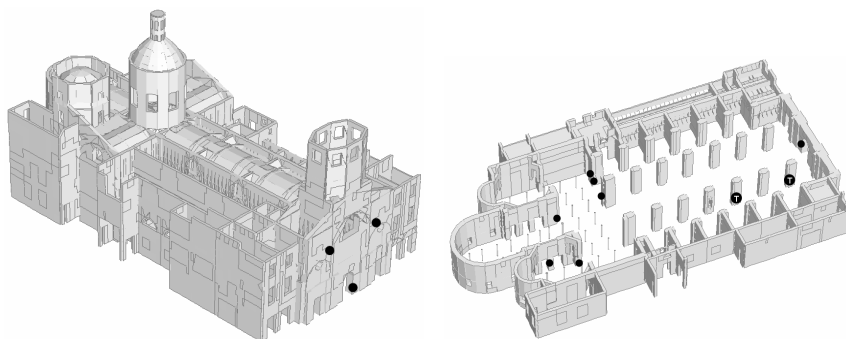
As a starting point, a sonic direct test was executed in correspondence of the masonry pillar previously tested by means of double flat-jack. Considered the several structural interventions that modified the original layout of the religious complex, comporting changes in materials and constructive techniques, any correlation between data emerged from sonic tests to variation in terms of elasticity modulus was not established, since the procedure was not considered reliable. Sonic tests localization is given in Figure 2.

Figure 2: Reggio Emilia cathedral, Sonic tests, localization.

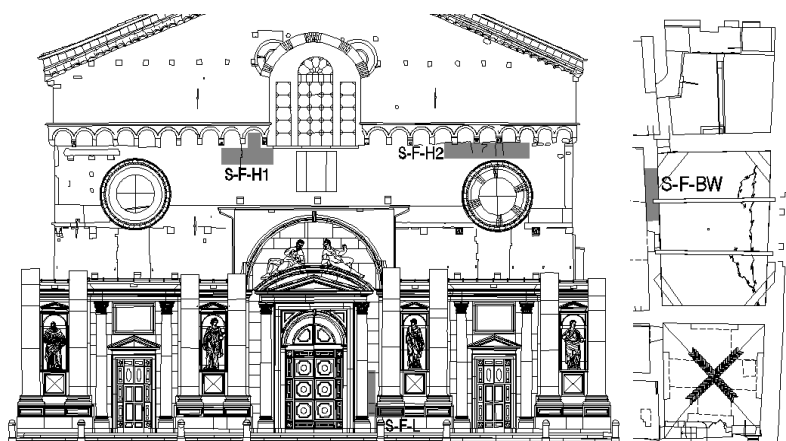
Figure 3: Positioning of sonic direct tests, Façade (elevation) and dome lantern back wall (plan view).

No odd velocity values were found, denoting absence of macroscopic inconsistencies within the tested masonry portions investigated. Several masonry walls tested denoted a general velocity uniformity, indicating a possible uniformity also in terms of mechanical characteristics, resulting in a positive homogeneous stress pattern. This was particularly evident in tests S-F-H1/H2, where a façade horizontal slice 17 m long was analyzed at the same height, denoting rather uniform velocity values (Figure 3).

A noticeable data scatter was noticed in correspondence of areas subjected to past restoration interventions, as is the case of the façade lantern back wall. Sonic results obtained in the lower part of the façade (test S-F-L) are indicative of a possible masonry variable inner configuration. Sonic velocities obtained in the upper façade tests (S-F-H1/H2) presented an overall value of 1215 m/s, averaged on 61 paths, in line with data emerged from the upper lines of test S-F-L. In some cases it was possible to appreciate that the analyzed structures presents a multi leaf structure, being this denounced by the marked difference in terms of velocity recorded in the superficial path respect paths crossing the inner section of the analyzed wall/pillar (Figure 4: tests S-C-FJ, S-N-D1/D2). Confirmation of this comes from the examination of the core samples extracted in the crypt's area.

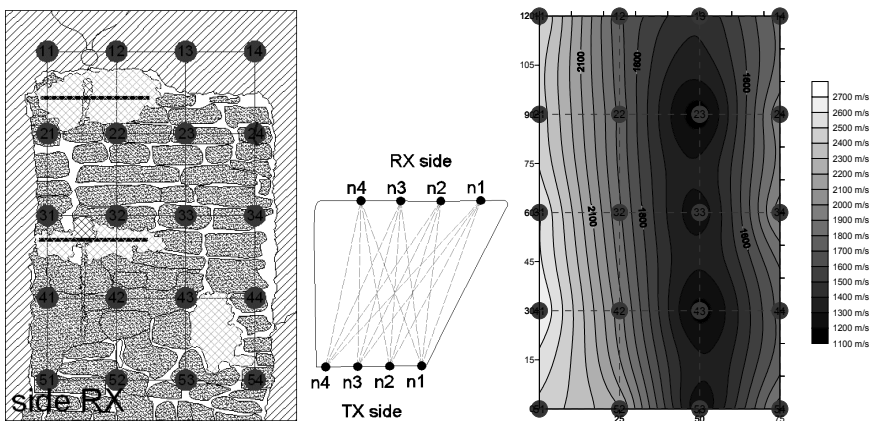
Sonic investigations results, related to the brickwork masonry typology, proposed the final impression (overall average velocity 1394 m/s on 349 sonic paths) that the successive implementation of structural models resorting from limit analysis approach, considering the selected masonry portions (macroelements) as rigid bodies, was possible, since the tested masonry portions did not denounce severe structural deficiencies, possible cause of sudden collapse (e.g. masonry crumbling) before the beginning of the considered mechanisms.

Figure 4: Reggio Emilia cathedral, crypt level: direct sonic test, acquisition grid, sonic paths and obtained velocities.

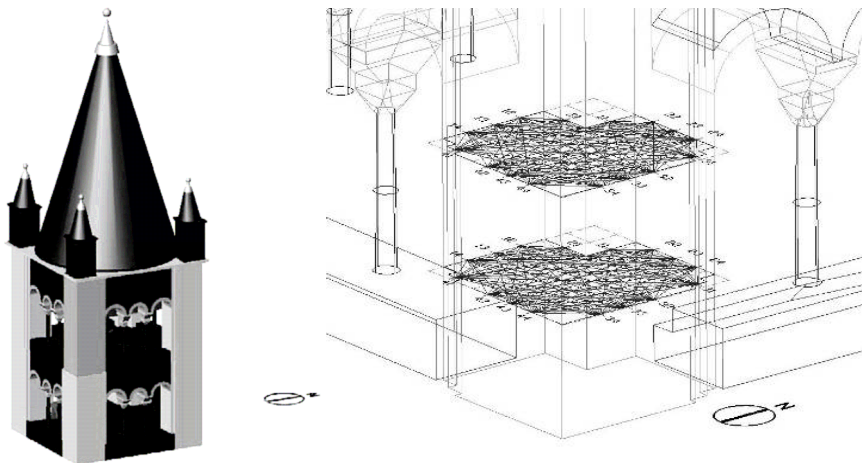
analyses (deterioration of the mortar joints caused by the rain and ice-thaw cycles, evident crack pattern, interaction with the structure supporting the bells), was carried out.

In particular, sonic tomographies at two different levels of an “L” shaped pillar of the upper level of the belfry (Figure 6) were applied (respectively at 0.55 and 1.85 m from the belfry floor) to have an insight on the inner composition of the masonry structural elements. Both of the two tests indicate that the inner part of the pillar is composed by a masonry with supposed reduced masonry consistency/different composition respect the external area, being this denounced by the different velocities emerged from the analysis (avg. velocity of the inner and outer areas corresponding respectively to approximately 1800 and 2500 m/s in the lower cross section and 1600/2600 m/s in the higher).

Figure 6: S. Zeno bell-tower: localization of the pillar interested by sonic testing and tomographic sections with indication of the sonic paths.

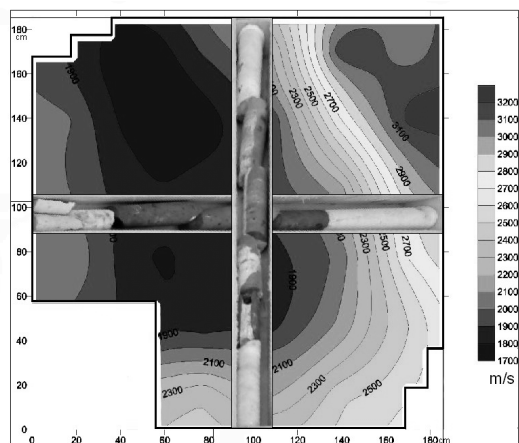
Such results, corroborated by the successive extraction of core samples in the area of execution of the tests, can be related to the presence of brickwork masonry in the inner part, presenting a velocity that generally denotes a material with fair/good mechanical characteristics, and an outer masonry composed by well arranged sandstone masonry blocks (Figure 7). Consequently to the outcomes of the investigation phase, structural FE linear models of the investigated pillar, simulating the dead load and thrust of the spire, as well as the horizontal action of the swinging bells, and considering different materials throughout the cross section as emerged, were implemented. From the numerical analysis it emerges that the pillars is subjected to compressive stresses ranging from approx. 2.0 (in its external sides - respect the belfry - and inner core) to 3.0 MPa (in the sides towards the inner belfry), these evaluations giving the possibility to determine the safety state of the pillar and influencing the successive phase of strengthening intervention planning (Figure 8).

Figure 7: Lower sonic tomography, S. Zeno bell-tower, Verona: velocities are related to masonry composition by means of core samples extraction.

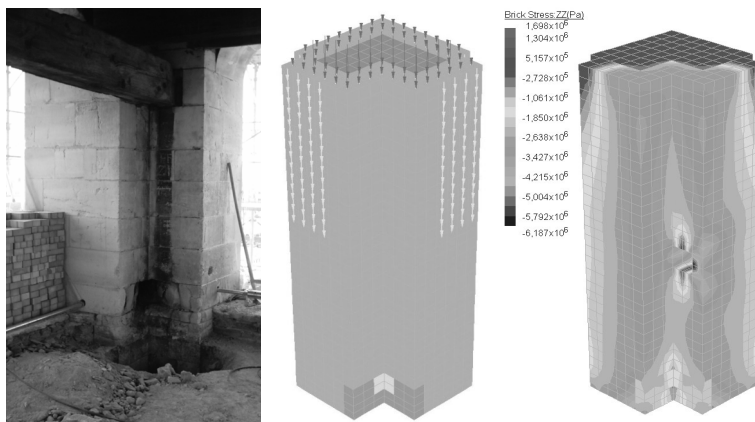
Figure 8: View of pillars of St. Zeno tower belfry and corresponding pre and post processed FE model.
