# Non-destructive testing techniques applied to the masonry and timber structures of the Crocifisso Church in Noto

L. Binda, L. Cantini, P. Condoleo & A. Saisi

*DIS – Department of Structural Engineering, Politecnico of Milan, Italy*

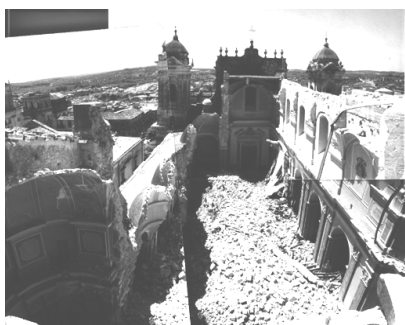
The dramatic collapse of the central nave and of part of the dome of the Noto Cathedral (Fig. 1) damaged by the 1990 earthquake, took place only six years later, in 1996 (De Benedictis et al [1]). The accurate on site and laboratory investigation confirmed that the earthquake was only worsening the situation of the materials and of the structure which was already highly damaged (Binda et al [2, 3]). The removal of the plaster (which was made in the 1960s) from the remaining pillars of the central nave revealed the pre-existence of a diffused distribution of vertical cracks and spalling of the corners in the external leaf made with limestone (calcarene) regular blocks (Fig. 2). In fact, these cracks

Figure 1: The Cathedral of Noto after the 1996 collapse.

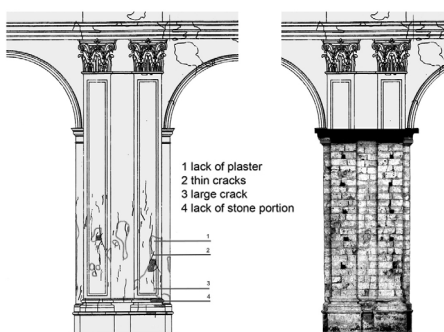
Figure 2: The damage survey of a Noto Cathedral pillar.

In the case of the Noto Cathedral, the internal rubble masonry of the pillars was found to be very weak [2]; its early higher deformation caused in the long range a high state of damage in the external stone leaf (Fig. 2). A further weakness was found in the materials used for the external leaf of the collapsed pillars. In fact while for the internal rubble filling the thick mortars joints were composed by hydrated lime and silt weak aggregates alternate with rather irregular courses of round river stones and there was a lack of connection

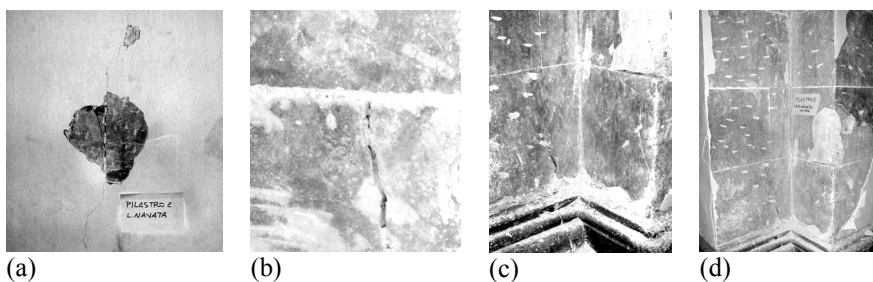
As said above an alarming state of damage was found in the pillars, by locally removing the plaster. The plaster, in fact, was hiding a complex of vertical cracks passing through the stones and continuing along the mortar joints (Fig. 6).

Figure 6: (a) The plaster did not show cracks; (b), (c), (d) damages visible after the plaster removal.

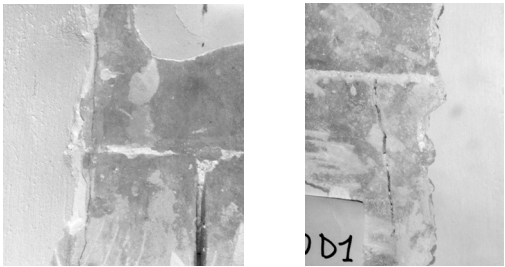
The plaster was particularly thin (Fig. 7) and completely detached in the area in which deep cracks were distributed.

Figure 7: A very thin plaster (4-5 mm thick) made with lime-gypsum mortar covers the pillars, hiding the cracks.

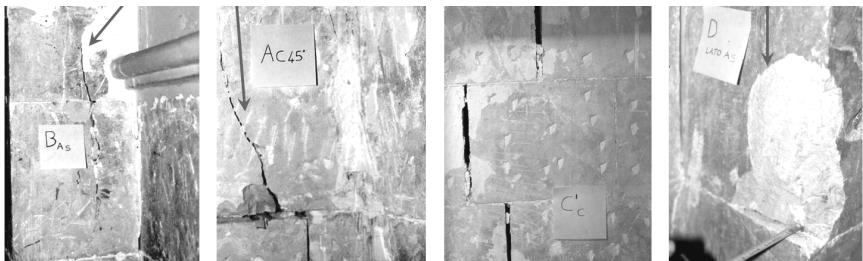
Figs. 8-10 show examples of the crack pattern of the pillars. As it possible to observe in Fig. 9, the cracks are diffused and interesting the whole prospect, with a concentration in the corners.

Figure 8: Example of damages: (a), (b) vertical cracks of the stone-blocks, (c) empty vertical joints (d) lack of material.

In some cases, the fissures were filled with mortar and the corners reconstructed (Fig. 8 and 9) with mortar. This fact suggests that the crack pattern was present before the plaster was applied.

The strengthening design was urgently changed and the pillars were urgently confined by stainless steel cross-shaped reinforcements confining the pillars at every two courses.

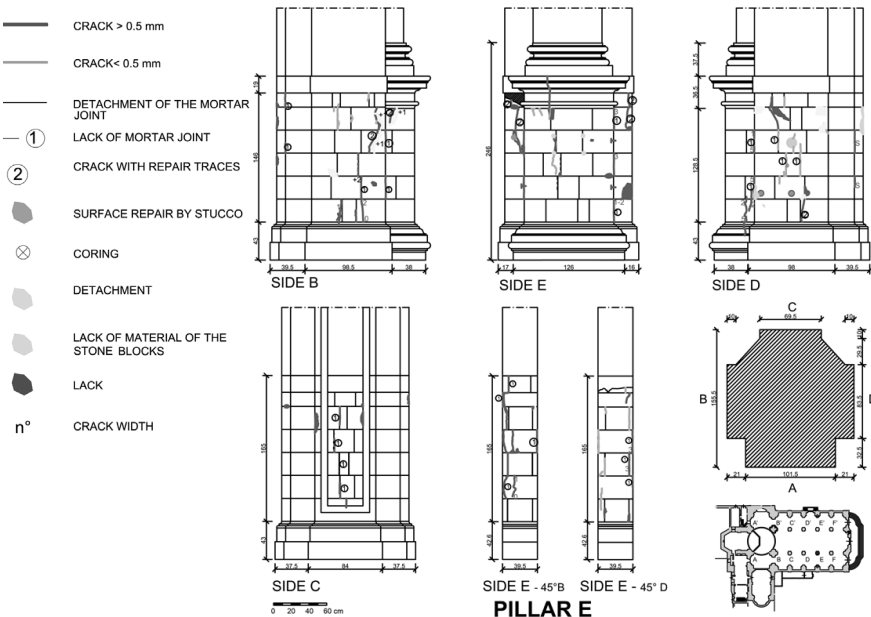
Figure 9: Crocifisso Church. Crack pattern of the base of the pillar E (Fig. 5).

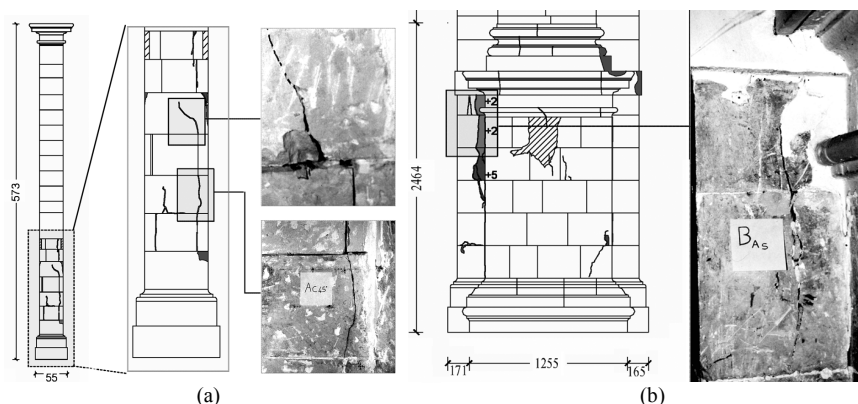
Figure 10: Crack pattern survey and detail of the pillars B (a) and C (b) (Fig. 5).

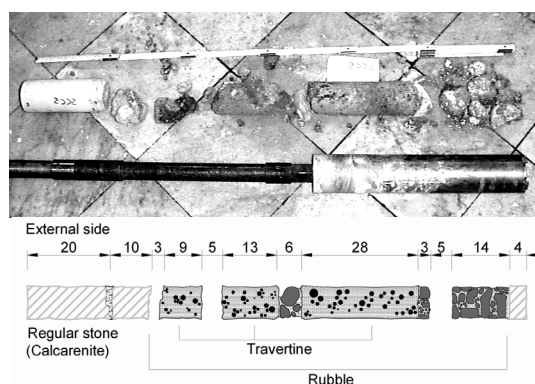
The coring and the boroscopy observation, which together with the stone disposal survey gave information on the section morphology, revealed a multiple leaf masonry (see also Fig. 5). The internal masonry, as said above, is a rubble one, composed of a rather weak mortar, pieces of limestone (Fig. 11).

Figure 11: Drilled core of pillar C (Fig. 5) and re-construction.

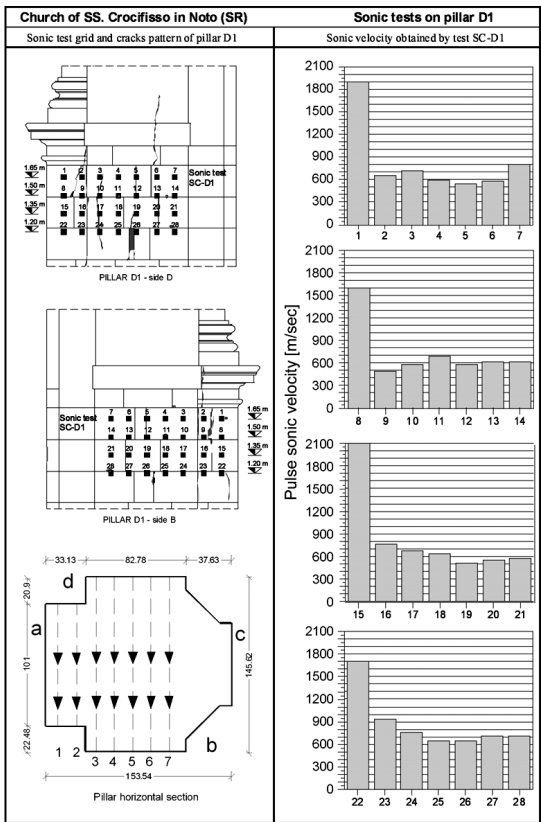
velocities are higher in coincidence with the external stone leaves and lower when the impulse crosses the internal rubble filling, as expected. These results confirm what found by coring (Fig. 11).

The sonic velocity also is lowered by the presence of cracks, when they are perpendicularly crossed. In fact the lowest average velocities (SC-D1) concern the pillar called D (Fig. 5), characterised by the worst crack pattern situation. It was also possible to notice that in the case of highly cracked external leaf the velocity became lower.

Figure 12: Crocifisso Church: results of sonic tests applied to the pillar D1 (Fig. 5).

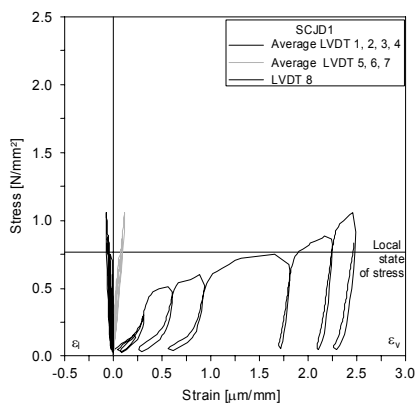
Figure 14: Flat-jack test result (test SC-D1 in Fig. 5).

In Fig. 14 and 15 (SC-D1, SC-D2) these two different behaviour are shown in the stress-strain plot as average of LVDTs 1, 2, 3, 4 and of 5, 6, 7 (Fig. 13).

It is then confirmed that there is a greater deformation in the joint when a certain state of stress is reached. Furthermore, the plot of Fig.14 shows a weaker behaviour of the masonry compared to SC-D2 (Fig. 15).

Nevertheless, in both cases the state of stress measured by the single flat-jack is outside the elastic range of the material. This explains also the detected damages.

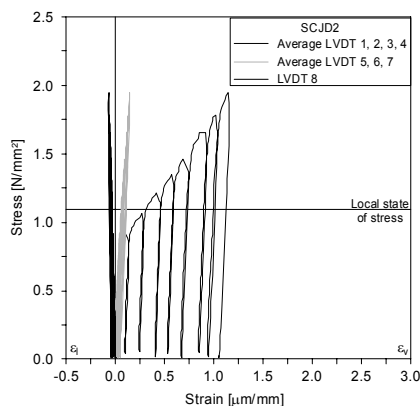
Figure 15: Flat-jack test result (test SC-D2 in Fig. 5).

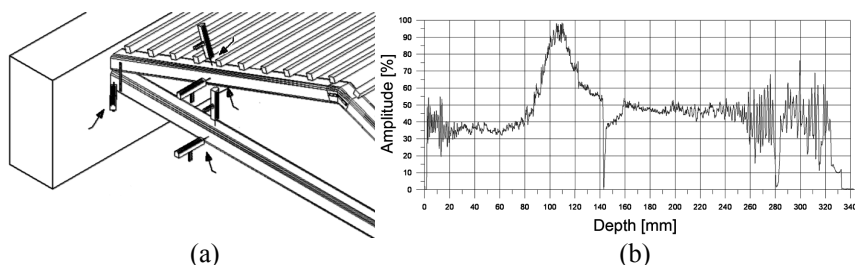
For each truss structure, three profiles were collected on the horizontal element, one on each inclined element and another on the secondary elements as shown in Fig. 17(a)). As an example, a profile obtained on the end of a horizontal element is shown in Fig. 17(b)). In general, very few profiles, localized at the ends of the horizontal elements, showed internal discontinuities.

Figure 17: Penetrometric tests: localization of the tests (a); amplitude vs. depth profile (b).

For the first ones it was decided that they could be preserved with few repair.
