Analysis of the old mortars and proposals for the conservation of the archeological site of Logos-Edessa

M. A. Stefanidou & I. Papayianni

Department of Civil Engineering, Aristotle University, Thessaloniki, Greece

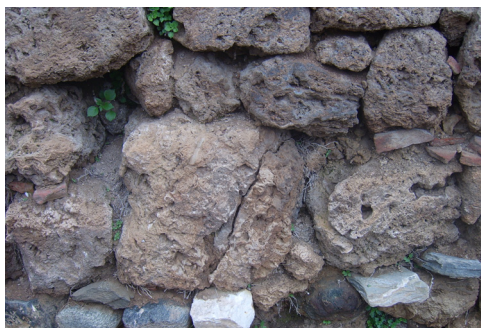
- Absence of joints,
- -cracks in brick and stone samples probably due to frost action,
- -biological growth,
- colour alteration of stones due to black crust deposition (figure 1).

Figure 1: Absence of joints and cracks in stones.

The final proposals for repair mortars were based on materials such as lime, natural pozzolana of high pozzolanic index (7MPa), local sand, local clay and natural coarse aggregates of silica origin. The usage of super-plastisizers free of sulfates was also suggested in order to keep the water requirements low. For the in situ application, instructions were given concerning the mixture of the materials, the water demand and the protection of the fresh mortars.

Materials	parts by weight
Lime dust	0.8
Natural pozzolana	0.6
Local clay	0.4
Local aggregates (0-8mm)	6.0
Super-plasticizer	1-2%b.w.of binder

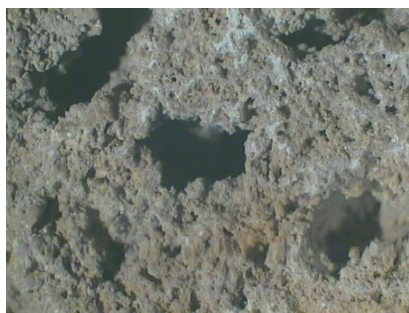
The stone is travertine and is in abundance in the area (figure 2). The mean strength is 1-1.5MPa while the open porosity is 18.2% and the specific gravity is 1.05. The properties of the stone are close to the mortars used and that was on the benefit of the masonry as it could work as a monolithic structure. The thickness of the joints was 1-3cm depending on the stone samples used.

Figure 2: Travertine used in Logos (Stereoscope x8).

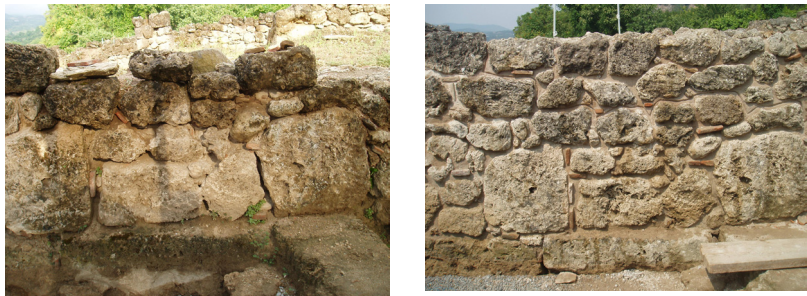
Figure 3: Structure before conservation works (left) and after the end of the works (right).

Finally the proposals were successfully completed by experienced restorers (figure 3).
