Rehabilitation of uncommon medieval timber structures

S. Niederhagemann

Deutsches Bergbau-Museum Bochum (DBM), Germany

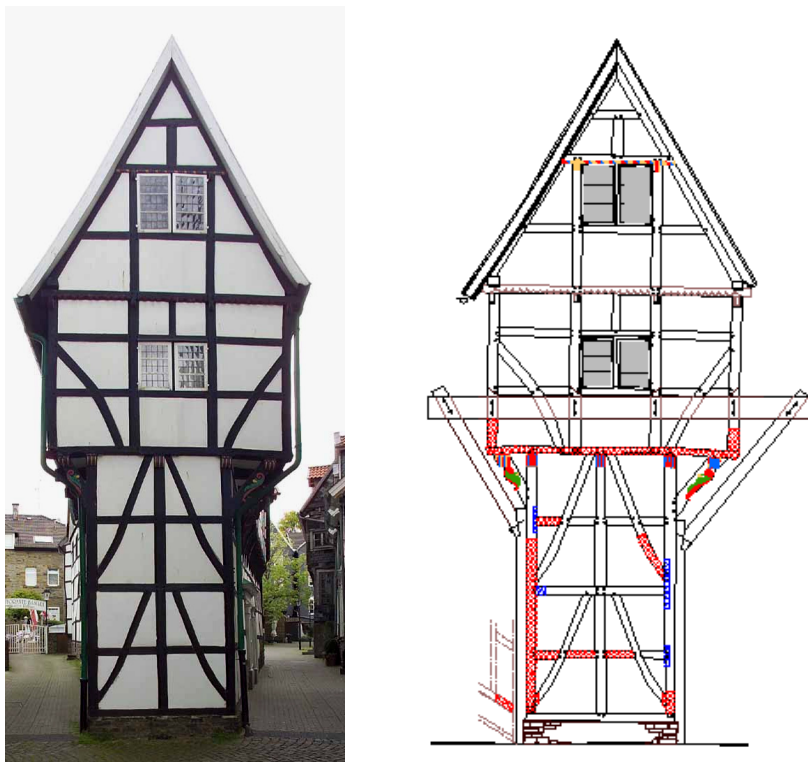
The continued existence of the "Bügeleisenhaus" could be safeguarded by covering and single repairs again and again without eliminating the actual causes of the damage. The weak point of the house is formed by the threshold of the 2nd level. The damage at the cantilever arm was eliminated only by installing an intermediate piece. In the end this piece could not carry the loads.

In the last few years the damage has increased at the upper floor threshold so that the deformations and settlements could already become recognizable with the unaided eye. With that the stability of the building no longer guaranteed direct safeguards were required.

Figure 1: Picture and drawing of the façade with temporary supporting structure and map of damage.

Both sides of the building are fitted with cantilever beams. The pathway beside the building must be free of any columns because of fire protection reasons. For the change of the threshold a special construction was developed which avoided any disturbing elements in the pathway. This temporary construction safeguarded the removal of the old threshold and the integration of the new threshold while the construction could not stand in the traffic space of the bordering streets. In the removal of the threshold the gable was not allowed to sag more than a millimetre. To that a tie construction was chosen, which was through bolted with the timber construction of the 2nd upper floor. The pillars of the construction were set next to the corner of the building and also though bolted with it. Because of the geometrically necessary protrusion of the ties a

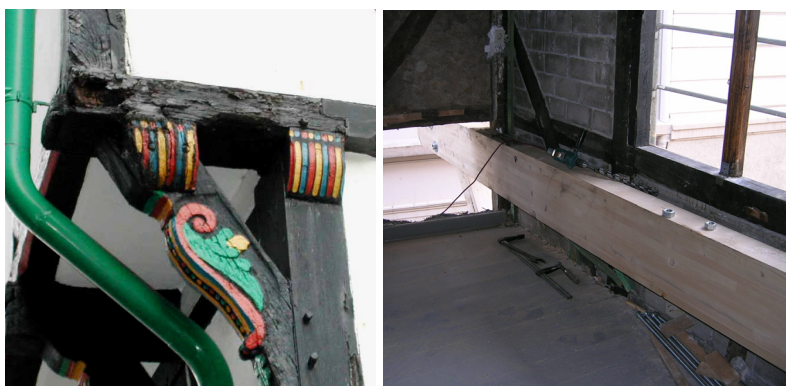
Figure 2: Condition of a bracket and detail of the temporary supporting structure.

composite lumber of 12/34 cm was necessary. The construction was though bolted with steel bolts of 26 mm diameter.

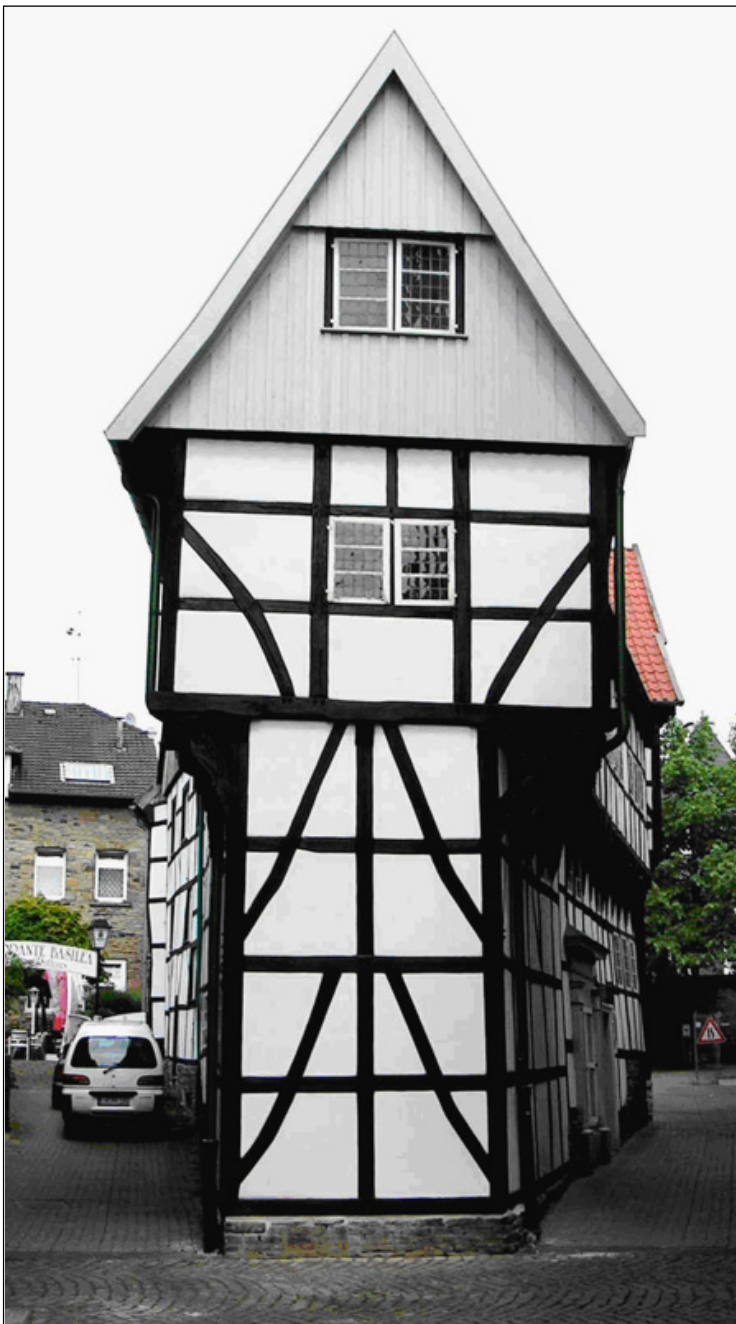
Figure 3: Façade after rehabilitation.

Architect, builder and monument conservationists were however conscious that a repair without additional measures would raise maintenance expenditure that could not be financed through the local history association. After long discussions it was decided to fit the gable with some graded lid roof boards following the formerly available façade planking. It could be guaranteed that all the rain would not run down the façade, but can drain at the bottom side of the boards freely. Additionally, rainwater pipes and the roof construction have been reworked [3].

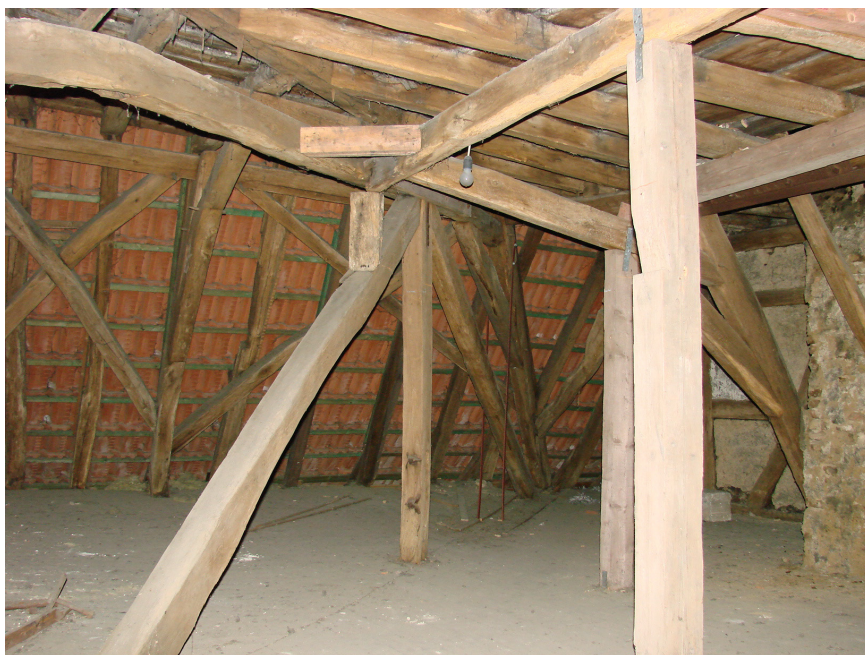
A characteristic of the building is the roof construction above the room 1.04. The ceiling was hung under a suspension structure running diagonally through the building so that the room could remain pillar-free. Such suspension structures were uncommon at the erection time of this house.

Figure 6: Roof truss.
