Estimation of residual carrying capacity and restoration of the historic reinforced concrete shells and frames erected in Estonia

H. Onton

*Department of Structural Design,
Tallinn University of Technology, Estonia*

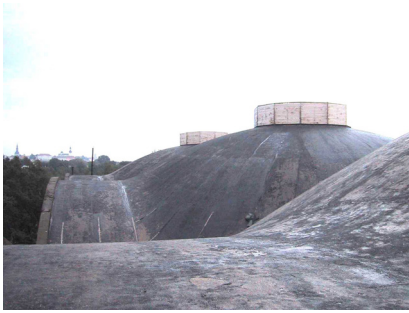
Figure 7: The shell coverage.

Now the upper surface of the shell is covered only partly with oxidized bitumen. Most upper surfaces of the shell have been washed with rain and are cracked. In autumn 2001, the central part of the spherical shell and two cylindrical shells were covered with SBS type roofing.

Before covering the shells with the SBS type roof covering, the old bitumen was scratched out and the fogged areas were treated with a biological repellent. The cleaned shells were covered with bond varnish. The new SBS type roof cover had two layers; it was armed with polyester fiber and covered with bulk. The roof covering was fixed additionally from edges with rivets (spacing 0.5 m) in the parts of shell, which had larger incline and window lighting surroundings. Additionally, the water drain system was repaired and new pipes were installed. The edge elements of the cylindrical shells were rimmed with sheet metal.

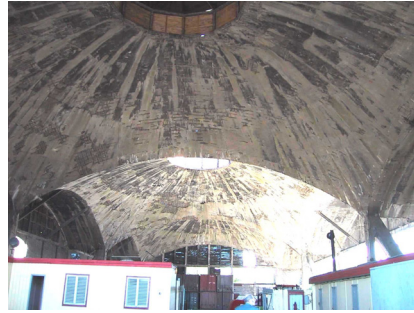
Because of very poor maintenance during the last decades and due to the absence of roofing, widows and doors, water and moisture has penetrated in the concrete surface, causing moisture and frost damage of concrete and corrosion of reinforcement and washing out of binder.

In some places corrosion of reinforcement is so extensive that only prints of the corrosion are left. On the lower surface of the shells nearby 50% of the cover layer is absent and some pieces of concrete cover are continuously falling down.

Due to the missing cover layer and decreasing cross section of reinforcement, the reinforcement does not serve its purpose in receiving the internal forces. The condition of the upper surface of the shells is better, due to the thicker cover layer of concrete.

Figure 8: Damage of the lower surface.

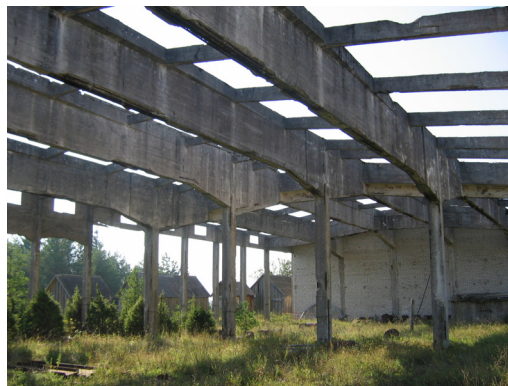
Damage is seen everywhere (columns, beams). Because of relatively wide cross-sections and reinforcement, the damage is not dangerous from the point of view of the stress-strain state. Restoration and reinforcement is still necessary.

The reason for the damage is poor maintenance during the last decades and due to the absence of roofing, widows and doors, water and moisture has penetrated in the concrete surface, causing moisture and frost damage of concrete and corrosion of reinforcement and washing out of binder.

Figure 9: Damage of the hangar frame.
