Deans Eye Window – Lincoln Cathedral, Lincolnshire, UK

G. A. Clifton

Director Historic Buildings, Gifford – Consulting Engineers, UK

Abstract

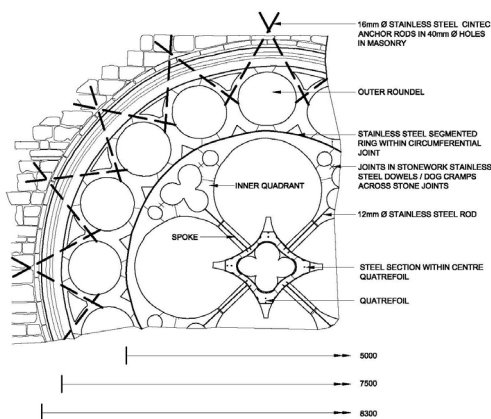
Figure 2: Structural solution.

The masonry tracery clearly cannot act as beams or a grillage spanning across the space, nor as a flat arch, as the span to depth ratio is of the order of 35. A simple structural analogy was developed for the structural system that would form the basis of a design, with the intention of restricting the stress in the masonry to 5 MPa compression with zero tension. (See figures 2 and 3.)

The outer roundels are assumed to act as cantilevers out from the gable wall carrying the shear loads from the inner area of the window. In order for this to be feasible tension needs to be carried through the joint to the gable wall requiring the inclusion of anchors within the depth of the tracery. A pair of Cintec stainless steel anchors were drilled through each of the edge stones into the gable wall and fully grouted.

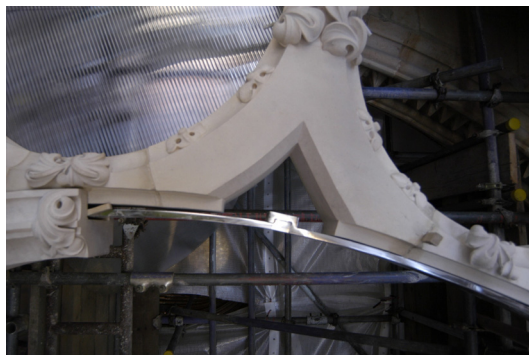
Figure 4: The Tension Ring.

The inner area of the window is presumed to act as a flat arch to the edge of the cantilevering roundels. In order for this to be feasible the central quatrefoil needs to be stiff and the edge of the inner window area needs to be restrained so that the arch cannot spread. The edge restraint from the gable and outer roundels is insufficient so a tension ring of stainless steel was incorporated into the joint between the inner section of the window and the outer roundels to provide that restraint. (See figure 4.)

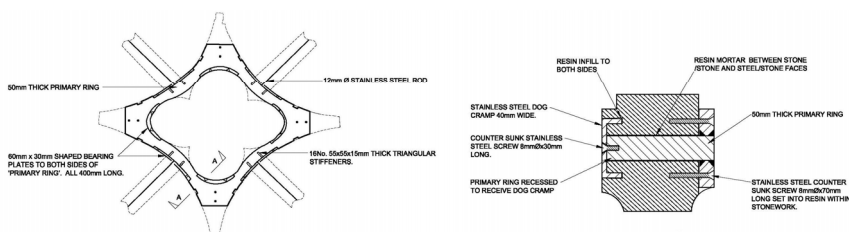
Figure 5: The central quatrefoil armature.

The central quatrefoil needs to be stiff and able to transmit the compression loads across it if the flat arch analogy is to be valid. A purely stone shape is unable to do this even if it has no joints. The introduction of a steel armature within the stone work, directly connected to the stone spokes, can transmit the loads adequately and be sufficiently stiff, in the three dimensions, to allow flat arch action. (See figure 5.)
