Methodologies for the evaluation of seismic vulnerability of complex masonry buildings: case histories in the historic centre of Sulmona

L. Binda, A. Anzani & G. Cardani
D.I.S – Politecnico di Milano, Italy

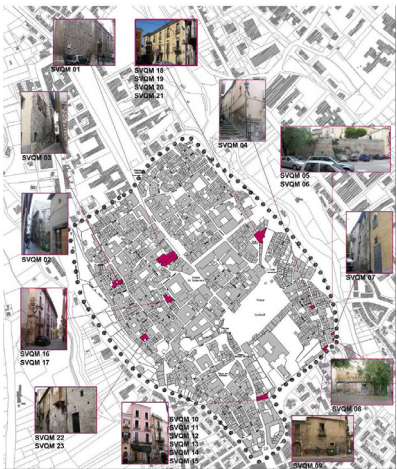
Figure 3: Recognition of building facades without plaster for masonry qualification.

Subsequently, a template aimed to the “Masonry quality evaluation” was adopted and applied to selected buildings characterized by facades with no plaster finishes, therefore having their stonework masonry texture available to visual inspection (figs. 3 and 4). The prediction of the seismic vulnerability of stonework masonry, and particularly of the multiple wythe stonework, can only be performed provided the intrinsic characteristics of the masonry have been accurately detected. The behaviour of masonry highly depends on the construction technique and this is shown from the section layout. In fact, the outer face frequently does not reveal how the masonry section is built since apparently similar facing textures (e.g. regular bonding) may correspond to different types of sections, as one or multiple wythes (Hendry [8]). A systematic study of the mechanical behaviour of stonework masonry begins from an extensive investigation taking into account the different layers constituting the wall and the kind of constraints which may or may not exist between the layers themselves. From the analysis of this information, constitutive laws for modelling the masonry behaviour and for designing possible repair interventions (e.g. injection of grout) can be selected. Input data for the structural analysis with numerical methods are the section survey and the type of connection between the layers. These features can also be taken into account when modelling the in-plane or out of plane failure mechanisms.

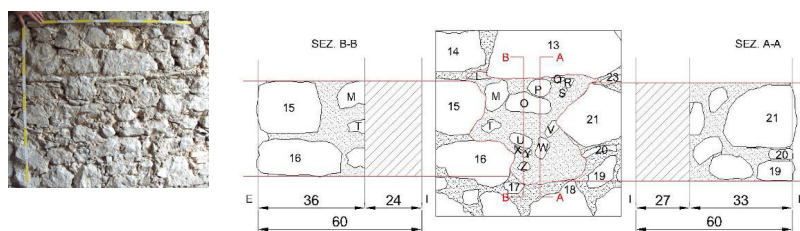
Figure 5: Three-leaf masonry section on block 39 in Ovidio Street.

Most of the historical buildings in Sulmona turn out to be characterized by three leaf stonework masonry (fig. 5). Considering the masonry textures on the wall facades, they mainly consist of disordered rubble stone rubble (according to

table 11.D.1 of the Italian Seismic Code 3431/2005 [9]), always of calcareous nature, with friable mortar. The observed textures are generally made of irregular and sub-horizontal courses, in few cases of regular ones, and with unfinished or partially finished stone blocks. The stone interlocking on the outer face is generally low or very low, in few cases medium. In general the masonry quality, evaluated by visual inspection, turns out to be scarce. On some of these buildings, also a second template aimed to the “Typological and seismic damage survey of buildings” and the evaluation of their vulnerability was applied. Both Templates had been set up within the framework of the Italian Network of University Laboratory of Seismic Engineering (ReLUIS).

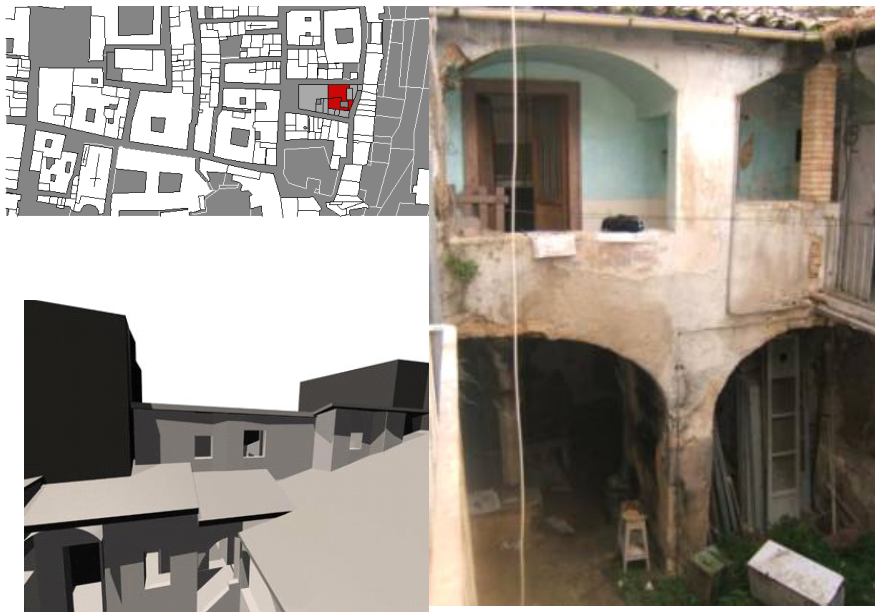
Figure 6: Location and views of block 69 in Acuti Street.

Aggregates of historical buildings have generally been subjected to the addition of several volumes in different times, and the possible discontinuities between the different volumes could affect the overall seismic behaviour. In fig. 6 block 69 in Acuti Street is shown as an example. Its volume was apparently rather simple when looked from the outside, whereas required to be subdivided into three macro-elements once surveyed in more detail (figs. 7-9). For a reliable interpretation of the signs of damage, the preliminary in-situ survey, useful to obtain details on the geometry of the structures, identifying irregularities like vertical deviations, rotations, etc. needed complementary indication coming from the investigation of the historical evolution of the structure in its complexity (fig. 10).

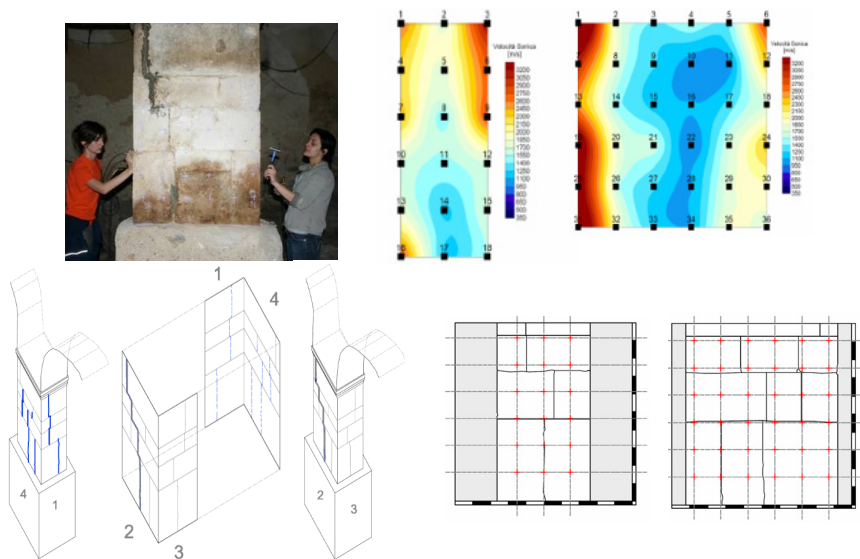
Figure 11: Sonic characterization and study of the crack pattern of a pillar at ground floor of block 69.

In fig. 11 the results of sonic tests on a pillar rising at ground floor of block 69 are reported. It is interesting to observe the agreement between the distribution of sonic velocity, with higher values corresponding to the outer portions of the pillar and lower values at mid span, and the crack pattern, showing cracks running where the lower velocity has been recorded.

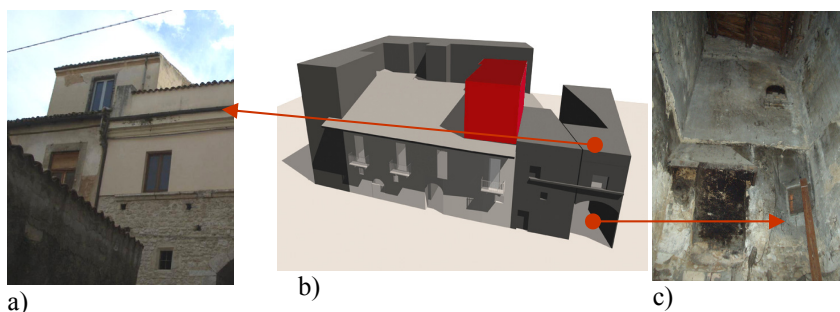
Figure 12: Weaknesses in block 69: standing out body (a); lack of floor (c).

After in situ and laboratory characterization and a 3D evaluation of the crack pattern, the main weakness characteristics towards the building seismic response were singled out. In fig. 12 the presence of a standing out body and a room with the lack of the floor are indicated as an example.

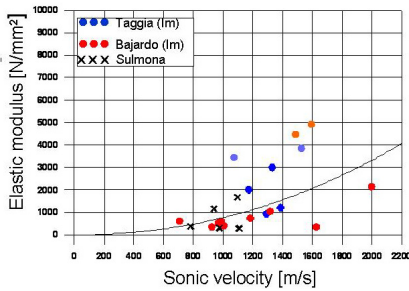
Figure 16: Relationship between E measured through double flat jack test and sonic velocity.

walls presented no connections. Results of sonic and flat jack characterization of a wall located in the more recent part of the complex are reported in figs. 15 and 16. The results of in situ testing gave a confirmation of what was observed by visual inspection. The masonry quality resulted generally scarce, characterized by low values of sonic velocity; in some cases flat jack tests encountered difficulties to be applied, and indicated very high values of both vertical and horizontal displacements.

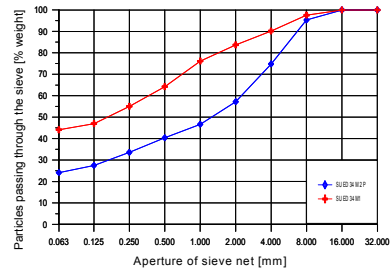
Figure 17: Grain size distribution of mortar aggregates.

The mortars were submitted to chemical and physical analyses. The binder was separated from the aggregate by thermal attack and the grain size distribution was measured as shown in fig. 17. Since the aggregate was mainly calcareous, it was not possible to determine the binder/aggregate ratio

chemically. Most of the mortars were similar, with the binder being hydrated lime. The stones belonged to several litho types but limestone was the most frequent one.
