Structural consolidation of the Apostle Santiago's church in Jerez de la Frontera (Cádiz, Spain)

E. Rodríguez-Mayorga, E. Yanes & A. Sáez

*Department of Continuum Mechanics and Structural Analysis,
University of Sevilla, Spain*

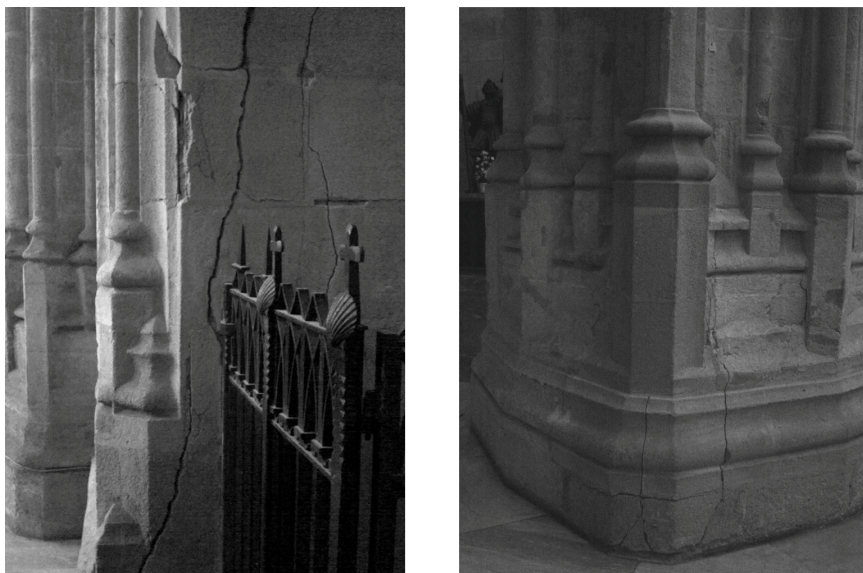
In 2004 the structure showed new symptoms of structural problems. These symptoms mainly affected the area around the baptismal chapel and column number 5 (fig 2). This fact led to the closure of the temple in 2005.

Figure 2: Damage on the walls of the Baptismal chapel (left) and on the basement of column 5 (right).

The proposed solution is to inject all the piers (except for pier 1) and the most damaged walls (fig 6). In this way the mechanical properties of those structural elements will be improved and a more homogeneous stiffness distribution in the structure will result.

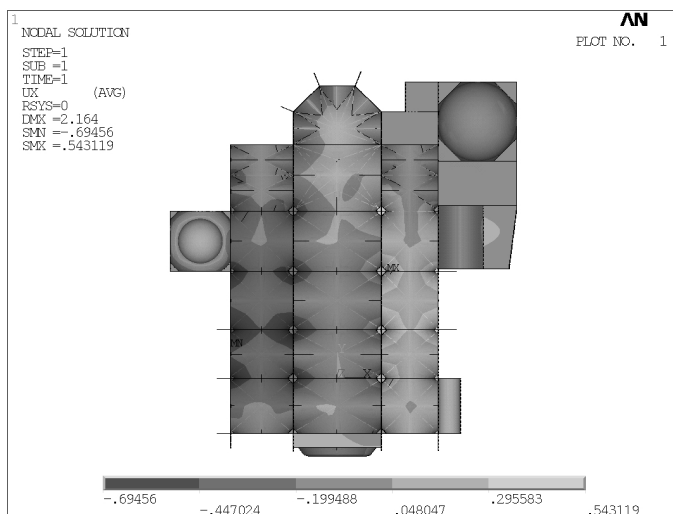
Figure 4 shows the displacements obtained along X axis (normal to the naves) in plan. Due to the irregular geometry of the church (fig 1), the structure presents asymmetric displacements, with a movement towards the Gospel-nave side, as expected.

Figure 4: Displacements along X axis (mm)

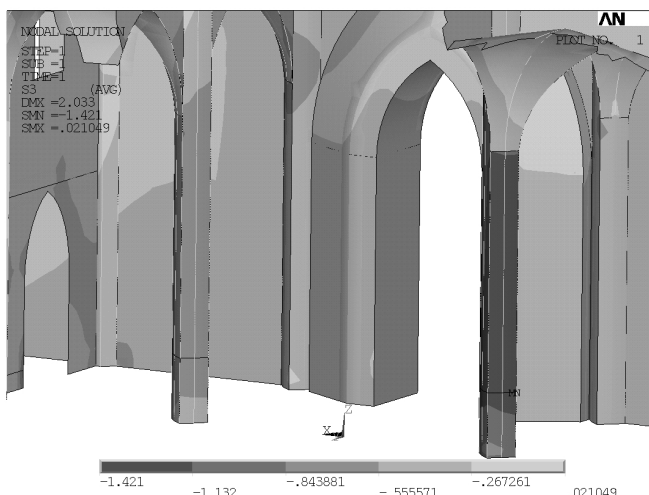
The distribution of compressive stresses (fig 5) is also asymmetric, with significantly different values at piers in both sides of the church. These values are different too among different piers according to their stiffnesses. Compressive stresses values are larger in piers number 1 and number 6. The rest of the piers show smaller values, but the resistance of the stone is lower too.

Figure 5: Compressive principal stresses in Baptismal Chapel and piers 5 and 1 (N/mm^2).

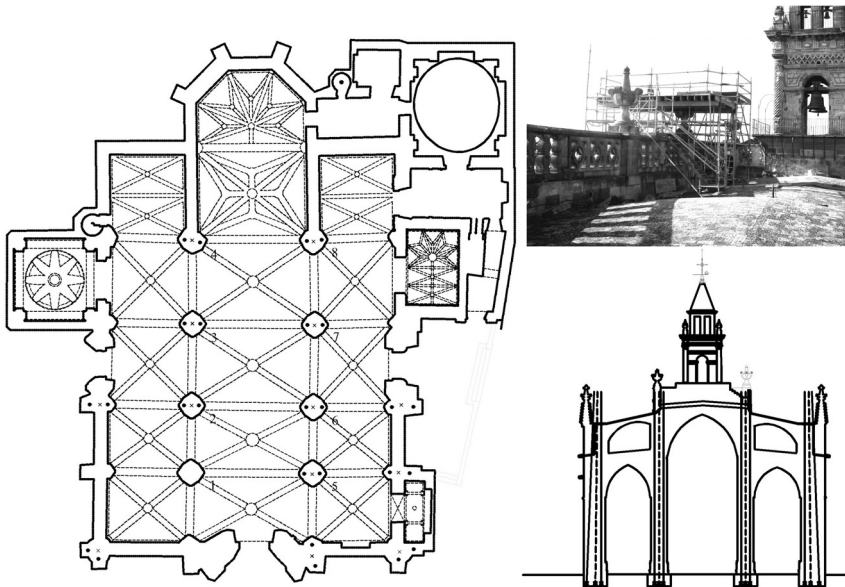
Figure 6: Scheme of injection placement; scaffold board prepared for beginning the works and scheme of vertical injections.

The injections to consolidate the core of the piers and some walls will be vertical, along the whole element, and there will be three of them in each pier, except for the column number 1 (fig 6). With this second phase of the consolidation, the mechanical properties of pier 1 are expected to be achieved.

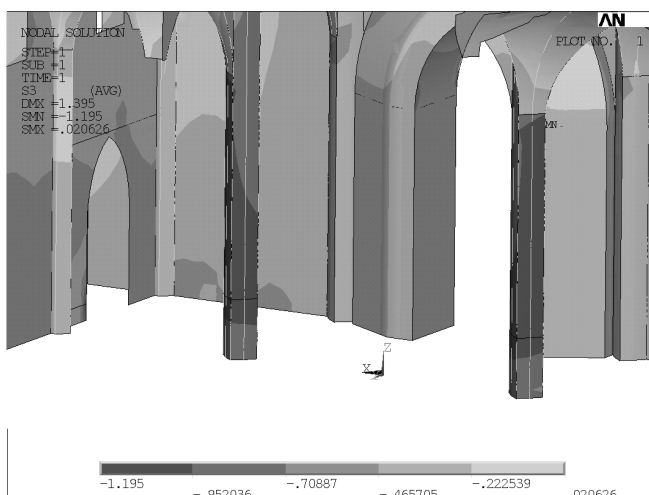
In fact, in considering the F. E. model that the material properties coincide with those of pier 1, a more homogeneous stress distribution will be obtained, as fig. 7 shows. In this situation, all piers would have a similar behaviour and acceptable safety coefficients (table 2), for compressive resistance of 3.62 N/mm^2 . The stress distribution and deformed shape would not be totally symmetrical because of the irregular geometry, but the values of the maximum stresses would have only a 5% of deviation, smaller than the 20% observed before.

Figure 7: Compressive principal stresses in Baptismal Chapel and piers 5 and 1 after consolidation (N/mm^2).

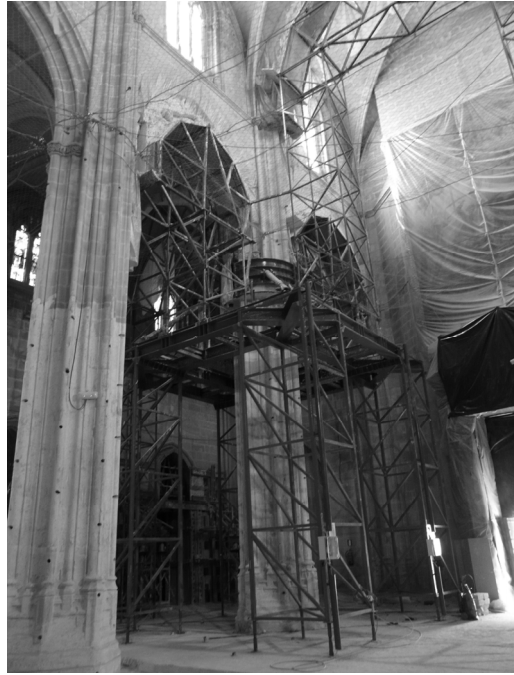
Figure 8: Scaffoldings designed to discharge the piers.

The initial step was the placement of scaffoldings to discharge the piers (fig 8). To place these elements, consolidation of the soil was necessary because of its low resistance. This was achieved by injection of a mixture of cement, bentonite and water.

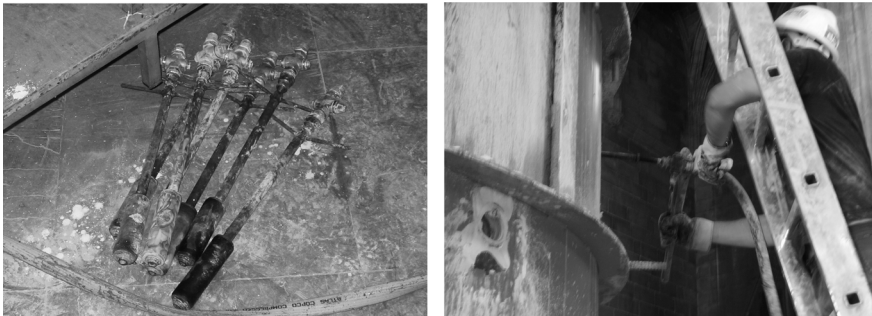
Figure 9: Valves and process of injection with the steel encasement.

Previous to the injection an exterior steel encasement filled with plaster was placed for avoiding lateral expansion of the piers (fig 9). Only the six lowest meters of each pier were injected. For this, a matrix of holes in alternate placements was drilled (fig 8).

After the exterior injection was finished, new values of the stone properties were taken. After this part of the reinforcement, about the 80% of the aimed final value is achieved (table 3).
