Unintended consequences: cathedral arch distress due to roof integration

M. Farmer & F. Peters

Wiss, Janney, Elstner Associates, Inc., Virginia, USA

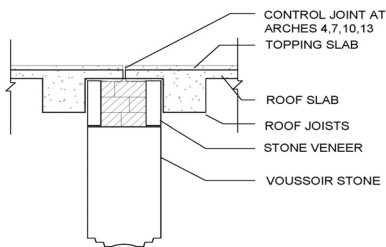
Figure 5: Typical masonry arch construction. The control joint is present in the roof structure but not the arch.

Arch No.'s 4, 7, 10 and 13 coincide with the locations of control joints within the concrete roof structure identified on the original construction drawings. There are no provisions within the stone masonry of the arch to accommodate the control joints. The control joints were presumably incorporated in the concrete roof structure to accommodate movement due to plastic drying shrinkage and volume changes resulting from thermal cycles, as well as to separate the concrete placements. Plastic drying shrinkage occurs early in the life of a concrete structure, as the concrete cures and changes from its plastic, flowable state to its eventual rigid state. The material volume decreases proportionally to its dimensions as water within the concrete is used for hydration of the cement and the remainder evaporates from the material. The exact amount of shrinkage undergone by a concrete structure is a function of several factors, including the cement content, the water/cement ratio, method of curing, and its normalized moisture content. Dimension change due to shrinkage can be as much as 1/8 inch in 20 feet [1]; the distance between expansion joints in the roof structure is approximately 63 feet. If the concrete is unable to slide across the supporting arch, then this displacement is imparted to the arch masonry.

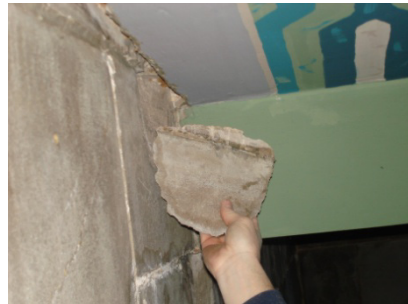
Figure 6: Typical spall and limestone damage observed and removed from the arches.

Scaffolding was then erected to visually examine at close range the arch from which the limestone fragment fell (Arch No. 10). Manual sounding of all arch units and Ultra-sonic Pulse Velocity (UPV) testing of several selected representative arch stones was also performed to assess their integrity. All existing distress, previous repairs, and details of the arch interface with the concrete roof structure were documented. Damage in the form of chips, spalls, and insipient spalls, as well as previous repairs were found. Several loose and unstable fragments were removed from Arch No. 10 to better assess its as-built condition and limit future risk of stone instability (fig. 6).

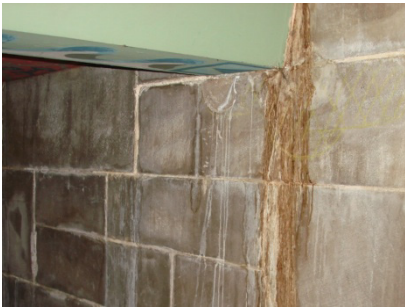
damage similar to that observed at Arch No. 10 was also found at Arch Nos 4, 7, and 13. The other arches appeared to be in good condition with little or no stone damage. Much of the damage and repairs were located at or adjacent to the purlins where they were bearing on the arches (fig. 7). Repairs included fragments re-attached with metal pins and structural adhesive (fig. 8). Dutchman repairs (replacement of the outer face of the stone cut to fit the dimensions of the deteriorated stone) were also evident, primarily at the ridge and intermediate purlin bearing areas. Of great concern was the depth of stone damage at these bearing points; if the bearing stones were damaged to a depth that reduced the bearing area for the purlins to unsafe limits, then structural modifications to the arches or the roof structure would be required.

Figure 7: Typical damage associated with the purlin bearing on the arches.

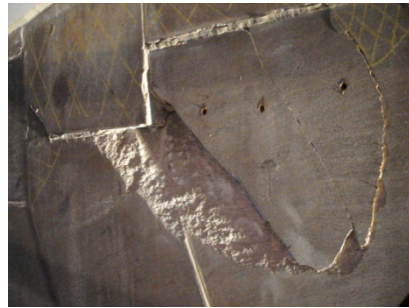
Figure 8: Several stone fragments were reattached using resin adhesive and brass pins.

The repairs conducted at that time included removal of some unstable fragments, as well as application of structural adhesive and metal dowels to re-attach other stone fragments.

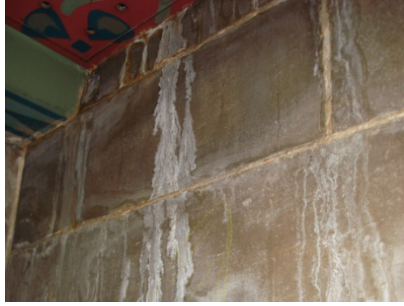
UPV testing and manual sounding determined that there are several stones that were depicted as solid on the original architectural drawings were actually only a 6 inch thick veneer placed over the structural clay tile infill. It also confirmed that numerous arch stones were cracked behind the surface of the veneer, though there was no visual evidence of cracking. There was also evidence of substantial water infiltration including efflorescence at joints and staining. Water staining was predominantly located at Arch Nos 4, 7, 10, and 13, below the flat section of roofing between the edge and intermediate purlins (fig. 9).

Figure 9: Staining and efflorescence visible on Arches 4, 7, 10, and 13 indicative of water infiltration from above.

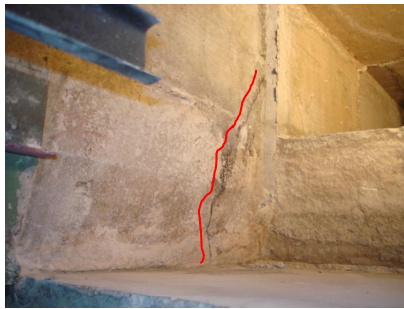
Figure 10: Cracking in the purlin ends at the bearing, compromising their shear load capacity.

When the stone masonry adjacent to the purlins was removed, it was discovered that the ends of several were cracked due to restraint and a lack of reinforcement continuity (fig. 10). The cracking reduced the purlin's effective bearing area. The end damage was most severe at the ridge purlins where, combined with the reduced bearing surface resulting from previous bearing stone damage, the remaining effective bearing area was deemed insufficient to safely support the ridge purlins. This necessitated major modifications of the concrete roof structure to increase the ridge purlin bearing area.

Due to the damage observed at the concrete ridge purlins and the limestone bearing below, major structural repairs were required to assure adequate load transfer from the ridge purlin to the arch. Supplemental haunches were designed and installed that expanded the bearing area to engage more of the stone below. The haunches were constructed to engage the concrete joist adjacent to the arches through tensioned rods (grouted after tensioning). A steel plate on the interior of the joints was required to fully develop the tensile loads required. The haunch bearing surface includes Teflon coated bearing plates mounted in the haunch and on the stone below to provide a virtually frictionless bearing condition (fig. 11). It was determined that installation of the haunches would be most efficiently accomplished by removing the section of the concrete roof slab over the arches and the infill material above the keystone. This material was removed above the arch on both sides of the ridge purlin ends down to the keystone itself (fig. 12). Since the keystone was originally notched to serve as a form for the concrete ridge purlin, the surface of the keystone adjacent to the purlins was lowered to the purlin bearing plane. This provided for greater haunch depth. If the original bearing area or the ridge purlin became further
