## **Non destructive investigation for historic documentation and construction qualification of monumental buildings: the case of S. Gregory Church in Bari, South Italy**

M. De Fino, F. Fatiguso, A. Scioti & G. De Tommasi

*Department of Civil, Environmental, Territory, Building Engineering and of Chemistry, Polytechnic of Bari, Italy*

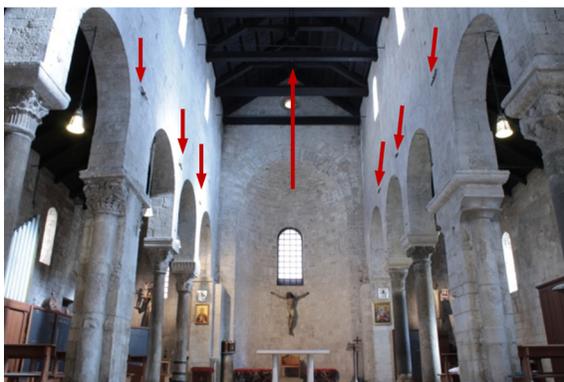
The first restoration phase from 1938 was needed because of the severe decay of the church. Specifically, the drift of the cross vaults on the north and south facades, the missing mutual connections of the masonries and the poor consistency of the inner part of all the cavity walls had caused a diffuse damage pattern: deformations of the facades toward the outside, vertical cracks in the corners, vertical cracks in the transversal section of the openings. In order to deal with the occurring rotation, some interventions were carried out: cross vaults were replaced by wooden trusses to eliminate the drift, most stone blocks at the corners were replaced to improve the connections and some metallic elements were used to tie the north and south facades. Those interventions are still visible in the church (fig. 4). Moreover, on that occasion, some complementary works concerned the realization of a drainage system under the flooring and the elimination of all Baroque decors and ornaments.

Figure 4: Interior of S. Gregory Church showing the wooden trusses and the metallic ties above the pillars and columns.

The second restoration phase from 1960 was needed because of the damages caused during the Second World War and worsened by the explosion of the ship Henderson in the harbor of Bari in 1945. Particularly, nine wooden trusses were collapsed and replaced. Moreover, the masonry pillars showed vertical cracks due to upper compression loads and, thus, consolidated by reinforcement bars and epoxy resin later in the 70s.

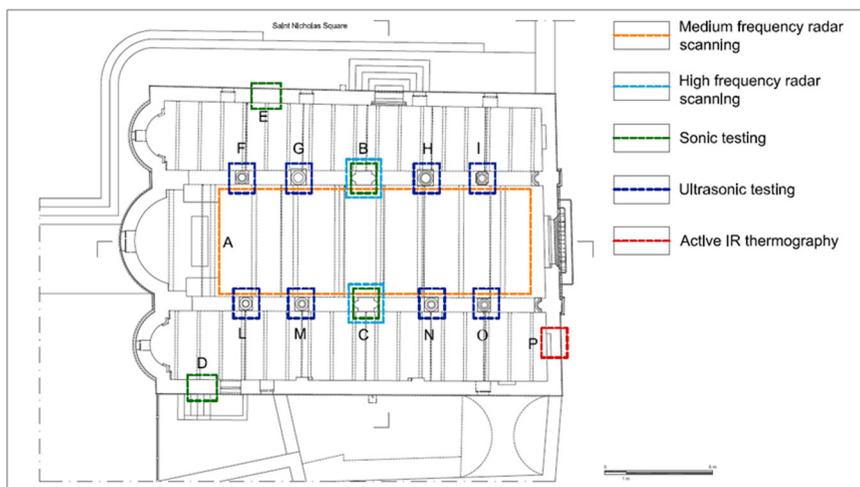
Figure 5: Plan of investigation tests.

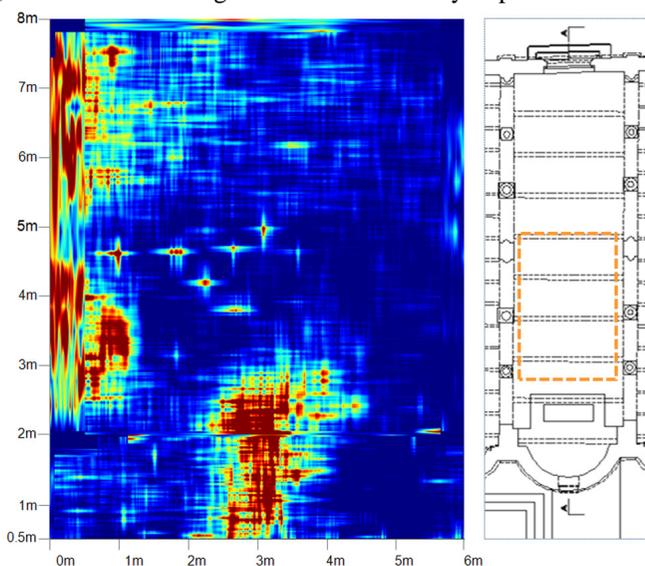
The radar tomography on the flooring steadily showed the intersection of the rhombus tiles under the surface, while some areas at different response could be clearly detected from 15cm till 65cm in depth, at the west side of the altar and at the south border of the central part of the nave (fig. 6). Those areas, whose reflection is higher than the average, might eventually correspond to underground cavities, with quite regular shape. The church site was certainly used in the past as graveyard, as testified by the eleven inscriptions on the south façade. Even though the burial of members of noble families generally took place outside the place of worship, it is plausible that small chanel houses were located inside. On the contrary, the presence of underground walls, belonging to previous construction phases, seems to be more doubtful, because the depth of those areas is quite limited and the expected response would have been a lower reflection, thus a higher attenuation, compared to the surroundings. However, the investigation provided valuable information to guide some local destructive tests.

Figure 6: Flooring tomography (30cm depth), showing a structural anomalies.

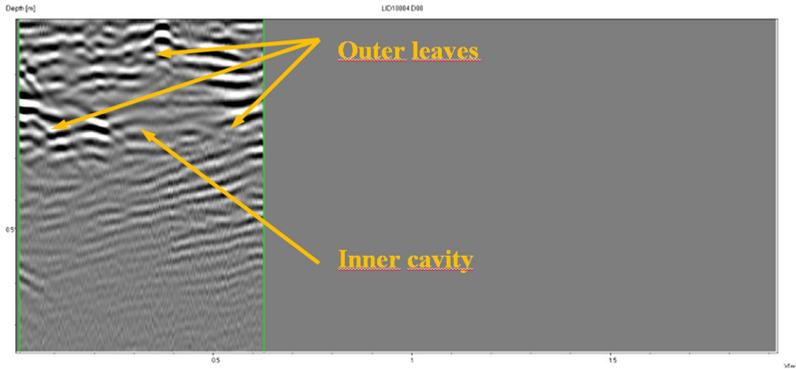
As far as the radar investigation on the pillars is concerned, the 2D radargrams showed the morphology of the structures, composed of stone blocks, 20cm thick, all along the perimeter and an inner cavity (fig. 7). Moreover, the 3D elaboration enabled the identification of the reinforcement work. Specifically, the presence of slightly inclined bars was detected by tomography that goes through half the depth of the pillar (fig. 8). Based on the arrangement of the holes, as detected by visual inspection and magnetometer testing on the four sides (fig. 9), it was assumed that those bars create a tridimensional grid within the pillar, whose tensile strength has been eventually improved.

Figure 7: Radargram of pillar C showing the construction morphology.

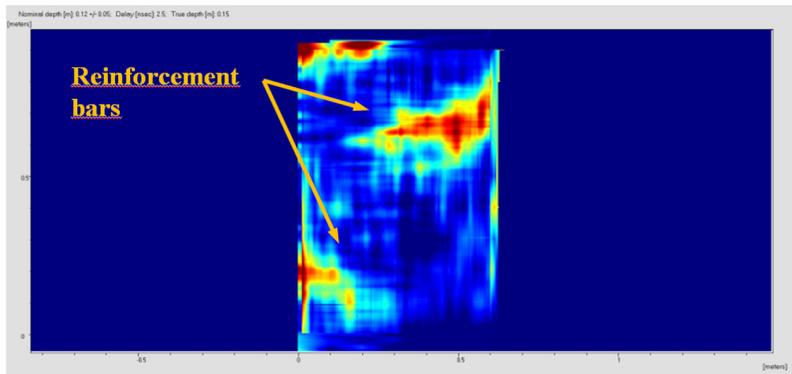
Figure 8: Radar tomography of pillar C showing the reinforcement bars.

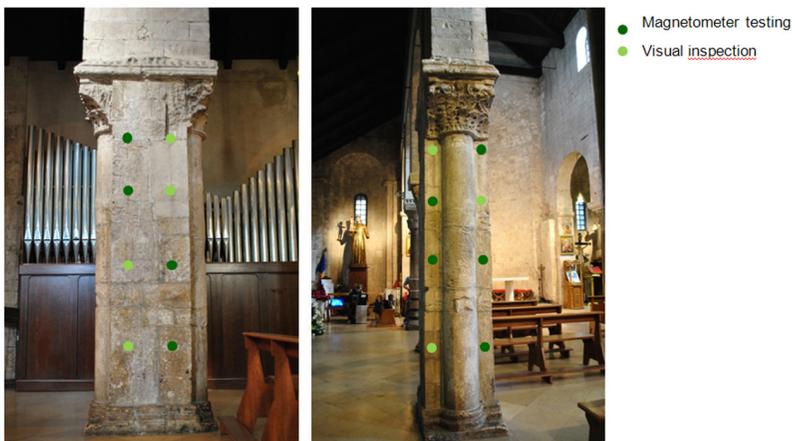
Figure 9: Surface position of reinforcement bars on pillar C.

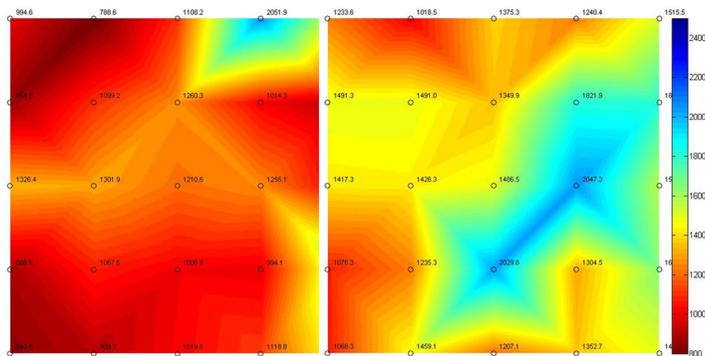
Sonic testing confirmed the previous results. Specifically, measurements showed quite different values: on the pillars, the average velocity was 2112.3 m/s for B and 2470.4 m/s for C (fig. 10), whereas, on the walls, it was 1105.8 m/s for D and 1437 m/s for E (fig. 11). All the data was acquired and elaborated, according to a procedure developed by the authors within a previous work [4]. Thus, it was speculated that all the investigated structures, both pillars and walls, have similar thickness, about 70cm, and similar morphology, comprising two outer leaves and an inner nucleus. As a consequence, the higher velocity response of the pillars was only due to the reinforcement, where the lower velocity response of the walls was connected with the diffuse poor consistency of the cavities, which were reasonably not reinforced when the pillars were. Some local destructive tests could confirm the assumption.

Figure 11: Sonic velocities on walls D and E.

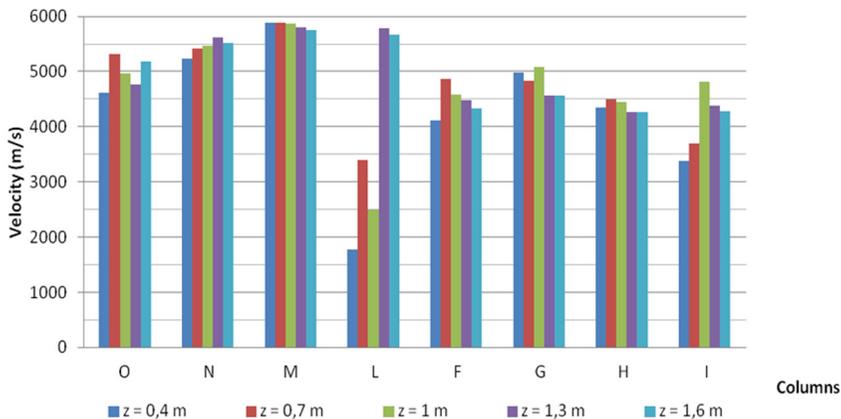
Differently, concerning the ultrasonic testing of all the marble columns, no critical situations were detected. All the velocities were found quite consistent and varied only due to different monolithic materials (fig. 12). As a consequence, the presence of inner discontinuities was ruled out. However, the measurements

Figure 12: Ultrasonic velocities on all the marble columns.

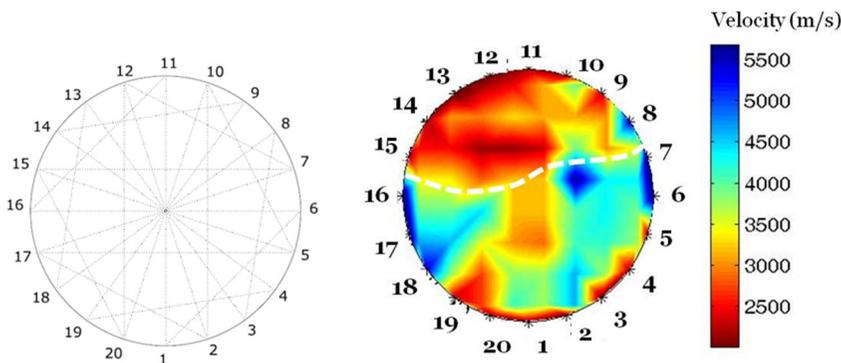
confirmed the damage of column L, whose tomography (fig. 13), showed that the visible cracks, corresponding to points 7 and 16, cross the whole section, creating a fracture surface, marked by white line. Moreover, it should be underlined that the cracking development has exceeded the area tied up by chains. As a consequence, a damage progression compared to the past could be speculated, requiring further assessment by monitoring.

Figure 13: Ultrasonic tomography of column L.

e.g. for the flooring and the cavity walls; monitoring cycles, e.g. for the cracked column; conservation measures, e.g. for thermal protection of the fresco.

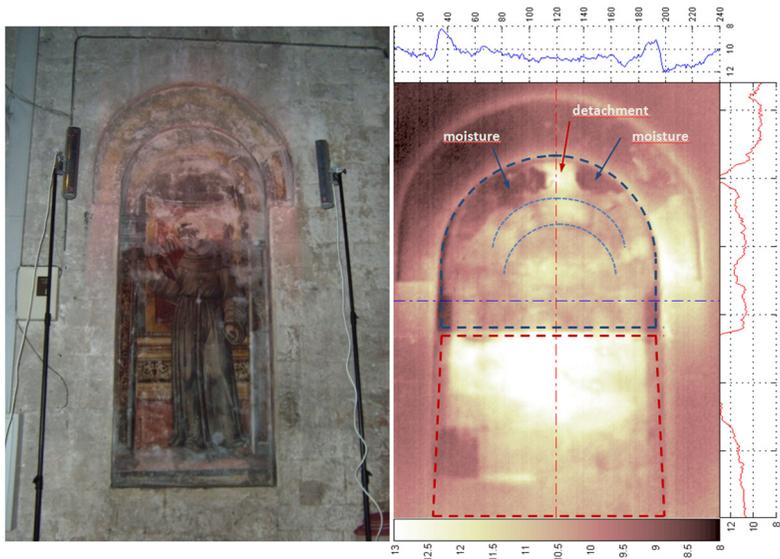
process [1]. The infrared response of the surface showed pretty different behavior between the upper and the lower part of the fresco, as defined by a straight line (fig. 14). In fact, while the upper part quickly dissipated the heat, enhancing the presence of moist areas, the lower part maintained higher temperatures. Thus, it was speculated that the fresco was placed on different supports, showing different thermal properties. Particularly, the upper part was supposed to be less insulating. As a consequence, it might be often cold, causing the air to condensate, especially in winter. The investigation also enabled the identification of an underlying arch and of all the detached parts where the temperature is slightly higher due to air gaps.

Figure 14: Visible and infrared image of the fresco.
