Deterioration of residential buildings in the *Ensanche* of Bilbao

N. Zuazua-Guisasola & L. Etxepare

Architecture Department, University of the Basque Country UPV/EHU, Spain

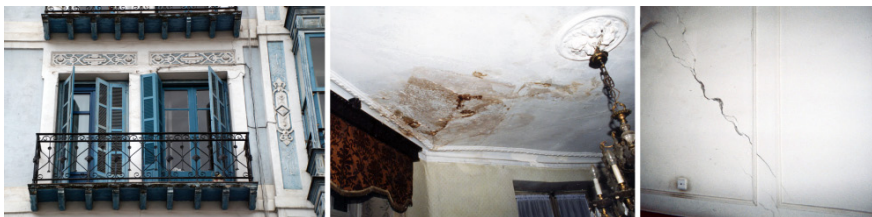
The dampness produced by the filtrations and condensations set on the façades moves into internal timber elements. These pieces, often covered up by decorative materials, cannot breathe and become rotten. Xylophages' insects attack rotten structural elements and damage timber framework, causing strength loss.

Filtrations and condensations are the prevailing problems on façades. Due to its porosity, ashlar stone absorbs rain water easily and the filtrations through it cause efflorescence, erosion and microorganisms.

The movement of ceramic and slate tiles in a two pitches roof is very common. It weakens the waterproof quality of the roof and water get through timber frame. The structural elements become rotten and consequently, structural strength is affected. Fungus, xylophages' insects and mould appear as well.

Figure 4: Some of the damage found in buildings with timber framework.

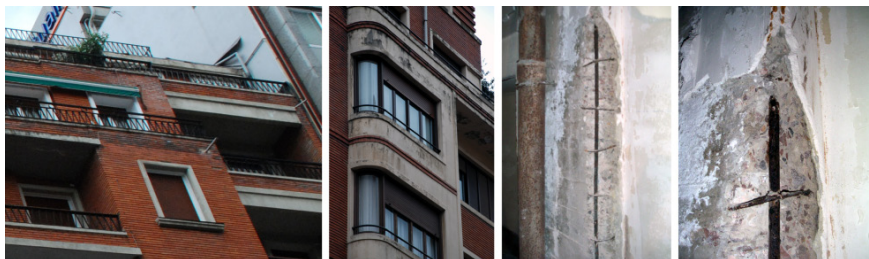
Basements, built without waterproof protection or with ineffective drainage system, have important damp problems. Dampness causes concrete deterioration and consequently oxidation occurs in steel bars. When steel bars get rusty, their volume increases originating tensions within the concrete. Weak concretes cannot stand the tensions and break into pieces, leaving internal surfaces exposed.

Filtrations and condensations cause dampness within the layers forming the façades. Because of this dampness the face cladding becomes detached, making filtration and condensation problem worse and increasing the presence of microorganism.

External thermal conditions also provoke expansion and contraction movements on material composing the envelope of the building. Detachment of cladding occurs and occasionally pieces fall down to the street.

Figure 5: Some of the damage found in buildings with reinforced concrete.
