## Assessment and restoration of a masonry dome in the cathedral of Tortosa enclosure

J. Lluís i Ginovart, A. Costa & G. Fortuny

### Abstract

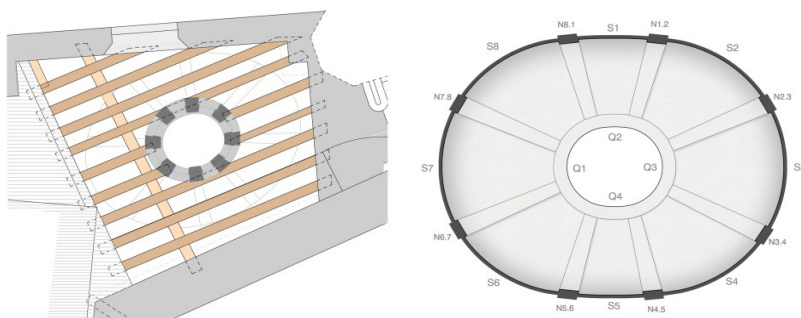
Figure 2: Scheme of the timber structure and nomenclature (aerial view).

had been attacked by termites, loosening the resistant section until it yielded under the weight of the lantern.

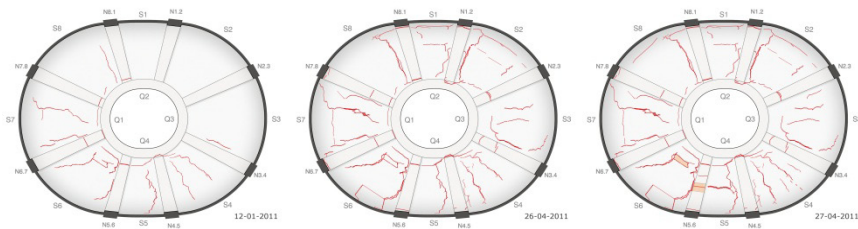
In late April 2011 little ceramic fragments fell over the floor and vertical cracks appeared in the upper half dome. The lantern was preventively underpinned and a scaffold was located to diminish the consequences of an eventual collapse.

The next day, vertical cracks developed fast and also horizontal ones appeared, revealing the start of typical collapse mechanisms in domes. Luckily the structure did not collapse and could be repaired.

Thus, it is deduced that the displacements of the dome were caused by the application of an asymmetric new load on the oculus. Cracking was the consequence of the accommodation process of the masonry to the new solicitations. Meridian cracks appeared at the first place, followed by the radial ones which could cause the collapse of the structure.

Finally, the dome did not fall because the cinematic process underpinning the lantern was stopped. Also, the rubbish of the extrados prevented the formation of the lower meridian cracks, which should have led to the collapse of the dome.

Figure 3: Breaking process of the dome.

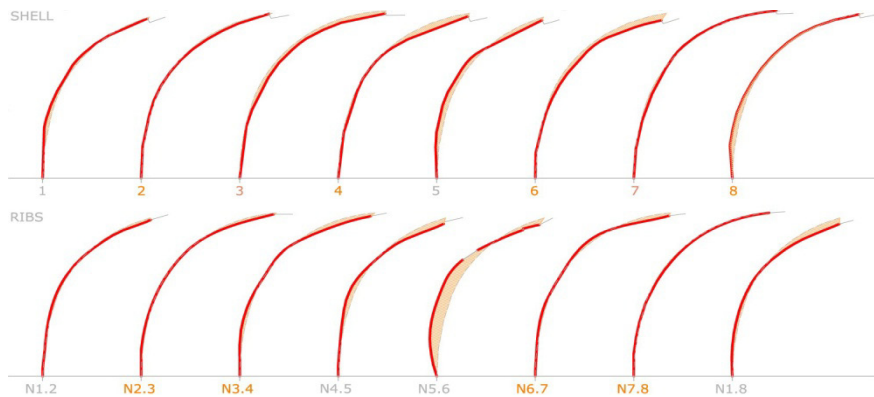
Figure 4: Photogrammetric survey and comparison of displacements.

An assessment is made of the deformations by the comparison of the two models. It revealed that the most deformed shell section was S6, moving down 8cm in the oculus. Also, the shell sections S3, S4 and S6 deformed similarly, but with lower values. The rest of the shell sections presented a horizontal displacement of the central zone, followed by the lowering of the upper part. Section S5 was the most deformed, with a displacement of about 6cm. Concerning the ribs, the most deformed ones were N3.4, N4.5, N5.6 and N6.7. All of them moved the same way: lowering of the upper edge (up to 6 cm) and horizontal displacement to the outside of up to 13cm (N5.6). So, the section S6 and the rib N5.6 were the most affected parts. They are on the same side of where the beam failed and also where an opening was found to access the extrados.

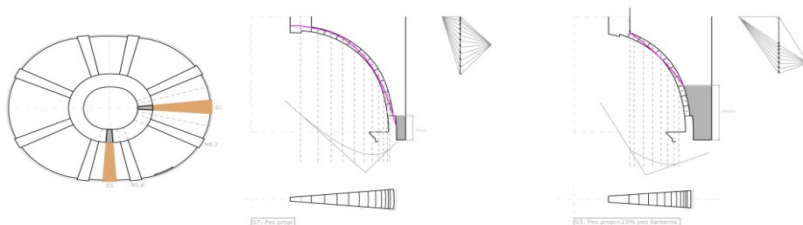
Figure 5: Thrust lines for S7 (H1 own weight) and S5 (H2 25% lantern weight).

The analysis reveals that the geometry of the dome is stable under its own weight, but has a very limited capacity to bear the lantern weight. So the wooden structure must be involved to guarantee the stability of the masonry. This way, a variation of loading conditions easily can cause the deformation of the shell and the formation of cracks. When the beam failed, the dome yielded under the dome weight, and the distribution of stresses changed. Therefore, the dome is no longer stable before reaching the breaking stress of the masonry. Main cracks concentrated near the opening, where the resistant section was weaker, and over the steeper sections.

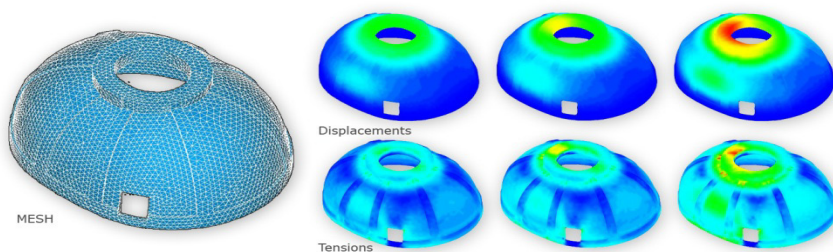
Figure 6: Model mesh and results for the different hypotheses.

Several calculations are performed considering different weights applied over the drum, reproducing the progressive breaking of the beam. The dome could not support the entire weight of the lantern, so all the hypotheses consider gravitational loads that are shared between the wood structure and the dome. A simplification is made considering one single homogeneous material with the following mechanic values: Young Modulus: 5000 N/mm<sup>2</sup>; Poisson: 0'15 [14, 15].

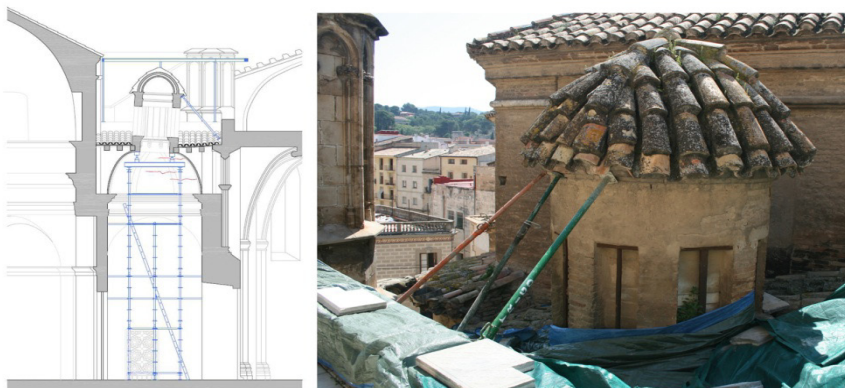
Figure 7: Underpinning of the lantern.

- Underpinning of the lantern: initial emergency shoring to prevent overturning of the lantern.
- Lower underpinning, in order to minimize the effects of an eventual collapse of the dome, and after to place the lower working platform.

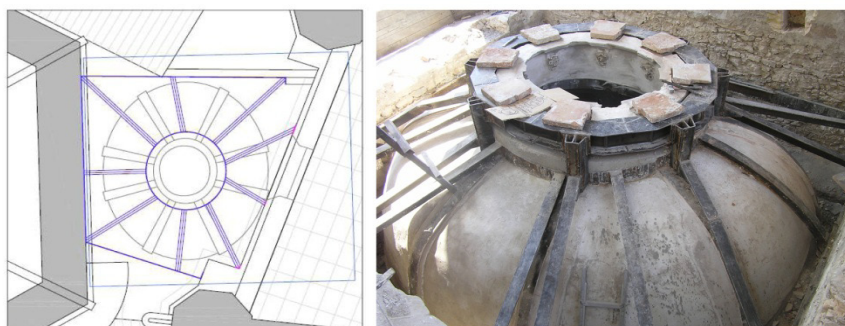
Figure 8: Securing of the oculus with a steel ring.

- Securing of the oculus with a corten steel ring, which after would translate the efforts to the walls through nine steel sections.
- Reinforcement of the ribs by the situation of a laminated steel profile on each one, fixed in the intrados by stainless steel connectors.
- Reparation of shell cracks with *guix i estopa*: the entire extrados are covered with this technique, and also the cracks on the intrados. Several stainless steel connectors are used to guarantee the fixation. A second layer of gypsum is made in both faces to give a smoother finish to the surfaces.

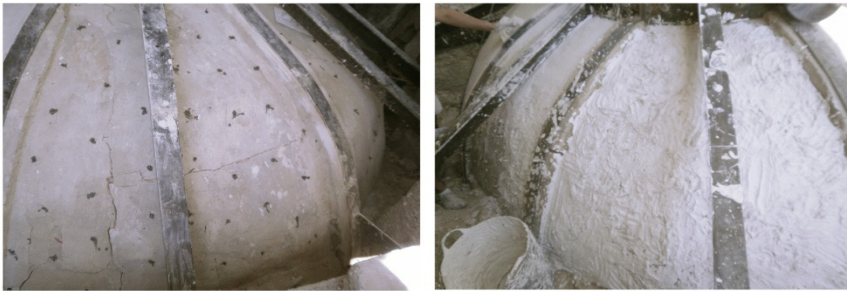
Figure 9: Reinforcement of the dome and its ribs.

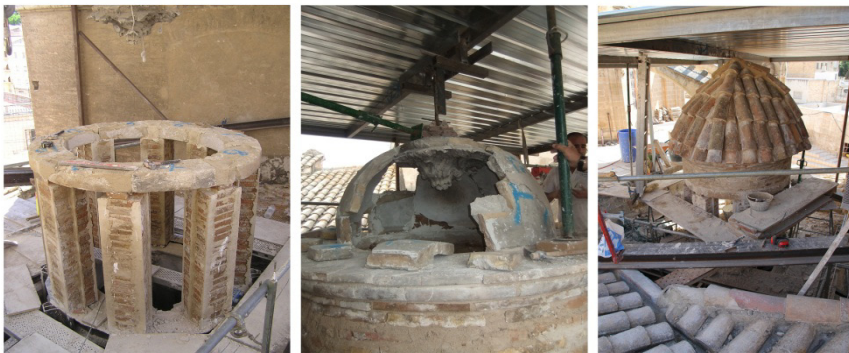
Figure 10: Reconstruction of the lantern.

- New bearing structure for the lantern and roof: a second steel ring is built in order to ensure the stability of both the lantern and the dome, and also to hold the new roof.
- Mounting of the lantern, which is reconstructed as it was built. The ceramic pieces unable to be recovered have been substituted by new ones using the same traditional techniques.
- Construction of the new roof with a thin sheet of reinforced concrete, connected to the perimeter walls and the new steel ring.
- Reconstruction of the elements and finishes: most of the decorative moldings have been saved and reused, preserving the original look of the dome and the lantern. The roofing is finished with artificial stone veneer, similar to the one used in the cathedral roofing, clearly distinguishing the new elements from the historical ones.
