## **Visual assessment of San Antonio Franciscan Mission churches in San Antonio for sustainable cultural heritage tourism**

S. T. Beeson & S. Doganer

*The University of Texas at San Antonio, College of Architecture, USA*

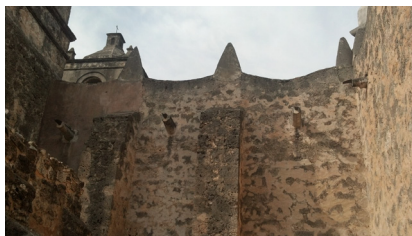
In the visual assessments conducted in the church of the Mission Concepcion, deterioration is the main concern at the outer façade (Figure 1). Deteriorated mortar and honeycombed stones are detected at the bottom parts of the western wall. The stones are deteriorated through the entire length of the northern wall and on the stones surrounding the tower openings.

Figure 1: West façade around the courtyard.

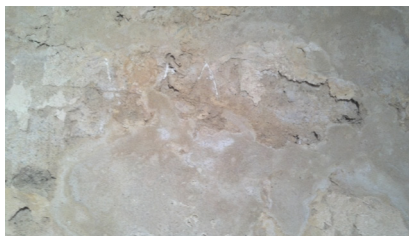
The interior walls of the church show indications of moisture as well. There is rising damp on the southern wall, and peelings on the paints on transept walls (Figure 2). The other parts of the church that were specified as problematic due to moisture were fixed in the last restoration process conducted in 2010. Most of the cracks were also fixed with an exception of those on the ceiling of the transept.

Figure 2: Peelings on the transept walls.

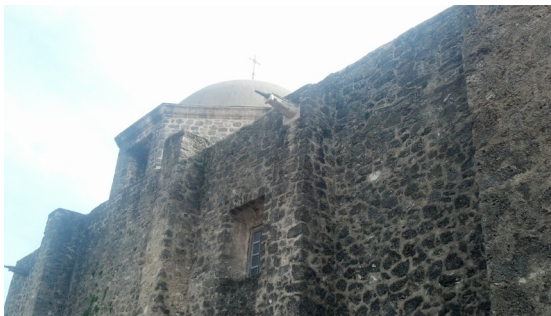
Until the recent restorations, the most serious problems threatening the integrity of the church structure were related to the drainage problem in the mission site. Rising damp around the entire building, honeycombing and deterioration on the stones, deterioration on mortar, and plants growing on the walls were among the problems encountered in and around the building. Today, there are no plants or missing stones on the walls; however, it is possible to see deteriorations on the western and northern façade, which also has a few bad stones (Figure 3).

Figure 3: Deteriorations on the north façade.

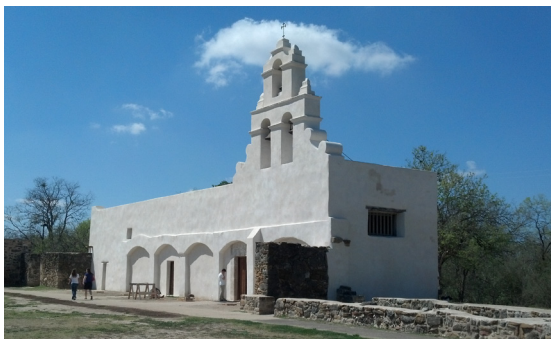
The survey report from the San Antonio Missions National Historical Park shows significant cracks on the eastern and western outer walls of the church [9]. Today these cracks do not exist anymore. However, it is suggested to monitor the church for further cracks to rule out any possible issues due to foundation settlement after the last works carried out in 2012. The outer walls are completely plastered; hence it is not possible to observe any deterioration on the masonry units or mortar (Figure 4). There are thin cracks on the interior walls, which could be seen as plaster cracks regarding their width. The platform installed on the northern end of the church is not causing extra load on the church walls, as it is not supported by them; however, it is fixed on the tiles of the church.

Figure 4: San Juan Mission Church.

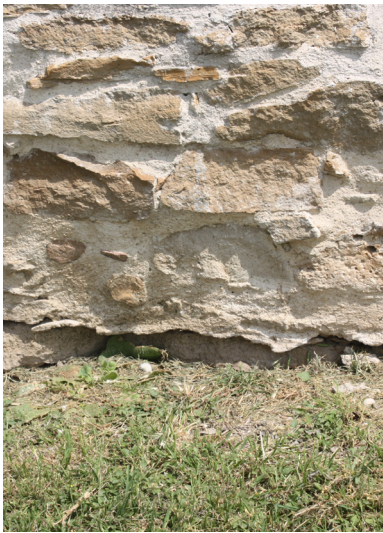
Today, the church building remains intact. Material loss, mortar in particular, is detected on the west outer façade (Figure 5). Cracks, though patched, are visible on the eastern and northern façade (Figure 6). Especially the cracks on the northern façade are critical and they threaten the structural integrity of the building. Though it is possible to spot them on the walls as well, they mostly originate at the top of the arched openings and proceed in both linear and angular directions.

Figure 5: Material loss on the west façade.

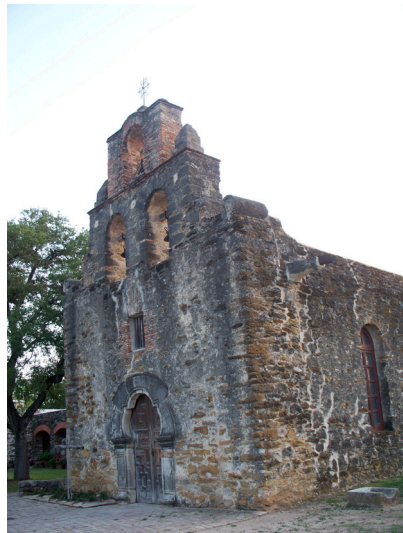
Figure 6: Cracks on the north and east façades.
