Heritage architecture from the *Colonización Antioqueña*: the case of the Santamaría Theater

J. C. Ochoa & H. H. Carvajal

*Department of Construction, School of Architecture,
Universidad Nacional de Colombia, Colombia*

2 Restoration of the Santamaría Theater in Jericó (Antioquia): stage one

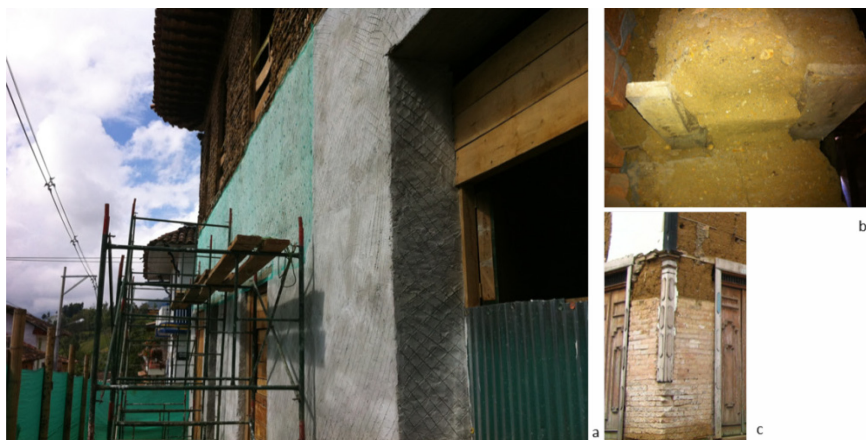
Figure 3: The rammed earth wall.

The theater's perimeter building has a structural system made of rammed earth load-bearing walls on the first floor and wattle and daub walls on the second, both of which are the object of study of this paper. The plaster had started to come away from the majority of these walls, and as a result they have suffered erosion, as is the case with the rammed earth walls, as well as wood decay in the wattle and daub walls.

Generally rammed earth walls show surface erosion through lack of plaster and prolonged exposure to the elements. In order to replace the surface the rammed earth wall was strengthened. This strengthening consists of restoring the original thickness of the wall with a material that is more durable and compatible than that which is currently being used. In this particular case the corners and the places for the doors and windows were strengthened using pieces of brick stuck to the rammed earth wall, which were then plastered, as can be seen in Fig. 3(c).

A mixture of lime and sand was used as plaster. The selection criterion was based on the need for a mortar on the first floor capable of resisting splashes of water and anthropic aggression. For the first layer the mixture was prepared using a ratio of 1:3; 1 part fat lime to 3 parts standard sand, and then using river sand for plaster in the second layer. The first layer of approximately 2cm was applied to the surface, which had been scratched to improve adhesion. The second layer was then applied using a wooden trowel. When required, a plastic mesh with an aperture of 1x1cm was inserted between the two layers to improve adhesion, for example, between the wooden lintels and the wall, and between the mezzanine and the walls, as can be seen in Fig. 3(a).

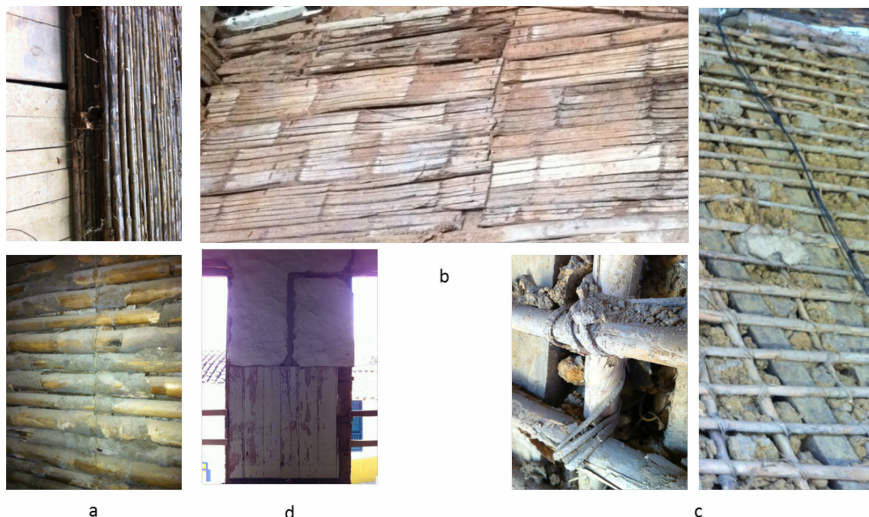
Figure 4: Types of wattle and daub walls.

Wattle and daub is a mixture of earth and plants. It is characterized in Antioquia by the use of earth, collected from the region itself, as well as the combination of woods such as reeds, Guadua (both in the form of round sticks or as a matting), sawn wood and, occasionally, metal. The theater's wattle and daub walls are formed by an internal structure or frame and made from sawn wood. Two vertical structures, or right feet, two horizontal structures, or *soleras*, the uppermost of which is also called a *carrera*, as well as a brace, which is known as a *diagonal* make up the frame. This frame serves as a support for the wooden beams, of which there are many different types within the theater: giant reeds laid either horizontally or vertically with no space between them, bound together and without fill (see Fig. 4(a)), Guadua matting nailed to the frame without fill, (see Fig. 4(b)), giant reeds bound in a horizontal position with a space of approximately 10cm between them and with earth filling between the two faces (see Fig. 4(c)); similarly there were wooden boards nailed to the frame unfilled or protecting the surface of a filled wall (see Fig. 4 (d)) . Without a doubt these different types of wattle and daub walls correspond to different construction or intervention periods.

For the intervention in the second-floor walls, all of which were made of *wattle and daub*, a wooden frame was used, which was then plastered with manure (cow or horse manure) while aiming to preserve the same feel of the theater. The following are the proportions that were used: 6 jars of clean manure, $1\frac{3}{4}$ jars of soil, 7 handfuls of Portland cement and 5 handfuls of lime. The mixing process is traditional to the area and involves: 1) trampling the manure and the soil four times and leaving it to rest for one day; 2) adding the cement, sprinkling it over the mixture, then trampling again; 3) adding the lime, trampling again, then readying it for application.
