## **The evolution of Late Medieval Seigniorial Residences in the Basque Country: analysis of a Pre-Renaissance Palace: the Guevara Palace in Segura (Gipuzkoa, Spain)**

D. Luengas-Carreño, M. Crespo de Antonio & S. Sánchez-Beitia  
*Higher Technical School of Architecture, UPV/EHU, Spain*

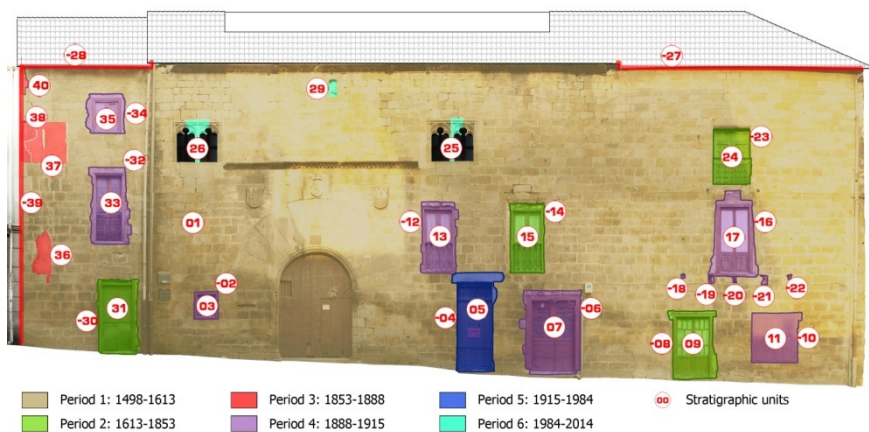
Figure 2: Stratigraphic study of the main façade.

The original main walls of the building were made in sandstone ashlars, which were distinguished by their great thickness and bounding (fig. 2). The original walls have discontinuities in the southern part of the building (left side of fig. 3) and some of interior rooms conserve their original round arched doorways.

Thermal imaging camera revealed the bounding of a significant number of plaster covered walls and architectural elements. The research discovered an ogee-headed arrowslit in the ground floor (fig. 2, stratigraphic unit 36), remains of three double trefoiled windows in the main floor (fig. 2, stratigraphic units 24 and 37), a small ogee-headed window at the top of the main façade (fig. 2, stratigraphic unit 29), and four round arched doors in the rooms (fig. 3).

The most relevant remains of this period are the cuts produced by the demolition of the side towers (fig. 2, stratigraphic units 39, 27 and 28). During this refurbishing work, a double trefoiled window and an ogee-headed arrowslit were bricked up (fig. 2, stratigraphic units 36 and 37). In the southern part, a new poor masonry rear facade and dividing wall were built (fig. 3).

During the refurbishment of the central subdivision, some brick walls were erected to create new rooms (fig. 3). Additionally, two double trefoiled windows and a small ogee-headed window were repaired (fig. 2, units 25, 26 and 29).

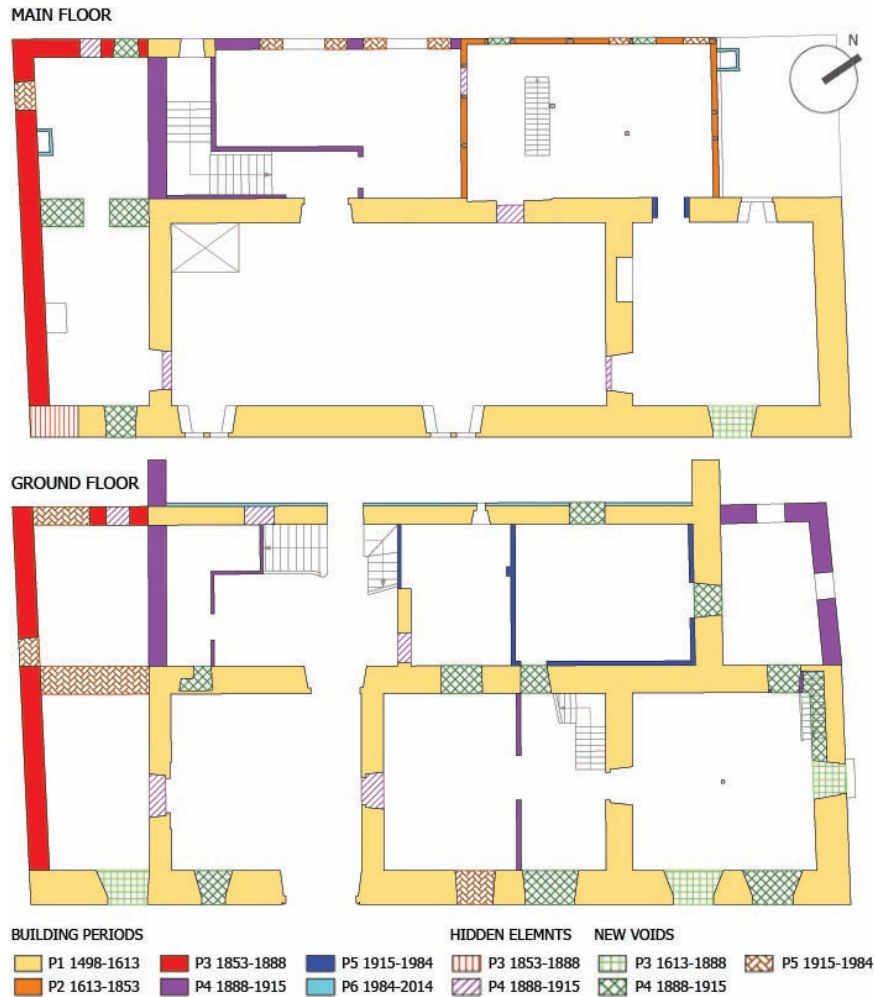
Figure 3: Building periods of the main and ground floors.

As mentioned in the previous analysis, the Guevara family abandoned the palace in the early sixteenth, and it was rented to peasant families, who used it as an inn. The renters raised new walls and built more rooms both in the mezzanine and in the main floor (right side of fig. 3), needing to open new windows in the main façade (fig. 2, stratigraphic units 9, 15, 24 and 31). In addition, timber framing enclosure was built in the northern part of the rear façade, which replaced a previous one destroyed in a fire, as evidenced by remnants in the adjacent walls.

In this building period not many changes were made. In the back area, three new brick walls were raised to build a new kitchen. In the southern subdivision, new voids were opened in the dividing wall, a masonry inner wall was demolished and some windows were bricked up (fig. 3).

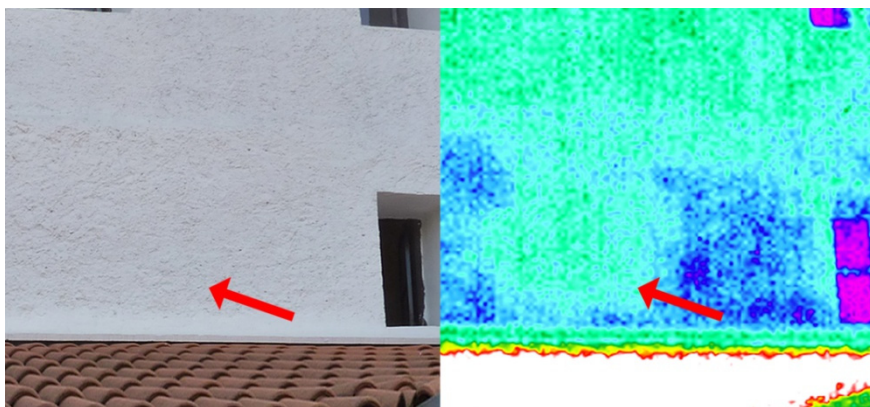
Figure 4: Hidden window in the rear façade.

The thermal imaging camera revealed a significant number of hidden architectural elements, such as rear façade windows (fig. 4), which appear in the drawings of 1888. Additionally, this camera was used to distinguish between the paste covered original and not original walls, owing to the difference of emissivity of the materials of both types of walls.

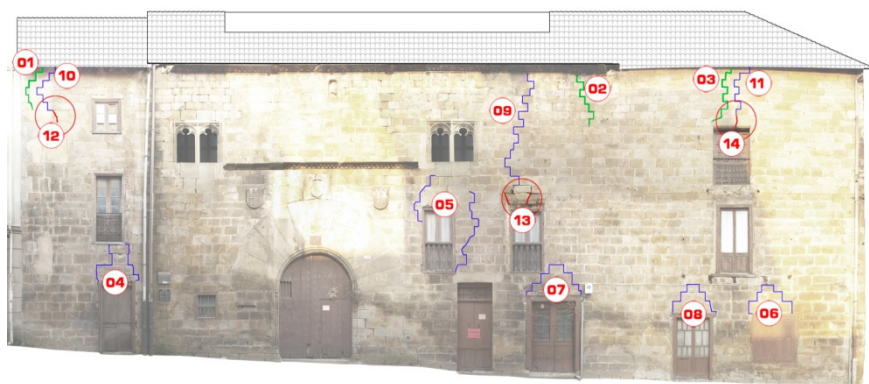
Figure 5: Cracks in the main façade.

The structural pathologies analysis revealed three large width cracks at the top of the main façade (fig. 5, units 1–3). The research determined that these cracks were stable and they did not pose a risk to the stability of the building. In this sense, the analysis of these elements established that the cause of these cracks was the great weight of the demolished side towers and their improper design (the primitive Tower Houses had thicker walls and they were structurally more stable than new ones). The study also disclosed seven small width cracks. Most of them were generated when new voids were opened, forming discharging arcs caused by the wrong dimensioning of the lintels of windows and doors (fig. 5, units 4–8). The other cracks were caused by the rupture of three original window lintels (fig. 5, units 9–11), also due to the weight of the towers.

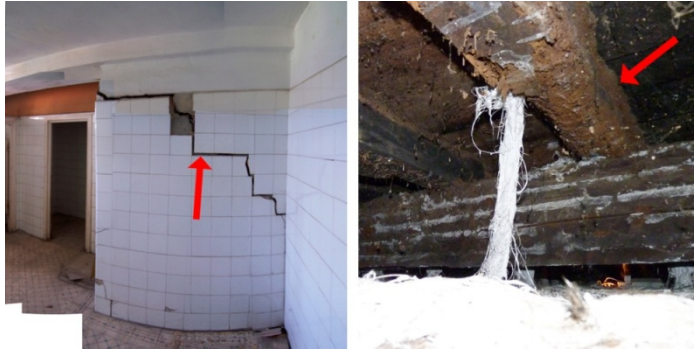
Figure 6: Crack in the toilets of the mezzanine and a woodworm damaged beam.

In the inner rooms, a large width crack highlighted in the toilets of mezzanine (fig. 6). The analysis revealed that this damage was located in the original stairwell hole. During the subdivision works of 1888, this hole was covered using non-structural panels (wooden doors), causing a great deformation and displacement of the floor.

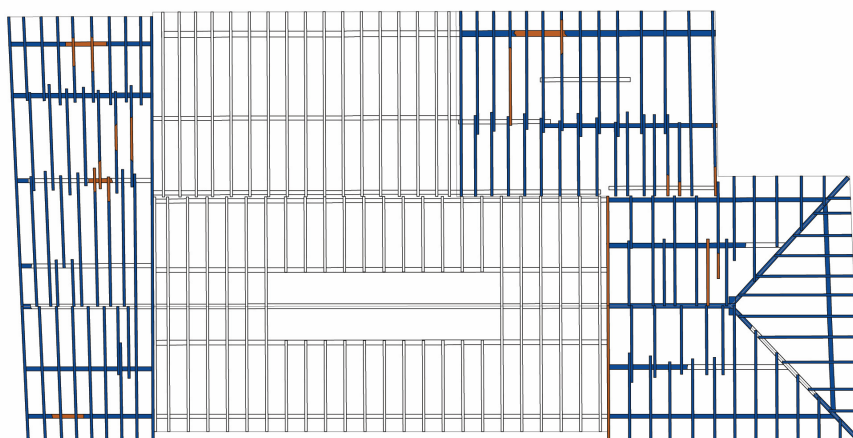
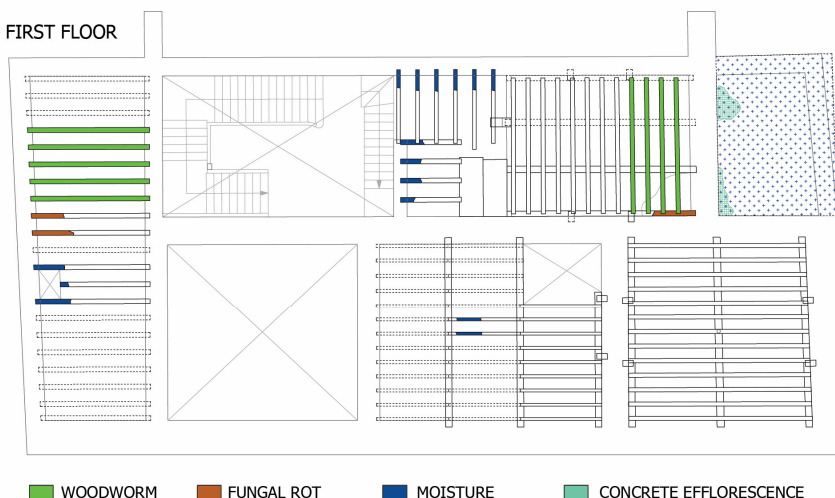
Figure 7: Pathologies of the structure.

The thermal imaging camera was used to provide an overall view of moisture of the palace. The southern roof was the most affected area by this pathology, owing to the lack of waterproofing. This also caused the appearance of woodworm and fungal rot in timber elements of the three floors in this subdivision (fig. 7). Other areas affected by moisture were the northern roof and the basement, in which the timber structure began to collapse partially. Furthermore, the analysis revealed that four timber beams of the kitchen were seriously damaged by Anobiidae (fig. 6). In the annexed construction, moisture also caused the appearance of efflorescence on the concrete roof (fig. 7, right top side of the first floor).

The research was also appropriate for the assessment of the state of preservation of the building. In this sense, the structural pathologies analysis revealed that the southern subdivision was the worst preserved area, being greatly affected by moisture, fungal rot and woodworm in its three floors and roof. The central subdivision was the best conserved area, owing to the refurbished work of 1994, in which the timber structure was strengthened and the roof was changed. In the northern subdivision, the most severe damage was located in the main floor, where water infiltration and misguided repairs were harming the timber structure. In the kitchen roof were discovered four timber beams affected by woodworm (Anobiidae).
