Knowledge and qualification of three ancient masonry churches in Pomarico, Italy

In this paper the analyses and qualifications of the three ancient masonry churches in Pomarico (Italy) are presented. The obtained on-site results of non-destructive tests and the restorations interventions are illustrated and compared among them.

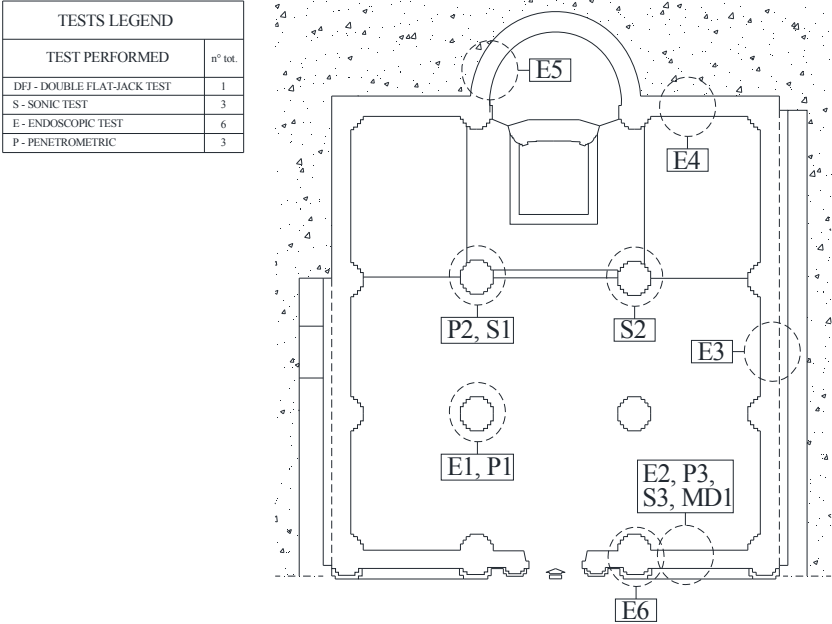
inspections, sonic tests, single and double flat-jack tests, and penetrometric tests. The total test planning performed is reported in Figure 1 with the identification of each test. Whereas, in Figure 2 is reported a detail of the masonry unit investigated with the double flat-jack test here discussed and the arrangement of the measurement equipment.

Figure 1: Test planning of the *Madonna del Carmine* church in Pomarico.

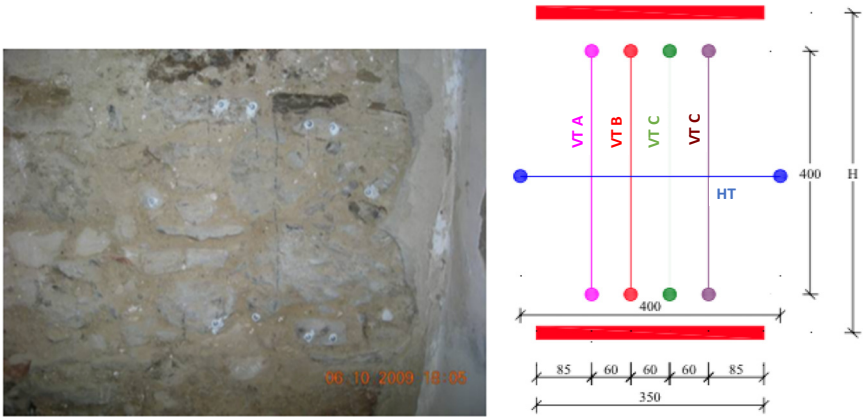
Figure 2: Details of the masonry texture investigated with the double flat-jack test and arrangement of measurement equipment.

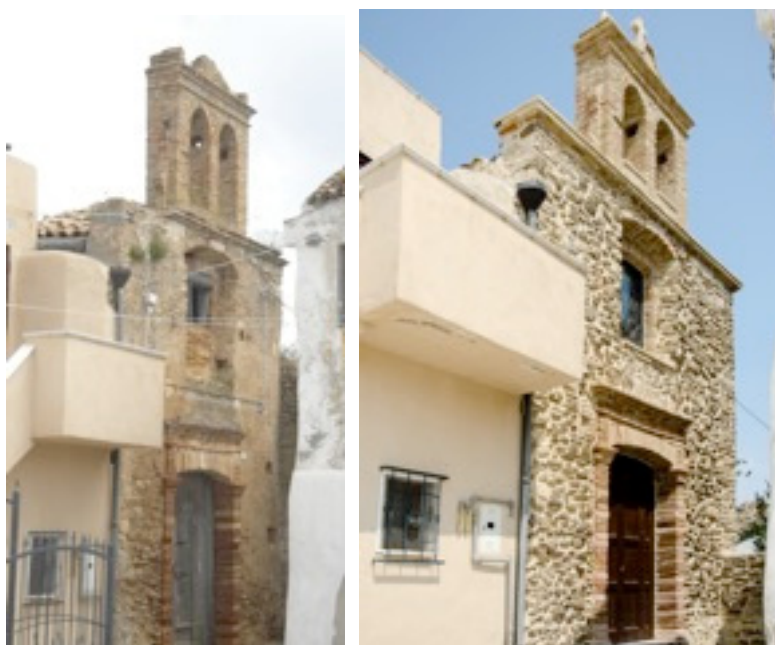
Figure 3: The church of *Pio Monte dei Morti* before (left) and after (right) recovery intervention.

Regarding the lateral sides, the right one is close to a private garden, while the opposite one (left side) was on a private building that was built added to the church. The behind side shows a significant crack (in the vertical guideline); it is in an area heavily tampered, with two closed windows and a central ones, largest than the other but equally closed using brick. So, the masonry has modified several times the geometry of the loads (and of the formal type as well); it has reduced its resistance and load bearing capacity. The roof, as said before, consists of a barrel vault (nave) and a cross vault (presbytery) whose buttress was realized using topsoil (according to the local construction system) to form an inclined plane on which were placed the brick tiles to form the roof.

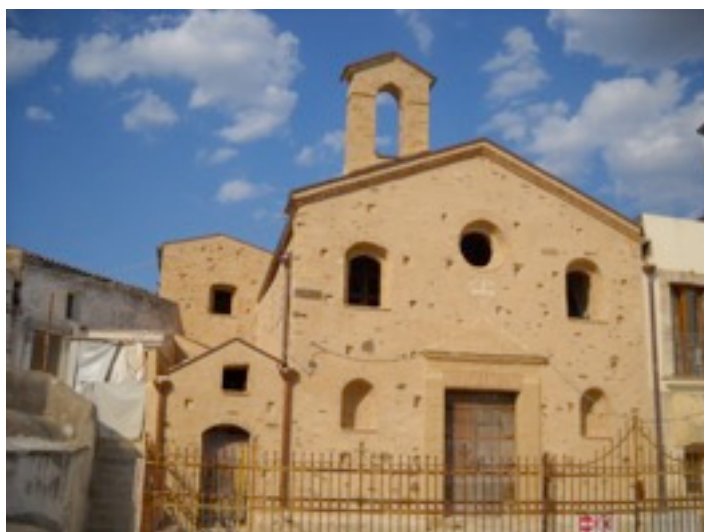
The church (Figure 4) has a very important pathological condition that affects all the part and elements of the building. In fact, because of the total disconnection of the brick tiles on the roof and of the absence of a system for the draining of

Figure 4: The church of *San Rocco*.

meteoric water, the vaults and the walls have undergone a process of pathological aging rather accelerated. To the above said reasons it is added the age of the material and technological elements, the very irregular form of the masonry, the topsoil on the buttress of the vault (that saturated with the meteoric water increasing its volume and weight); it is clear that the structure of the cover was set to undergo a collapse by crushing, generating a damage state extremely evident. The same situation characterizes the load-bearing masonry with evident crack produced by crushing.

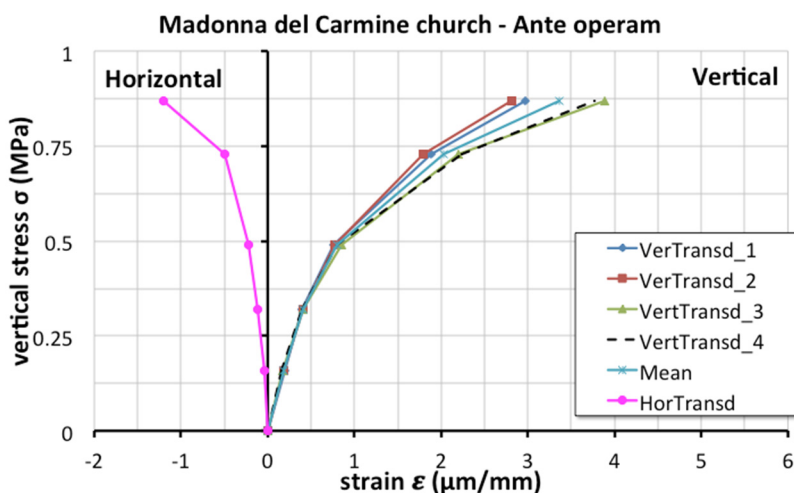
The results of the double flat-jack test obtained for the masonry of the *Madonna del Carmine* church is depicted in Figure 5. The test was carried out placing one horizontal and four vertical displacement transducers with a measurement length of 400 mm. To date is not yet available the result of the double flat-jack test re-performed on the same masonry specimen after the grout injection.

Figure 5: *Madonna del Carmine* double flat-jack test. Vertical stress in the masonry versus vertical and horizontal strain.

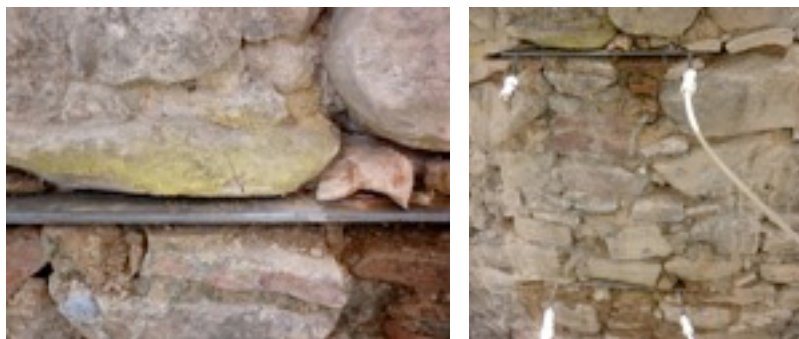
Figure 6: Double flat-jack test and masonry characterization.

In the case of *Pio Monte dei Morti* and *San Rocco* churches the double flat-jack test was repeated two times on the same masonry specimen. At first the masonry specimen investigated (Figure 6) was tested *as built* (*ante-operam* condition). Afterwards, in both the churches a diffused intervention of consolidation with grout injections was performed for repairing and strengthening the masonry of the walls. It was used a lime grout injected with a low pressure (2.5 atm) with a density of 50 kg per square meter.

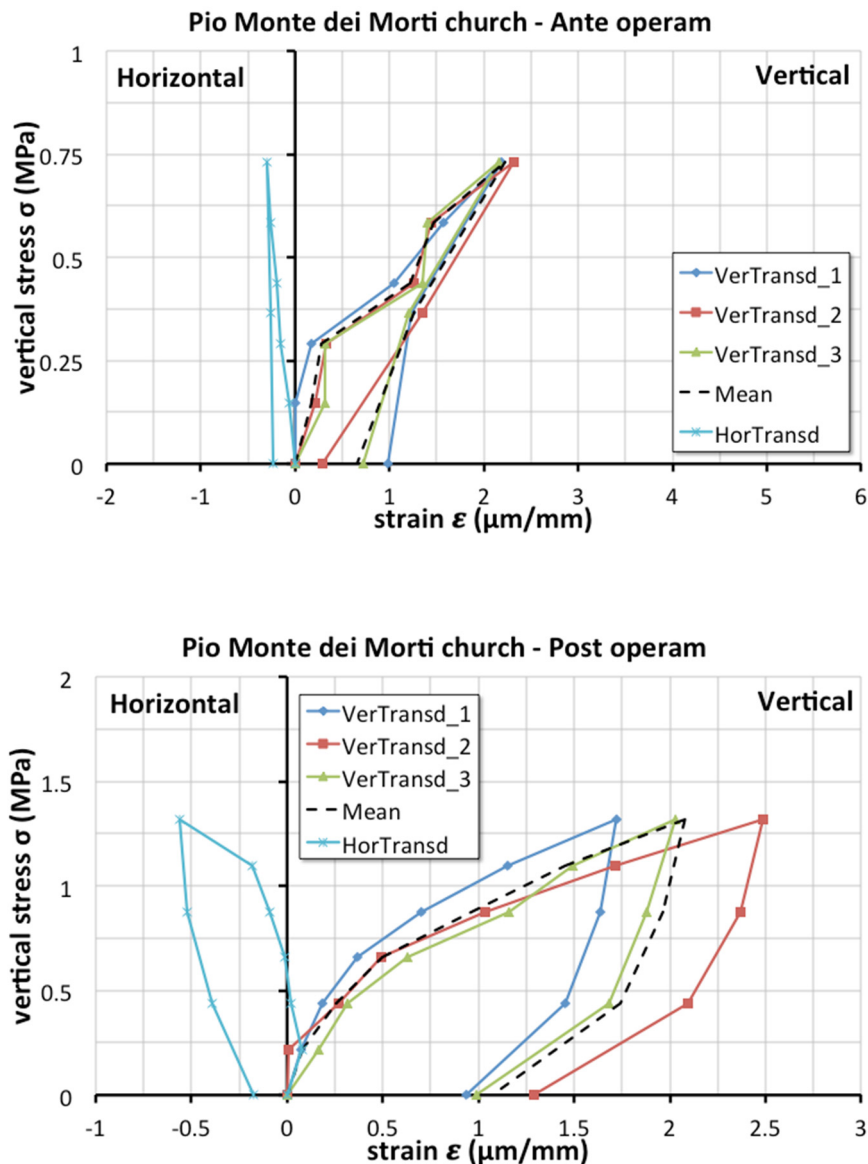
The tests were performed placing one horizontal and three vertical displacement transducers with a measurement length of 300 mm. In Figure 7 and Figure 8 the derived relationships between the vertical stress in the masonry and the horizontal (on the left) and vertical (on the right) strain are plotted. In each figure the mean stress-strain curve (dashed line) obtained from the curves related to each vertical displacement transducer is also reported.

Figure 7: *Pio dei Morti* double flat-jack test. Vertical stress in the masonry versus vertical and horizontal strain ante-operam and with grout injection.

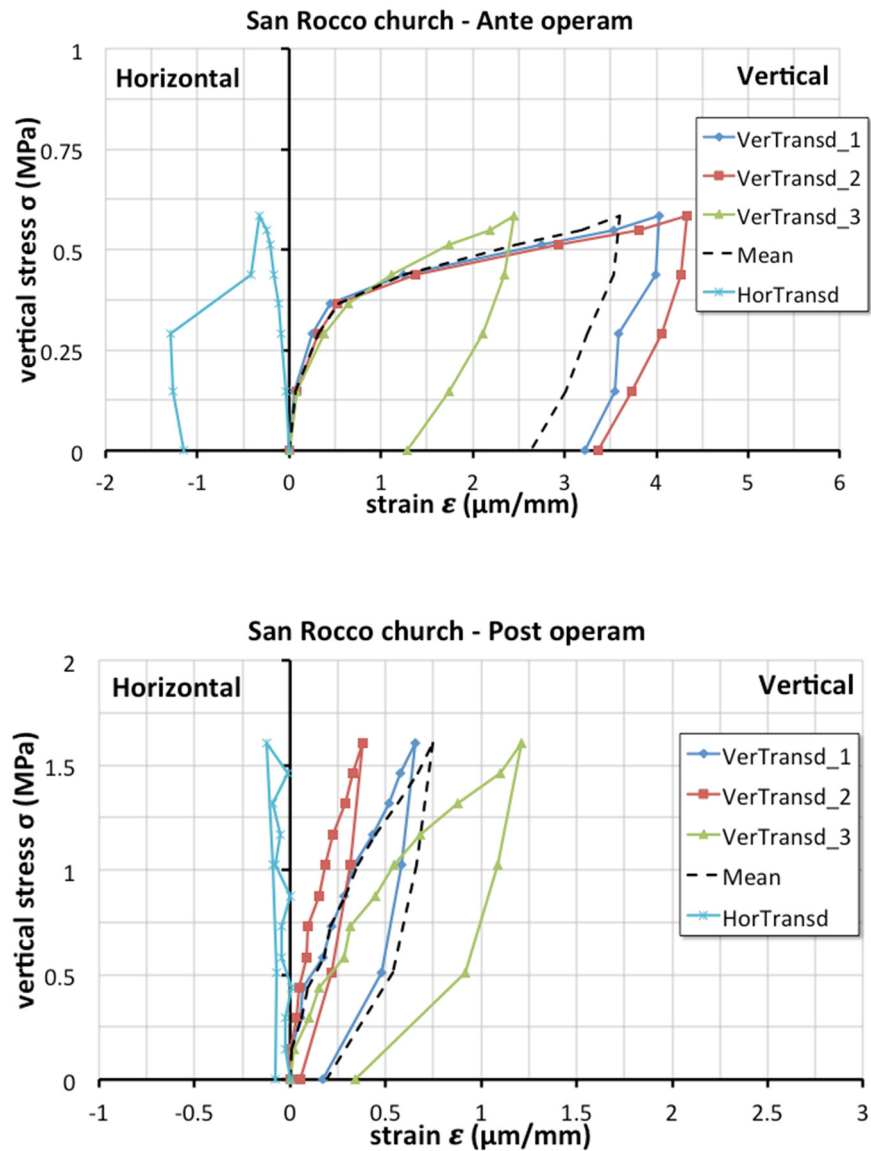
Figure 8: *San Rocco* double flat-jack test. Vertical stress in the masonry versus vertical and horizontal strain ante-operam and with grout injection.

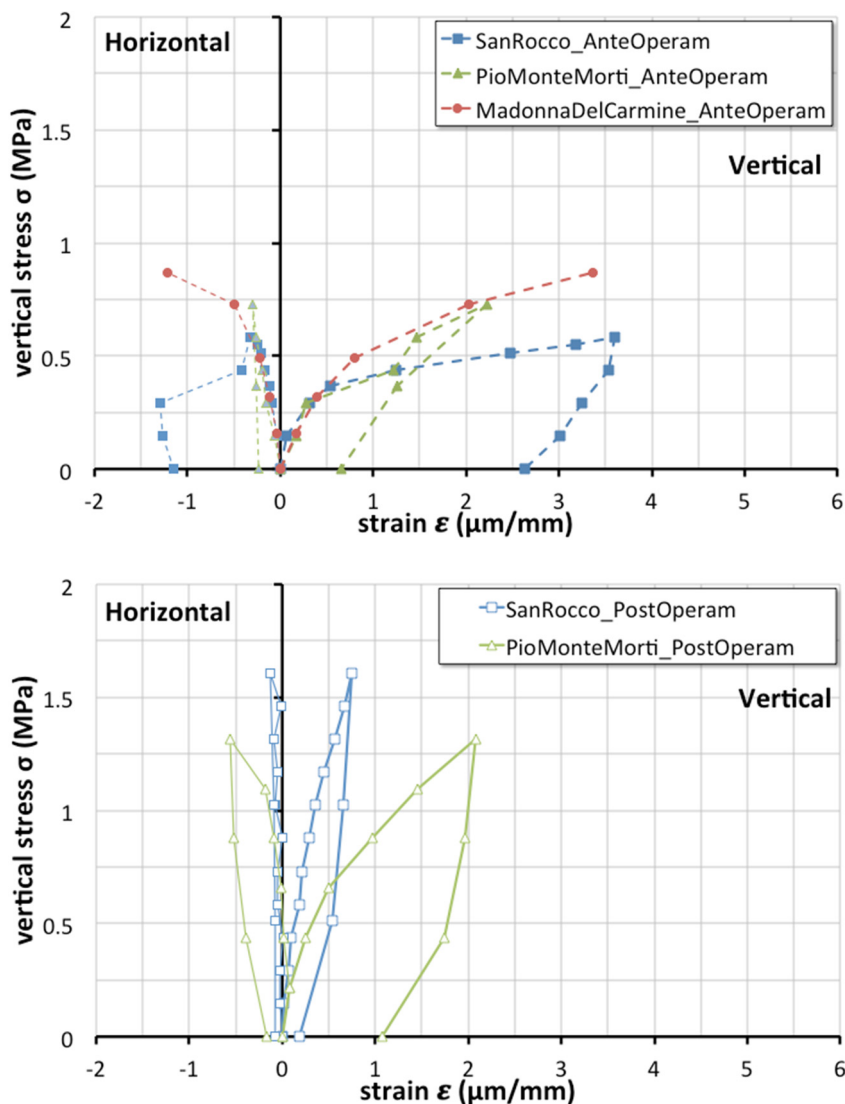
The comparisons highlight that the grout injections produce a significant improvement of strength and stiffness of the masonry investigated. In fact, in the cases analysed grout injection permits of increasing the peak strength more than 200% (in the case of *San Rocco* church). It's worth noting that this intervention does not modify the elements aspects and increases the masonry durability since fills its cracks, voids and cavities within the material matrix. Moreover, the injections tend to uniform the quality and the mechanical properties of masonry all over the bearing elements on which is applied.

In the cases analysed the double flat jack test provides, for masonry with stone of irregular size and poor mortar, a compressive strength ranged between 0.58 MPa and 0.87 MPa. For the same masonry typology, for example, the Italian code [12] indicates instead a range of compressive strength of 1.00–1.80 MPa.

Figure 9: Comparisons among the stress-strain curves derived from the double flat-jack tests performed.
