## **Inspection of Palladio's Bridge in Bassano del Grappa, Italy, using positioning techniques by ropes**

D. Foppoli

*Foppoli Moretta e Associati, Italy*

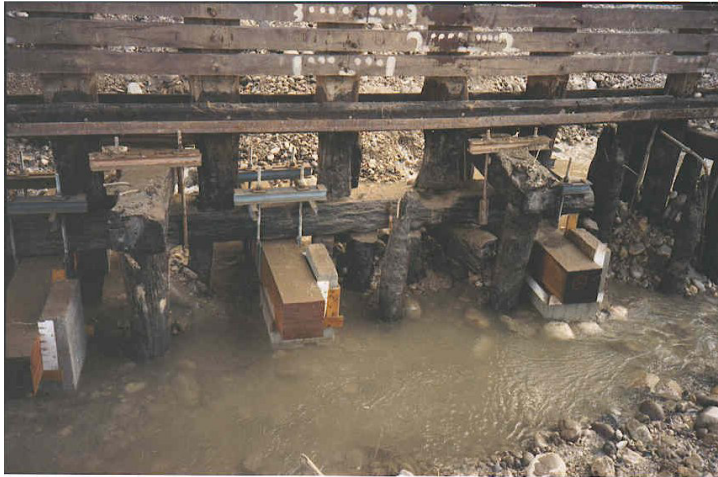
As seen in Fig. 3 in the riverbed at the base of the poles supporting the deck, another cross beam is placed which connects the poles and is supported by wooden crosspieces supported partially by wooden piles and partially by reinforced concrete piles placed during the last consolidation works.

An urgent intervention was made in consolidating the foundations and drilling for each pier four couples of reinforced concrete piles, with a reinforced concrete capital on the top, on which 4 wooden crosspieces were supported to sustain the transversal beam at the base of the poles (Fig. 3).

Figure 3: Cross beam at the base of the poles during the last restoration works.

The wooden structure was consolidated maintaining the existing elements, eliminating the decayed parts and restoring sections with casts of conglomerate resin mixed with quartz sands.

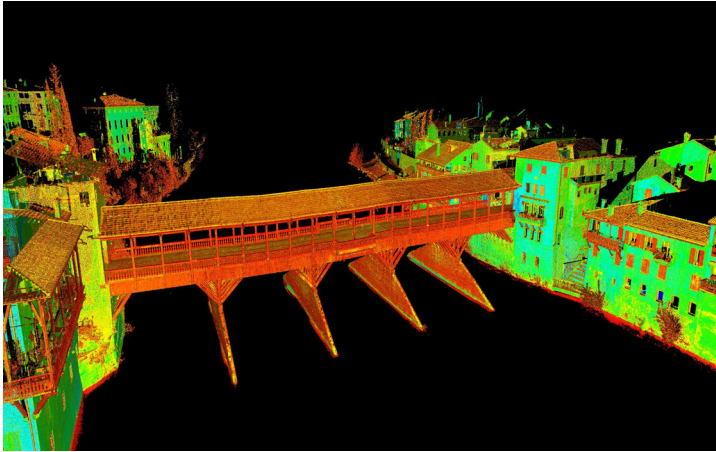
Figure 4: The point cloud obtained by laser-scanner survey.

The deformations of the roadway are evident at eyesight and it is reasonable to assume that they have developed after the placement of the pavement, which occurred in 1992. Their measure allows getting the current outline of deformation at the intrados of the bridge's deck. Feedback can also be sought by observing the strong deflection of the planks covering the piers. In this case too, it is reasonable to assume that in 1990–1991 the planks have been put in place with a proper horizontal alignment, so their actual geometrical irregularities indicate absolute settlements suffered by the structure after that date. In fact, the measures thus obtained converge satisfactorily providing a reasonable estimate of the absolute failures of the structure, which are very relevant, with maximum values of 35–41 cm for the 2nd pier.

With regard to the structure of the deck, inflections were also measured from the intrados of the current beams. These measurements, carried out span by span along three alignments, have drawn attention to the fact that in some cases the inflections assume high values, locally up to 25 cm (1/50 of the span) in the middle of the 2nd span.

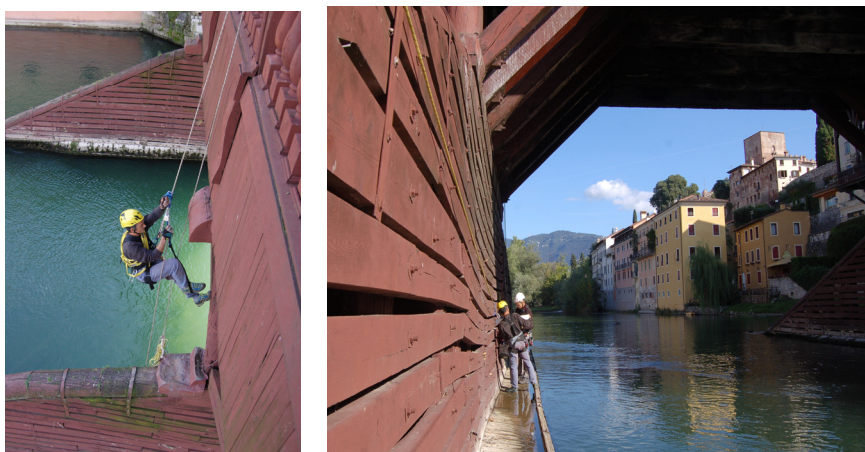
Figure 5: Inspection performed by ropes and measurement of drill resistance.

Where signs of deterioration such as cracks, fissures, torsions, wood rot and holes of xylophages insects were found, the visual investigation was integrated through the use of manual tools (awl and hammer). In this way it was possible to outline the area to be subjected to a more accurate instrumental analysis, carried out by Resistograph (Rinn [7]), in order to locate and quantify regions of internal decay on timber elements (Fig. 5 on the right).

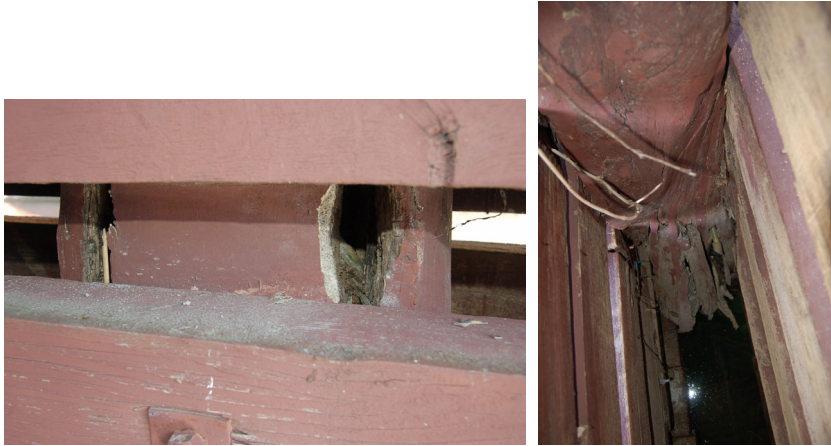
Almost all the elements are cracked at the centerline, perhaps because of the holes drilled to insert the threaded bars connecting the planks. Systematically within these cracks, extensive decay phenomena have developed generally connected to the formation of wood rot. It was also noted that where the past reinforcement with casted resin has been employed, separation and detachment between the resin and the wood at points of contact has occurred. Presumably, this phenomena is consequent to the cyclic wet-dry expansions due to changes in the level of river. These slots result in a preferential way of wood rot penetration, thus causing the incremental increase of the decay phenomena (Fig. 6 on the left). In correspondence of the 2nd pier it was also possible to photograph within the planks and therefore observe the complete decay of the lower part of the poles, (Fig. 6 on the right).

Figure 6: Decay phenomena at the contact between wood and resin casts and at the base of some poles.

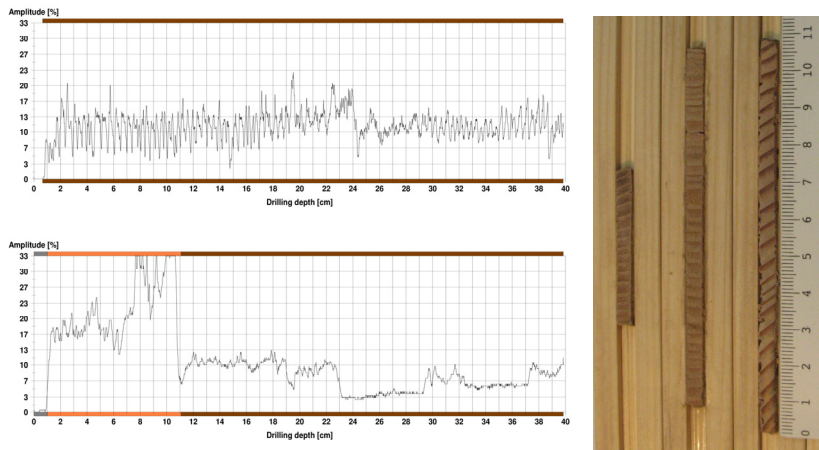
In order to analyze the elements for which plain signs of deterioration are not visible, the inspection has been integrated with instrumental techniques. Tests found significantly different values of drill resistance between the timber put in place at higher level (Fig. 7 on the left above), and the one that is directly affected by variations of water level (Fig. 7 on the left below).

The identification of wood samples (Fig. 7 on the right) was finally carried out using dichotomous record cards allowing for the identification of the timber used in the structure, among coniferous wood (*larix decidua*) with which the struts are made, and deciduous oak (presumably *durmast*) with which poles are made.

Figure 7: Drilling tests at lower and higher level of the structure, macroscopic observation of the section of wood samples.
