Restoration conservation works carried out at the historical Malabadi Bridge, Turkey

H. Sert, S. Yılmaz, M. Elbir, E. M. Partal, H. Demirci, A. Avşin, M. Nas & G. S. Turan *Ministry of Transport, Maritime Affairs and Communication, General Directorate of Highways, Department of Structures, Division of Historical Bridges, Turkey*

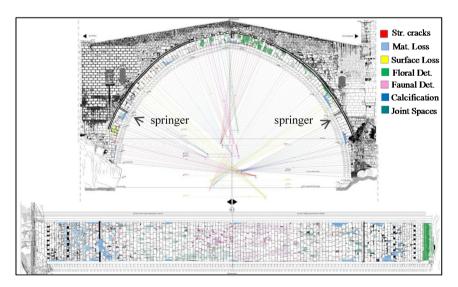
During surveys executed on June 2009, the bridge surfaces were scanned in 3D through ground laser scanning method and the bridge and its vicinity were documented with the survey drawings and photographs. Apart from such studies, the structural problems were determined the deteriorations observed on the stone were classified. Accordingly, there observed losses on the surfaces of the original stones in exfoliated form excluding the surfaces plastered during late period repairs, abrasions in coarse porosity form and detachments which may be in the form of various pieces at different dimensions and may get deeper occasionally. In addition, there observed structural and superficial cracks at springer level of the crushed masonry materials and the capillary cracks on the stone. All such visual observations are shown on the visual decay analysis in colored form with legends under the titles of superficial/structural cracks, material and surface losses, floral and faunal deteriorations, joint spaces etc. (Figure 7).

Figure 7: Visual decay form of K1 (main) arch of the bridge.

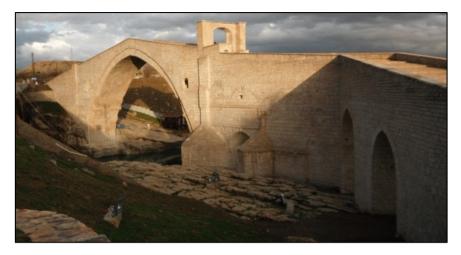
Figure 8: Historical Malabadi Bridge after restoration.
