# KNOX METROPOLITAN CHURCH BELL TOWER RESTORATION PROJECT

JUNE BOTKIN

Botkin Historic Building Conservators Ltd., Canada

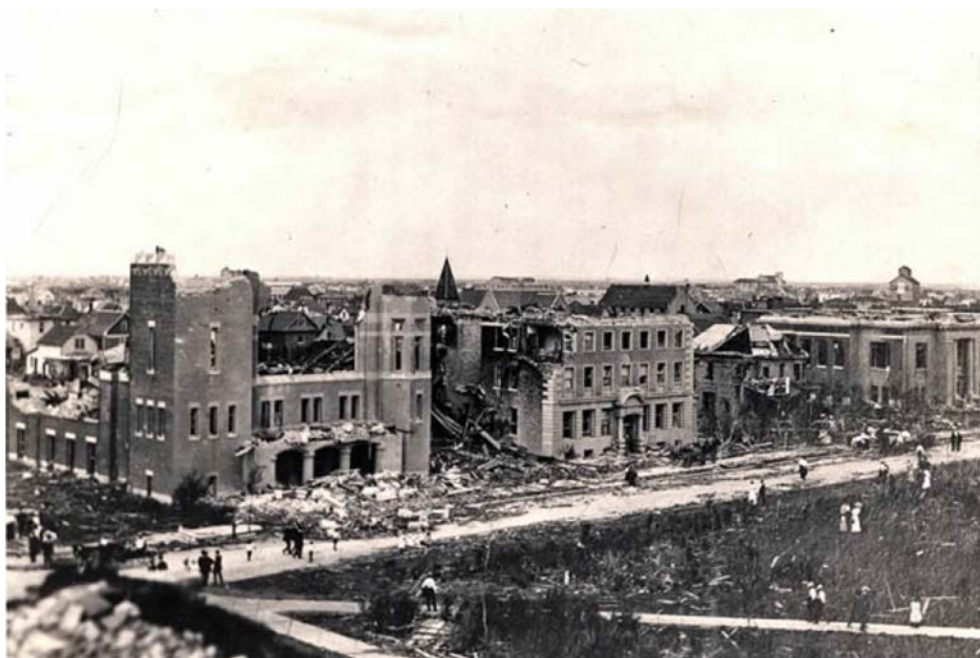
“The Leader described the damage to this building as “the most complete wreck of all.” The main entrance and a small portion of the wall is all that remains of the front of the building. The south wall and extension is gone except for about eight feet of bricks. This building will have to be entirely rebuilt” [2].

Figure 1: Destruction of Metropolitan Methodist Church and buildings along Lorne Street 1912.

Following this horrific event, the church, under the supervision of Francis Henry Portnall, was redesigned and rebuilt in the style in which it appears today. The quality of the workmanship during the rebuild and the required reuse of damaged building materials is what led to the present-day masonry conservation project undertaken on the top 15 m (50 feet) of the bell tower.

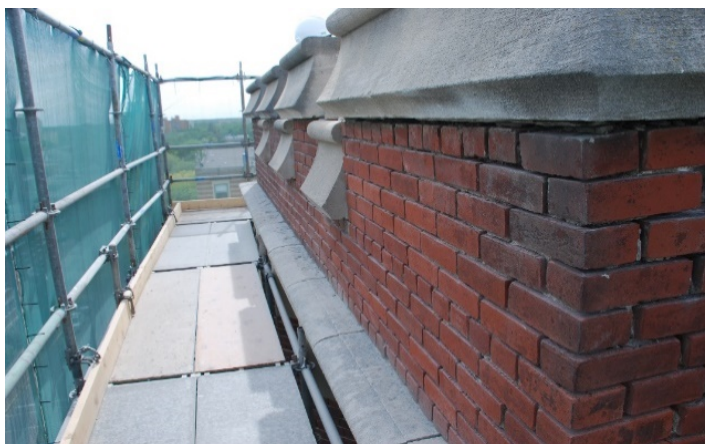
It was found that the amount of missing front point mortar and bedding mortar was more significant than originally thought (see Fig. 3). This meant that the building would require a complete repoint instead of performing selective repointing on each of the building faces as was first presumed. The condition of the stones was also confirmed and an area for demonstration work for each component of the masonry work being completed was chosen.

Figure 3: Masonry condition at parapet.

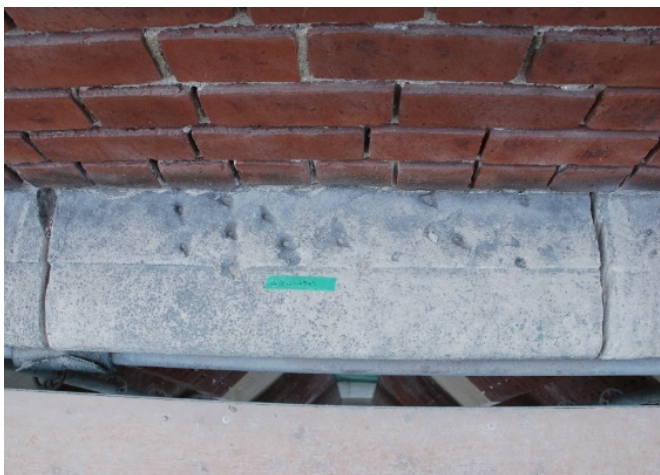
The bricks within the work area showed evidence of impact marks across their faces. In some locations, the top of the cornice stones were heavily pitted (see Fig. 4). This was a result of the stones being hurdled across the park during the tornado and because of how and where they were reinstalled during the rebuilding process.

The length of these stones also became inconsistent. Along the west face, multiple cornice stones were measured and found to be less than 381 mm (15") in length which created multiple mortar joints between the stones. These anomalies were believed to be caused by the stones being badly damaged and broken during the tornado which required them to be dressed into smaller usable lengths.

Figure 4: Pitted cornice stone.

Following the guidelines outlined in *The Conservation of Historic Places in Canada*, 2nd edition, the decision was made to leave the bulk of the impact marks in the stone and brick untouched. The Dutchman repairs completed in 1912 were left untouched as well. One Dutchman on the string course running along the bottom of the Louvres on the east side was replaced because an iron cramp holding the stone repair in place had become saturated with water causing rust jacking and spaulding. The cramp was carefully removed and a rust inhibitor applied to the iron cramp parts left in-situ. A new 6 mm (1/4") stainless steel threaded rod was drilled into the stone backer and epoxied in place. The stone replacement also had an 8 mm (5/16") hole drilled into it which was filled with epoxy and set into the repair pocket. The hole was made 2 mm (1/16") larger than the stainless-steel dowel to allow for expansion of the epoxy without damaging the stone. The stone was bedded in JAHN M70 restoration mortar and the joint line around the Dutchman finished flush with the surrounding stone surfaces.

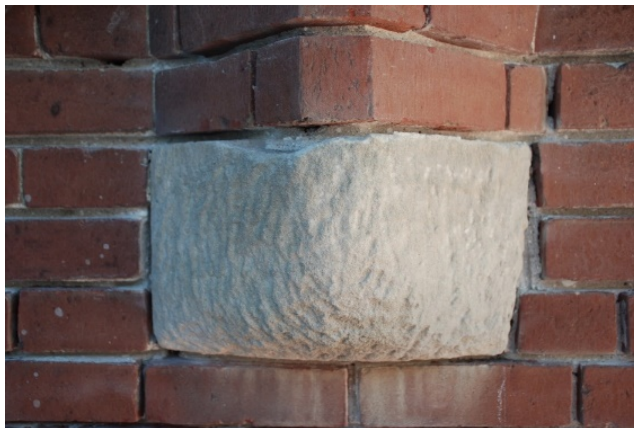
The string course wrapping the building at the top of the Louver's had numerous Dutchman repairs where the stone had not been properly seated in the repair pocket. In some locations where a large stone would have originally been placed, smaller stones were set and carved to replicate the original features. This would have also been the result of damage to the stones during the tornado and the requirement to dress the stone to a useable size. In one case this was not possible and, as a result, a bowl on the north face of the tower was only partially carved and hidden from view (see Fig. 5).

This partially carved stone allowed for the continuity of the brick coursing to be carried around the building face and remain consistent throughout the rebuild.

Figure 5: Partially carved bowl.

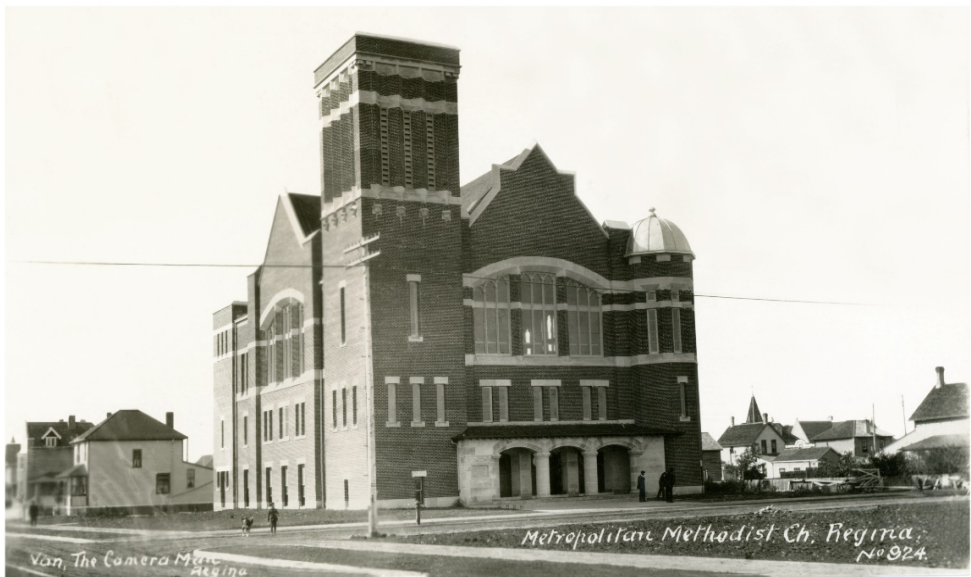
The large windows inserted in the upper gable ends on the north, south and east faces had been recreated in a different design style. The original windows were segmentally headed with three sets of three glazing units separated by brick pilasters. Below the main window were three pairs of smaller rectangular windows each with an Indiana limestone lintel. The sill extended across the face of the building (see Fig. 6).

Figure 6: Metropolitan Methodist Church looking West, circa 1907.

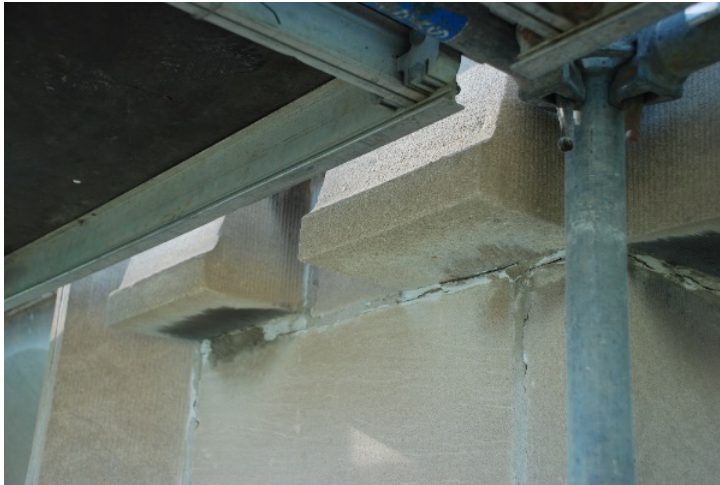
Cleaning was undertaken over two days; November 18 and 19, 2016 with temperatures below –6°C (42.8°F). Due to these temperatures, the lowest pressure that could be reached safely was 22 psi. On day 1, the parapet had been cleaned and the level below had just been started. The west face of the cap stones along the top of the parapet proved problematic to clean. This was partly because of the weather affecting the equipment and partly because of the location. After the initial cleaning, further cleaning was required to remove wand marks and black staining without damaging the patina of the stone. Another problem area proved to be the underside of the dentals below the cornice (see Fig. 8).

Due to water runoff down the face of the dentals, some areas were stained black. It was impossible to remove all the staining without causing permanent damage to the stones so it was decided to leave the residual staining as it would appear as a shadow from the ground. A small area of brick was also cleaned as a test to remove lime stains resulting from repointing. The lime stains were caused by an unexpected thunderstorm where the wet mortar

Figure 8: Dental staining.
