LONG-TERM MONITORING AND COMPARATIVE ANALYSIS OF THE DURABILITY OF LIME-BASED RENDERS

ESKO SISTONEN, KALYANI KUMAR & PETRI MUTANEN
Department of Civil Engineering, Aalto University, Finland

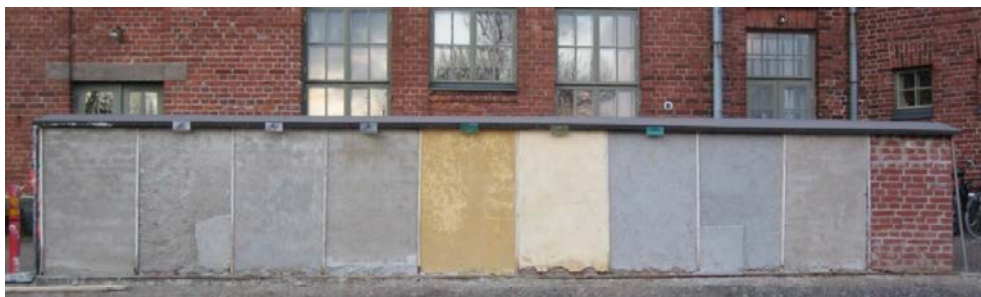
Figure 1: Original test wall in Suomenlinna Sea Fortress, as seen in July 2015.

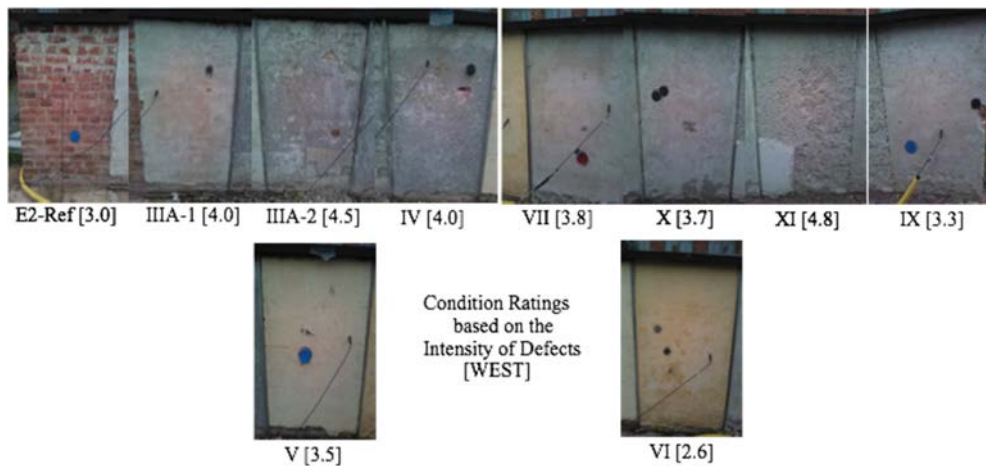
Figure 7: Schematic representation of condition ratings for the West Side of test wall.

Based on the laboratory tests performed on the samples collected in the summer of 2015, the condition of the render surfaces on the West Side of the test wall can be discussed. Mortar VII (Table 2), which was a ready-mix lime-cement mortar, was not painted and appeared to have lots of cracks on its surface. This mortar was fully carbonated and was in poor condition as can be seen from the condition assessment report. This mortar sample went through the most number of tests in this study and its high water-binder ratio caused it to perform poor in certain tests. Mortars X and XI were lime-pozzolana mortars and a drilled sample was not taken from mortar XI (KP50/50/650) because it was extensively damaged and drilling was not possible at all. It appeared to be in bad condition on visual inspection and thus, it performed very badly during the condition assessment as well. Mortar X (KP80/20/650) appeared to be in a good condition on visual inspection but it performed poorly in the laboratory tests although detailed experimental analysis was not carried out for this sample as it was also broken during drilling [1].

The remaining mortars IX, V, IV, IIIA-2 and III-A1 were hydraulic lime mortars and performed in similar manners. Mortar IIIA-2 appeared to be in bad condition even visually and its rough surface was due to the high amount of aggregates. Mortar had fallen from the wall in most parts of the section. The section was very hollow and could not support the drilling machine to extract the mortar sample so a hammered sample was taken from its surface. This mortar was based on the recipe with higher water-binder ratios compared to other recipes, which may be the reason behind its poor performance in tests such as tensile strength and water absorption. Mortar IV was made with the least amount of aggregates. It was quite deteriorated and broken during drilling and looked bad with many cracks all over its surface. Mortar V performed satisfactorily in the tests although it had lots of large cracks on its surface. Mortar IX was rendered in cold weather (November 2008) and its late rendering caused frost damage especially in the lower parts of the wall, but overall it performed well due to its good mix composition [1].

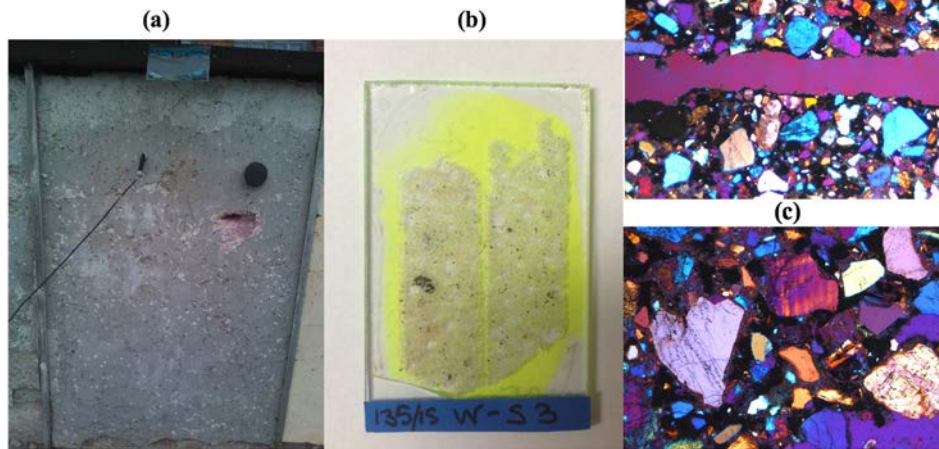
West Side: Section IV - WP 5-T

Presently, with the accumulated data, it is unwise to make any further assessments about the other renderings, or do a comparative analysis. Figs 8 and 9 give an example of a less deteriorated render section on the west side of the wall. Fig. 8 shows the relative humidity and temperature trend for the same render over a period of 16 months.

Figure 8: An example from Render Section IV of the West Side of test wall. (a) The rendering; (b) The thin section; (c) Microscopic images from the thin-section.
