# VISUAL DOCUMENTATION OF THE STATE OF CONSERVATION BY MEANS OF UAV: THE CASE OF MARBLE CLADDING SYSTEM ON THE FAÇADES OF THE BRAZILIAN PALACE OF CONGRESS

BRUNA BARBOSA LIMA & VANDA ALICE GARCIA ZANONI  
Faculdade de Arquitetura e Urbanismo, Universidade de Brasília, Brazil

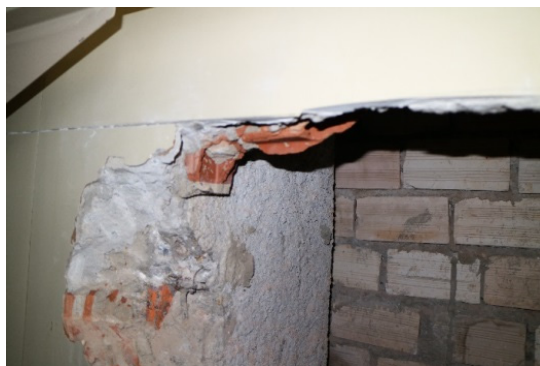
A prospecting on the outer wall of the Southeast gable showed the presence of 20 mm marble slabs and 1/8 galvanized steel fixation wires at the back of the slabs. Petrographic tests carried out on samples of stone from this area suggested that they are interventions subsequent to the building construction, and interviews conducted with the teams responsible for building maintenance corroborate this hypothesis.

The internal prospecting of the Northwest façade confirmed the existence of double walls, according to the original designs. The outer wall, the support of the façade cladding system, is made of 6-hole ceramic bricks and dimensions of 14 cm x 19 cm x 9 cm of light brown colour, which probably indicates a brick of high burning and greater resistance. The masonry type of seating observed is very common in external vertical wall systems due to resistance and water tightness improving. The internal masonry, in its turn, has 8-hole clay red ceramic bricks of 19 cm x 19 cm x 9 cm (Figs 3 and 4). It is also possible to observe at Fig. 3 the pillar of concrete and steel located between the double walls.

Figure 3: Prospecting at the south tower, northwest gable. (Source: Author, 2018.)
