Seismic behaviour and strengthening of a vulnerable structure

F. V. Karantoni

University of Patras, Department of Civil Engineering, Greece

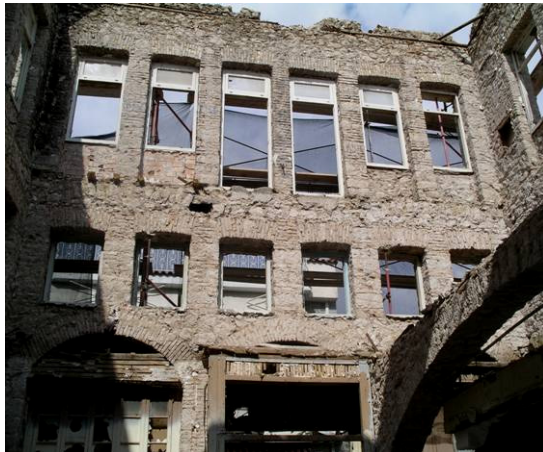
Figure 2: The inside north side of the building.

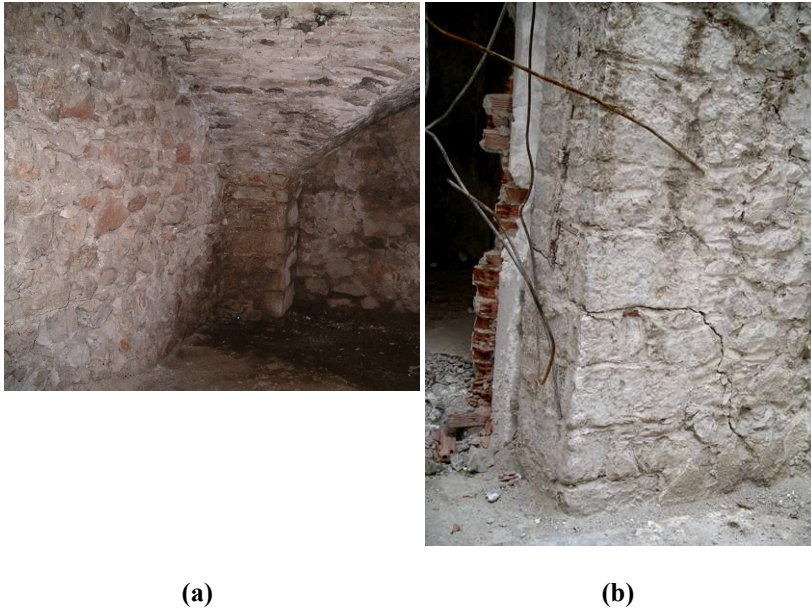
It is worth mentioning that the masonry has not developed seismic damage though the neighbourhood has been shaken by earthquakes during the life of the structure. The damage to the walls is caused by human interventions and by decay due to the lack of conservation and has led to a serious degradation of the masonry quality. The poor condition of the masonry and the high percentage of openings increase the seismic vulnerability of this structure; yet in spite of

Figure 3: (a) The basement, and (b) the cracked arced wall of the ground floor.

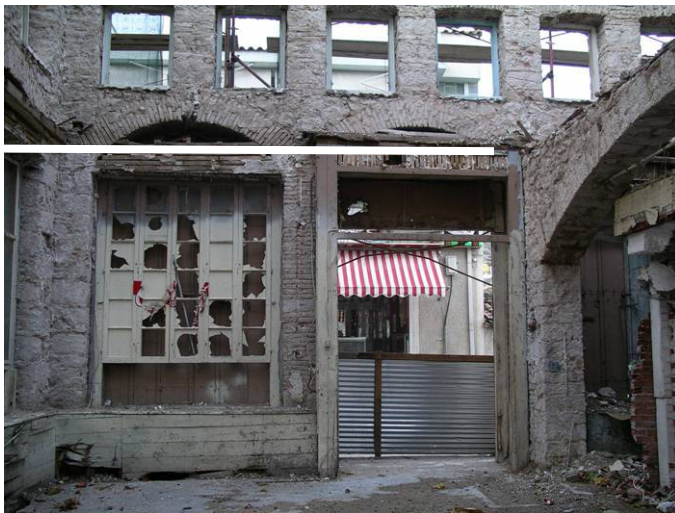
The building was erected around 1900 AD. The data collected shows that it was built in two phases. One part of the building has three storeys with a total height of 11.2 m, and the other part has two storeys with a total height of 7.0 m. The adjacent wall (running from east to west) carries the load from the two parts. Each one of the two sections has a basement. In Fig. 1 the plane view of the storeys is presented. The main material of the structural walls is uncoarsed stone masonry but some parts are of solid bricks and some other of parallel alternate rows of solid bricks and stone. The building has floors of wooden beams and a roof of wooden truss and clay tiles and its main characteristic is the high percentage of openings in the north and the west side (71% of the length of the walls, see Figs. 1 and 2), and the two cross vaults which constitute the basement roof (see Fig. 3). One of the four columns, which support each one of the cross vaults, is also shown in Fig. 3. These columns are not in conjunction to the structural walls but they are 50 mm apart. The openings in the south face have been filled up with stone and cement blocks. The openings in the west side of the second storey of the two storey part of the building have also been filled up. These walls are embedded to the adjacent walls and are not jointed to them. This yields the separation of the majority of the vertical interfaces due to developed cracking. On the ground floor the only internal wall running from north to south is supported from the vaulted roof of the basement and was added after the erection of the building. This wall has developed diagonal cracking near the lower part due to settlement. Another unusual characteristic is that the openings of the ground story intersect the floor of the first storey (see Fig. 4).

Figure 4: The inserted trace of the second storey floor, which intersects the arced openings.

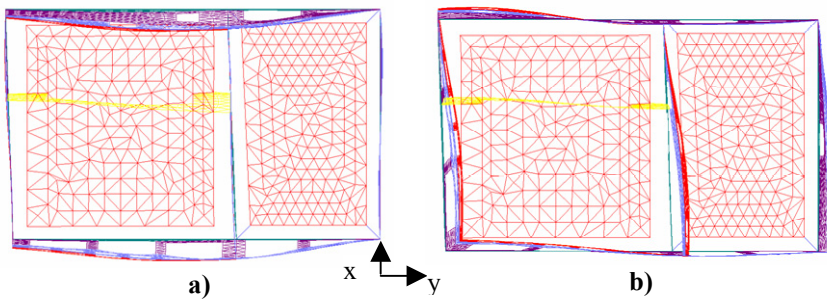
The modal shapes of the first significant mode of each direction are presented in Fig. 7. As is shown, the main characteristic of the modal shape in x direction (with natural period $T_x = 0.43$ sec) is the out-of-plane bending of the walls transverse to the x axis. The modal shape in y direction (with natural period $T_y = 0.29$ sec) is also the out-of-plane bending accompanied with rotation about the corner adjacent to the most stiff east and south walls.

Figure 7: The modal shapes of the original building along: (a) x, and (b) y axes in plane view.

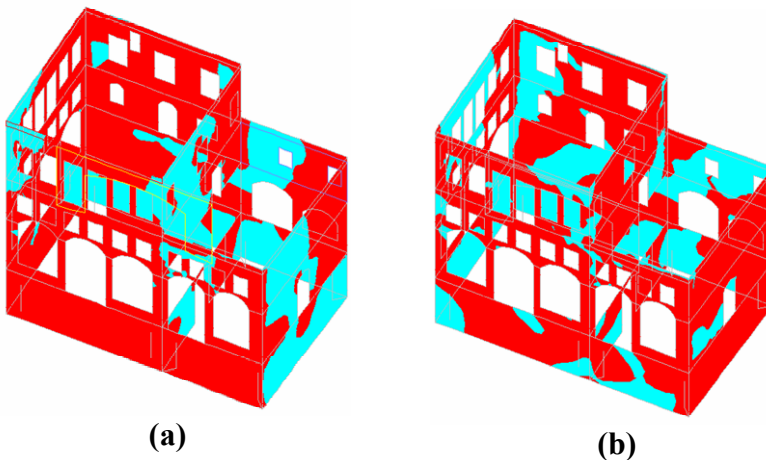
overstressed. In Fig. 8 the red (dark, in black and white mode) area represents the area of the walls where the principal tensile contours of inner face of the wall exceed the tensile strength of masonry. It is shown that only a small part of the building can sustain the design loads. The fact that the building remains without any seismic damage over one hundred years is due to the probabilistic determination of the design seismic loads. As is well known, the seismic loads are determined for an earthquake with repeat period of 475 years.

Figure 8: Contours of principal tensile stresses of the inner side of the masonry of the original building for: (a) load combination $G+0.3Q-E_x+0.3E_y$, and (b) $G+0.3Q-0.3E_x-E_y$. The stresses of dark (red) areas exceed the tensile strength of the masonry.

These discouraged results of the analysis in combination with the restrictions for the strengthening measures required the need of examining the effectiveness of various techniques [5–7]. Eleven new analyses were made for the assessment of various proposals. In the section that follows the most effective measure is presented.

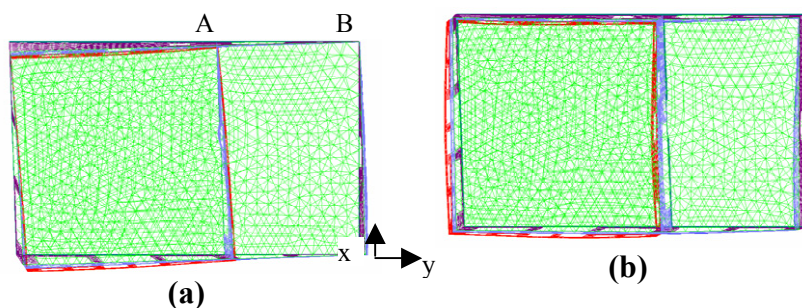
Figure 9: The modal shapes of the strengthened building along: (a) x, and (b) y axes, in plane view.

A new spectral analysis was performed taking into account the modification of the structural system and the masonry properties. In Fig. 9 the modal shapes after the abovementioned strengthening techniques are shown. For excitation along the x axis, the walls of the three-storey section rotate about its south-east corner indicated by the letter A in Fig. 9 and the walls of the two-storey section rotate about the corner indicated by the letter B in Fig. 9. For excitation about the y axis, a translation of all the walls along to the axis is observed. The natural periods of the modified building are found to be $T_x=0.14$ sec and $T_y=0.11$ sec. Given that $T < T_1$, the calculation of the seismic load is obtained using Equation (2) with $q=1.5$ for the strengthened building, which gave a spectral acceleration $0.413g$. The measures result in a dramatic reduction of the principal tensile stresses on masonry as shown in Fig. 10. Indeed, only some elements at the springs of arced openings of the ground storey seem to be overstressed. Local prestressing on these areas may entirely solve the problem.

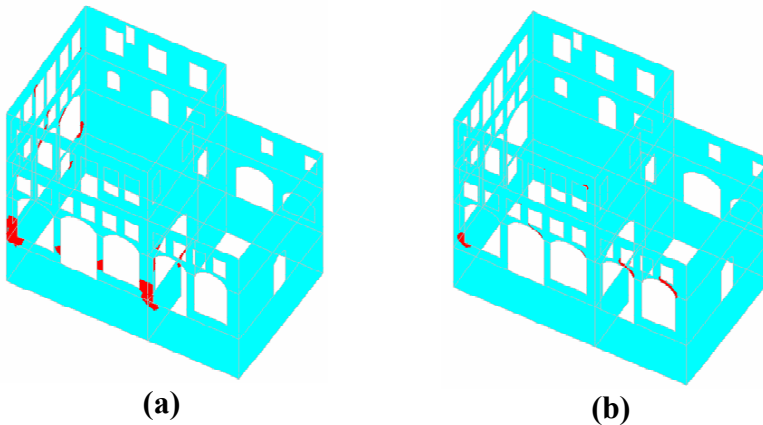
Figure 10: Contours of principal tensile stresses of the inner side of the masonry of the strengthened building for: (a) load combination $G+0.3Q-E_x+0.3E_y$, and (b) $G+0.3Q-0.3E_x-E_y$. The stresses shown as dark (red) areas exceed the tensile strength of the masonry.
