An outline of RC buildings performance under tsunami triggered by the East Japan Great Earthquake

C. Cuadra & S. Ishiyama

*Department of Architectural and Environment Systems,
Akita Prefectural University, Japan*

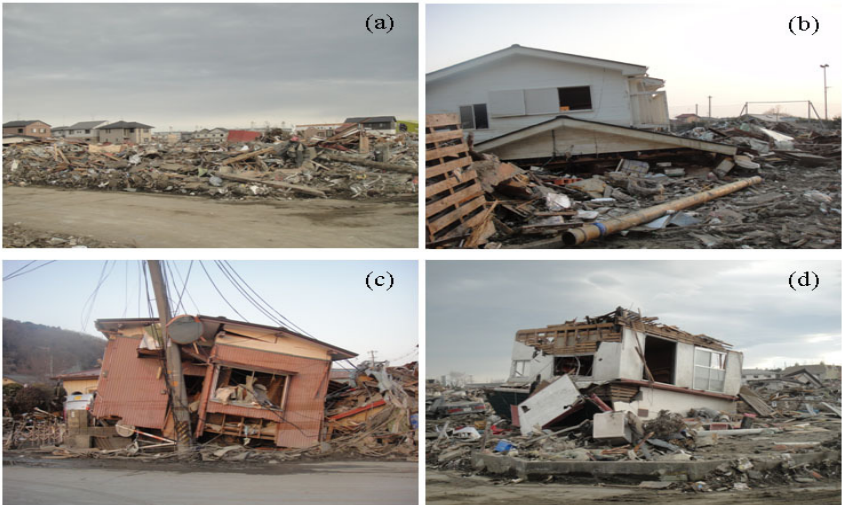
Figure 5: Damage on wooden houses.

Figure 5 shows some typical damage on wooden houses that was produced by the tsunami. In Figure 5(a) from the wooden debris, it can be observed that houses were destroyed by the tsunami action. It can be also observed that houses located on high sites were not affected. In Figures 5(b) and 5(c) the first floor was destroyed by the tsunami and the upper parts of the houses were transported and then left by the tsunami in a different place from their original location. In the case of Figure 5(d) the tsunami destroyed the first floor and also produced the overturning of the remaining upper floor.

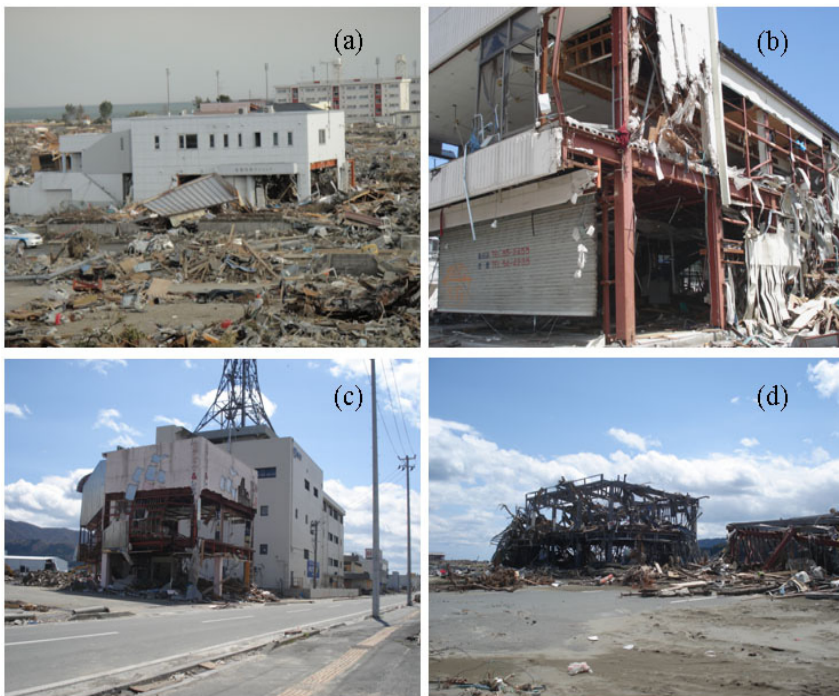
Figure 6: Damage on steel structures.

the lateral stiffness is appropriately designed to resist the earthquake force. However, during the tsunami attack the water pressure acting on panels or in general in elements of a large area generated large lateral forces that destroyed that non-structural elements and in some cases the failure of these elements led to the failure and even the collapse of the main structure.

Damage on steel structures can be observed in Figure 6. When the inundation depth reached only the first floor the structure remained almost intact; however, the wall panels of the first floor suffered some damage as can be observed in Figure 6(a). In Figures 6(b) and 6(c) the inundation depth reached the second floor and wall panels and ceiling were destroyed. In this case, the structures remained standing up; however, some local failure of the structural elements was observed. Figure 6(d) shows a total collapse of steel structures. In this case, the building was completely covered by water.

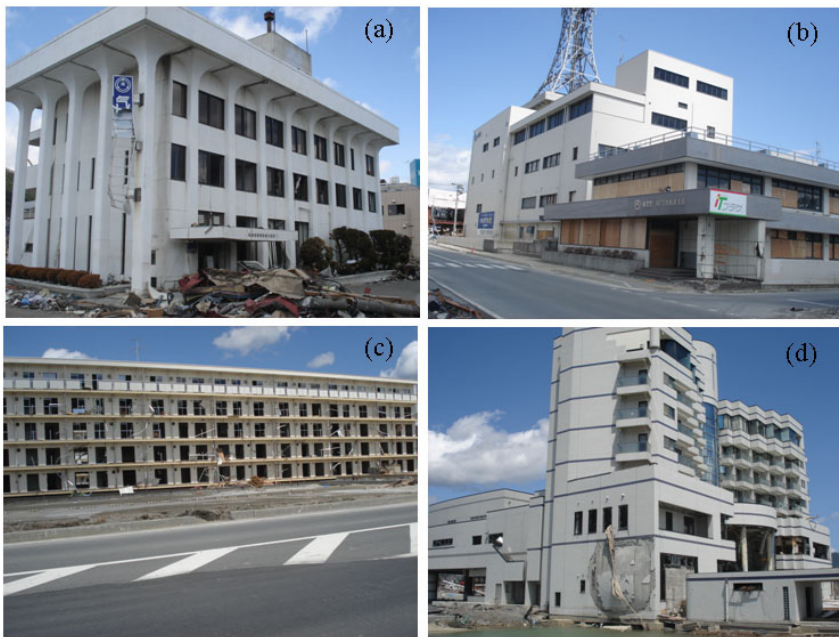
Figure 7: RC buildings after tsunami attack.

Many reinforced concrete structures resisted the tsunami action without collapse as can be observed in Figure 7. Figure 7(a) is the building of a local bank located at Funato city, and it can be observed from the damage of the windows that the tsunami reached the second floor. In Figure 7(b) it is also inferred that the

tsunami reached the second floor by observing that the window panes were destroyed and now are replaced by wooden panels. Figure 7(c) is an apartment building located at Rikusentakata city and, from the damage of the balconies, it is inferred that the tsunami reached the fourth floor. Figure 7(d) shows the condition of a hotel building located very near the shoreline. The building resisted the tsunami attack; however, the lower floors suffered the destruction of the non-structural elements and also, as can be observed in the figure, there was damage of a reinforced concrete wall due to the lateral water pressure. In this building it was also observed that the cover concrete of structural elements that columns spilled out, probably due to a combination of earthquake vibration action and posterior tsunami.

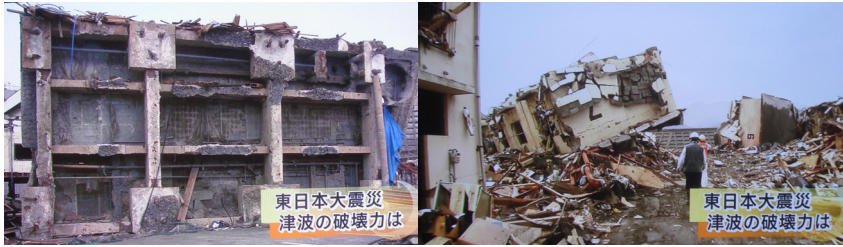
Figure 8: Damage on reinforced concrete buildings.

In general, reinforced concrete buildings did not collapse; however, under certain conditions, the tsunami action caused the overturning and even transportation of the building from its original location. This is reported by a survey team of the Tohoku Branch of the Architectural Institute of Japan [3]. This damage occurred at Onagawa town and the affected buildings were buildings with weak foundations, and with shapes like boxes that do not permit the transit of the water and facilitate the action of the floating force. In Figure 8 damage of these buildings, presented by the Japanese Broadcasting Television (NHK), is shown.
