## Case study: the strengthening and seismic safety of the Oni synagogue in Georgia

### Abstract

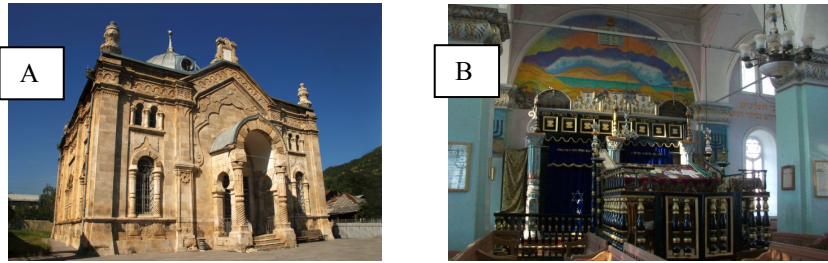
Figure 1: The synagogue in Oni after the strengthening and restoration: A – general view; B – interior.

Temporary conservation of the building after earthquake has not been carried out. Despite this, further damage to the drum and the dome during the aftershock period did not occur. Retrofitting of these structures was completed two years later. Permanent conservation (authors of the project of conservation of the Synagogue complex-architect are Prof. S. Bostanashvili and structural engineer Dr. M. Dinielashvili) was aimed primarily at strengthening of bearing walls, arches, corner vaults, portico, stele, sculptures, drum, etc. (Fig. 1). The project included the following major steps [8]:

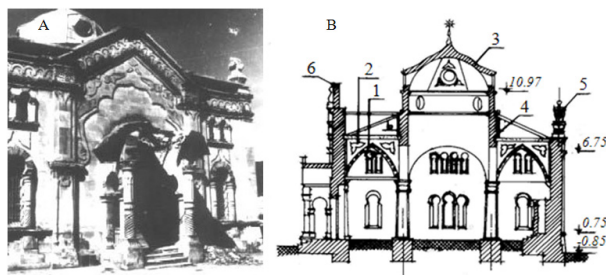
The earthquake caused substantial damage to the building, which did not collapse, however, due to its symmetrical structure, rigid walls, steel ties, and small arch spans. Overall views of the building after earthquake are presented in Figure 3A. Cracks developed in actually all bearing elements, such as arches, shell, external walls, and in the drum (Fig. 4). The crack opening in the arches was 5–10 mm. Many architectural elements and sculptures situated outside, at the facades, were severely damaged. Some of them collapsed, including fragments of walls (Fig. 3).

Figure 3: The synagogue in Oni: A – view after the earthquake; B – the cross section: 1 – arch; 2 – ceiling; 3 – dome; 4 – drum; 5 – collapsed sculpture; 6 – collapsed facade element; 7 – collapsed portico.

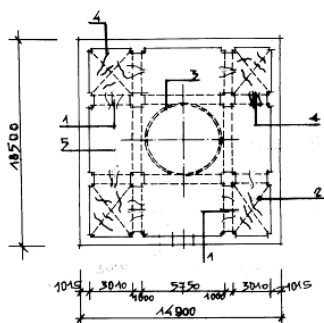
Figure 4: Plafond plan with the cracks shown: 1 – arch; 2 – surmounted vaults ceiling; 3 – dome; 4 – cracks; 5 – wooden ceiling.

- Removal of plaster, thorough cleaning, and filling of cracks with cement-lime mortar. Steel wedges were used to control complete filling of wide cracks (>6 mm).
- Reinforced plastering of arch and shell surfaces in damaged areas. One layer of steel meshes (150x150 mm) of  $\varnothing 6$  mm wires served as reinforcement. The meshes were tied to  $\varnothing 10$  mm steel anchors, each situated in a pre-drilled hole

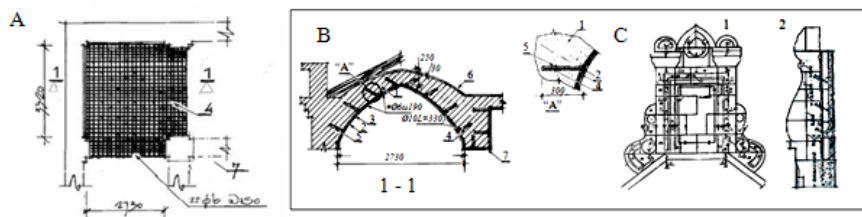
Figure 5: Details of strengthening (dimensions in mm). A, B – details of arches and vaults reinforcement: 1 – arch; 2 – reinforced plastering layer; 3 – steel mesh; 4 – drilling; 5 – steel anchor C – strengthening of the frontal stele: 1 – frontal facade; 2 – lateral facade

at a  $30^\circ$  angle to the surface (Fig. 6). Cement - lime mortar was applied ( $f_{ck} = 10$  MPa), so that the layer thickness was 40 mm.

- Strengthening of the drum. Thin  $10 \times 10$  mm mesh of  $\phi 1$  mm wires was used for external reinforcement. Cement lime mortar ( $f_{ck} = 10$  MPa) was applied to provide a 30 mm layer.
- Restoration of non – bearing external parts and architectural elements of the building, using similar techniques.

Details of strengthening are shown in Figure 5. As a result of the strengthening the capacity bearing of the above structures elements and seismic resistance became higher than they were before the earthquake.

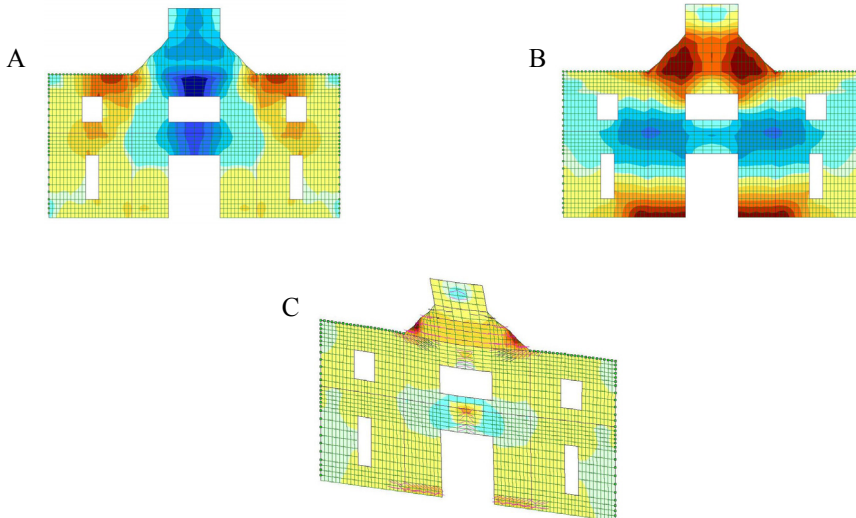
Figure 12: Non-linear analyses of frontal walls: A – Bending moments in X direction; B – Bending moments in Y direction; C – Principal stresses (destruction bottom layer).
